**PROSIECT LIFE+ CORSYDD MÔN A LLŶN  
ANGLESEY AND LLŶN FENS LIFE+ PROJECT  
LIFE 07 NAT UK 000948**

**RESTORATION OF A KEY GROUNDWATER SUPPLY  
PATHWAY AND RELATED HYDROLOGICAL RESTORATION  
WORK AT CORS BODEILIO NATIONAL NATURE RESERVE**

**Final Report of the Anglesey & Llyn Fens LIFE Project: Technical Report No. 2.**

<b>Version</b>	<b>1</b>
<b>Authors</b>	<b>Peter Jones, Justin Hanson, Rhoswen Leonard and Janine Guest</b>
<b>Date</b>	<b>23 December 2014</b>

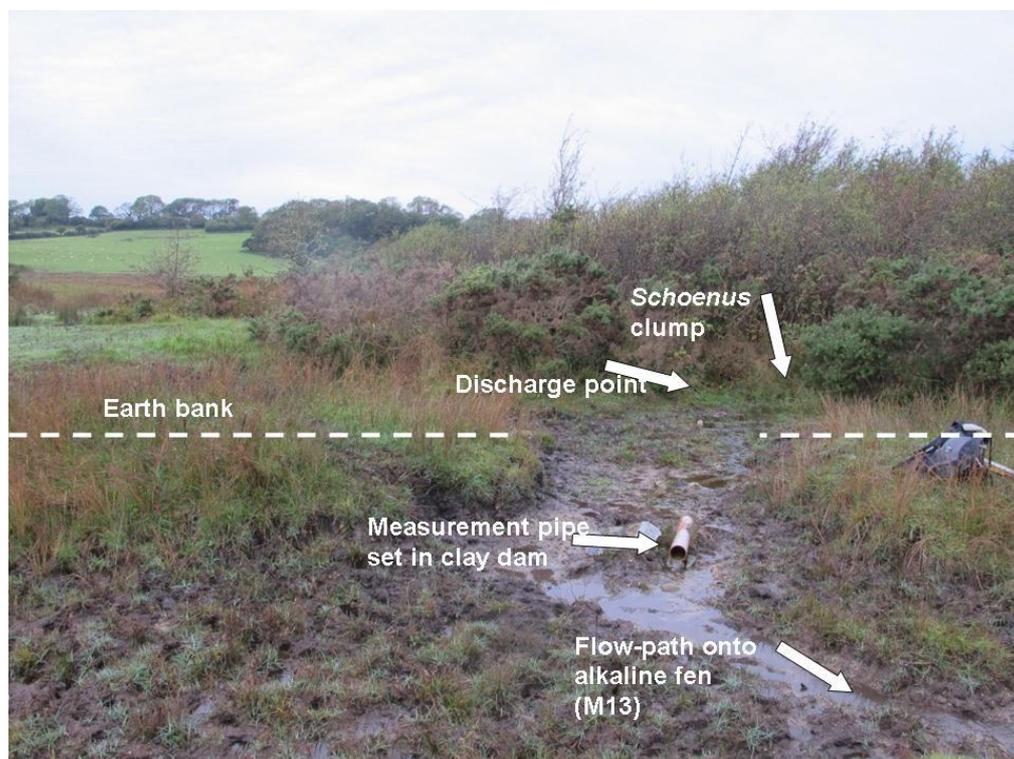
**Figure 4.** Flow gauging at Fly Orchid Spring, 18 October 2013, looking W from just below discharge point. Note heavy poaching by ponies in the foreground. A few *Schoenus* clumps occur at the discharge point and well above the main expanse of M13 vegetation (behind the photographer).

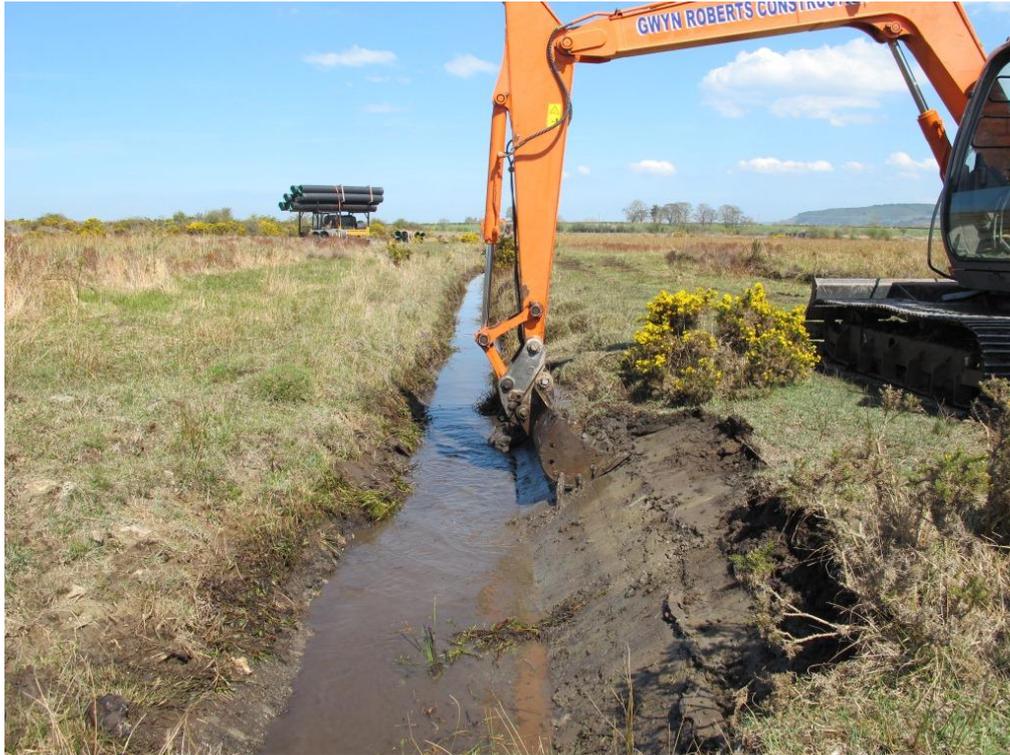
**Figure 13.** Cleaning of ditch section A-B to create a graded bed for the bypass pipe. Sections of bypass pipe can be seen in the distance tied onto a steel cage mounted on a tracked dumper. Image taken 7 May 2013, looking NE from close to point A. Original image number IMG\_8085.

Ditch cleaning was preceded by an operation to strip *Schoenus* turfs from the ditch flanks; these were placed to one-side ready for reinstatement. The pipe sections used are 6 m sections of 450 mm diameter twin-wall high-density polyethylene pipe<sup>5</sup> and a total of 145 m was installed. The post-installation fall in level from inlet to outlet is 25.5 cm (0.17%). The pipe is fitted with two rectangular inspection hatches and with an adjustable 90 degree bend fitted over the end of the pipe intake (Figure 15, 16). Under high water level (typically winter-time) conditions, the outflow of the pipe is almost or completely submerged as a result of measures to raise water levels in ditch section B-C. Both the pipe inlet and outlet were finished with surrounding stone headwalls constructed as dry-stone features from limestone dug up during the initial ditch cleaning (Figure 15). An option to locate transverse impermeable seals along the former ditch line was considered but ultimately rejected as un-necessary: leakage of water along the former ditch course does not appear to be significant. Measures to positively anchor the pipe in the excavated ditch profile were discussed on-site with the contractor but ultimately rejected as un-necessary. However, during the summer of 2014 a section of pipe close to point A 'floated' to a point where it actually broke through the peat covering in a few places. Remediation works will need to be undertaken during the after-LIFE phase.

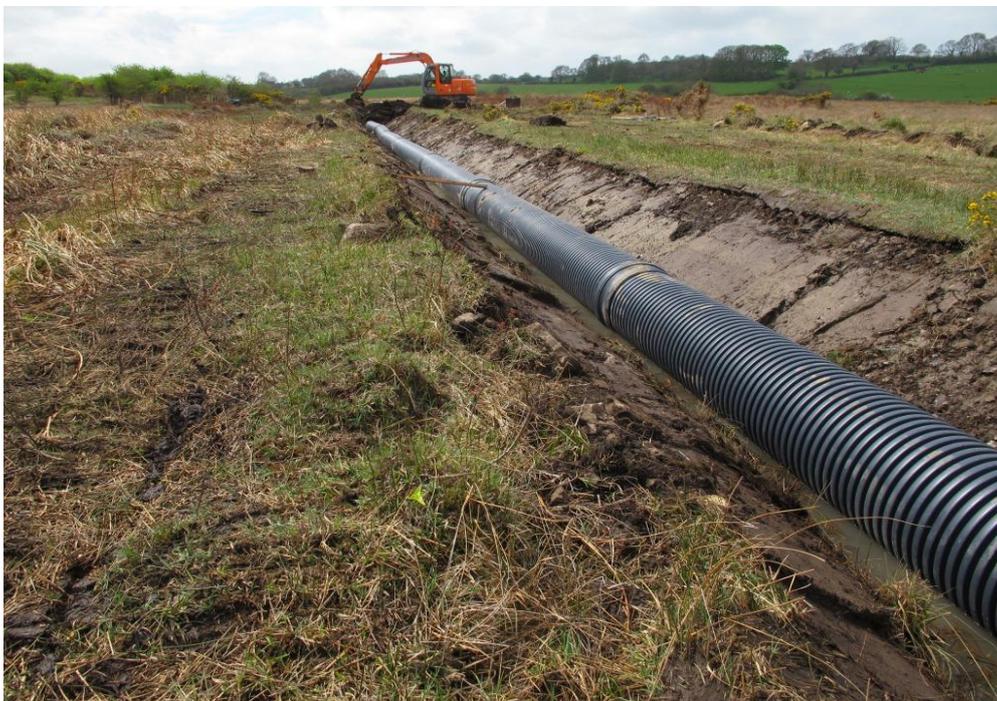
**Figure 14.** Infill of ditch section A-B and burial of the bypass pipe at Cors Bodeilio NNR, 8 May 2013. The peat infill visible in the distance was sourced from peat cutting areas in compartment CB1NE. Photo looking SW with Ynys on left. Original file number IMG\_8110.

The infilled ditch surface was finished slightly proud of surrounding ground level to allow for settlement, with *Schoenus* turfs bedded in at locations close to their original position along the ditch axis. Care was taken to ensure material was replaced in the correct stratigraphic order. Ponding of water on the upslope side of the infilled ditch was noted in places and dealt with by excavating shallow runnels over the infill (Figure 23a). These could be infilled in due course, though most were observed to support significant growths of *Chara* by the winter of 2013/14.

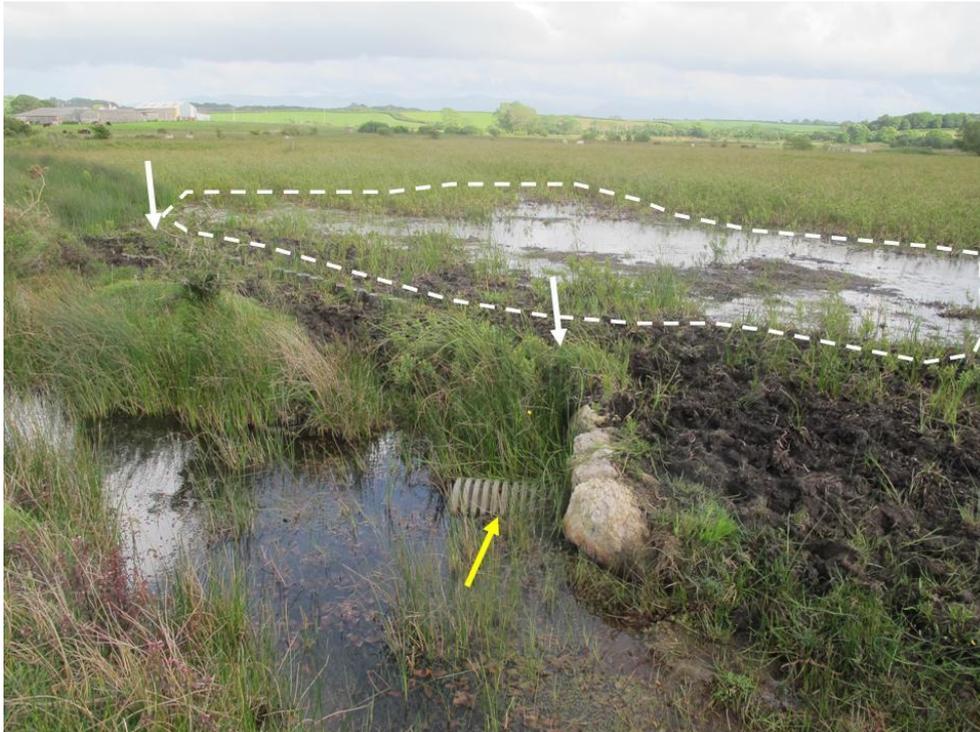
**Figure 22.** Image looking SE from the bypass pipe outlet (see yellow arrow – this is point B of Figure 1) showing standing water (shown bordered by the white dashed line – note that standing water continues beyond into the *Cladium* stand), with the two white arrows denoting the plastic piling dam at the edge of the peat body. The standing water in the foreground is part of ditch section B-C, where water levels have been raised through installation of plastic dams in the ditch – see Figure 25b. Image IMG\_5942, 10 June 2014.

The use of hexagonal plastic piling for raising ditch water levels and water levels within the peat has worked well and can be recommended for similar applications elsewhere. The plastic-piled dam at the end of the bypass pipe (see Figure 22) should be extended E to prevent outflow of water over peat.

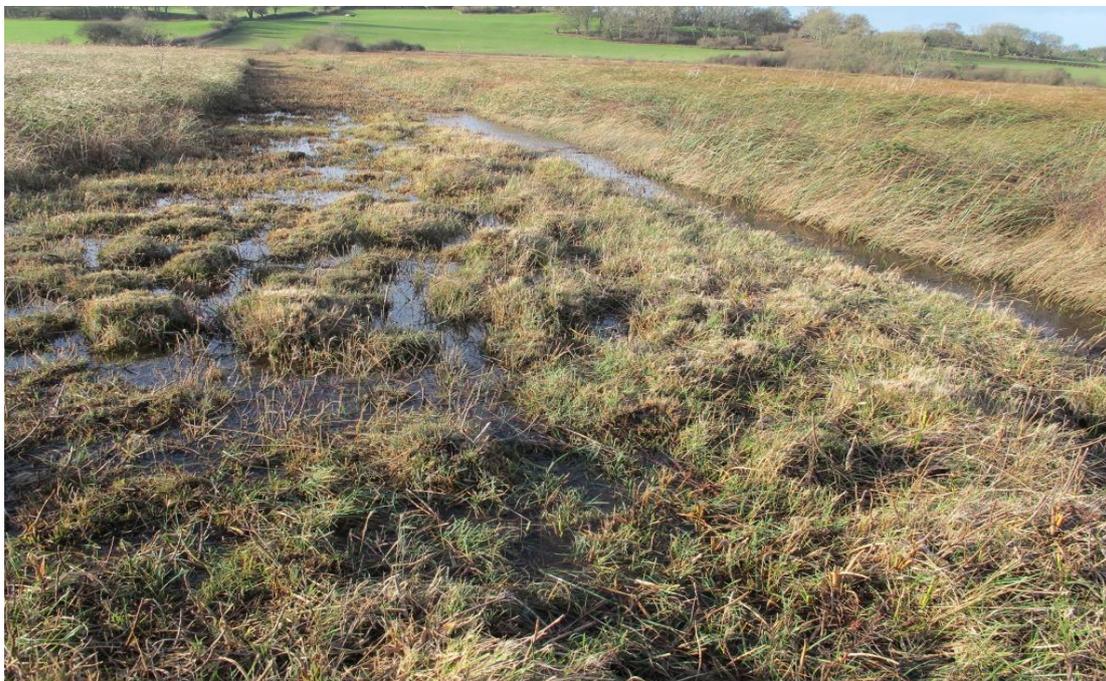
Ditch water levels upstream of the bypass pipe intake are now significantly higher, with almost bank-full conditions noted during the winter and after periods of rainfall (Figure 24). Ditch water levels have also been raised in ditch section B-C (Figure 25 a & b), though bank-full conditions could not have been achieved without immersion of the bypass pipe outlet.

**Figure 24.** View looking upstream from point X towards point D (see Figure 1 for locations) on 24 December 2013. Note the high water level in the ditch and in the area of mown fen to the left (S) of the drain. Water level transect T1 crosses this drain from S to N (L to R in this image) in the distance. Original image number IMG\_3689.

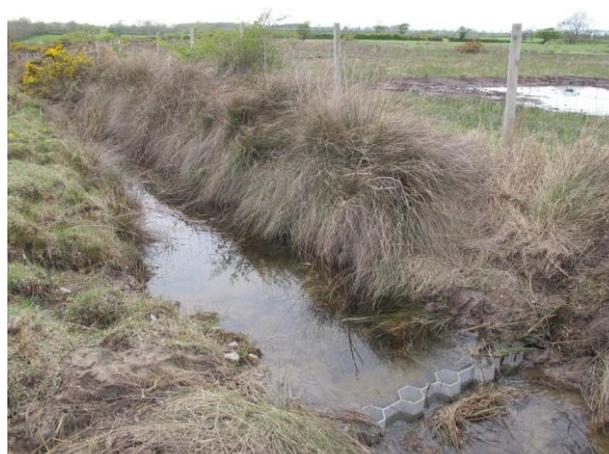
**Figure 25b.** View looking NW up ditch section B-C showing one of the hexagonal plastic dams in the foreground, peat cutting 2 on the N side of the ditch, and a dense strip of *Schoenus* tussocks on the northern ditch bank. Image date 14 May 2013, original file number IMG\_8308.
