Arboricultural Impact Assessment

Roath Flood Risk Management Scheme
Roath Brook
Cardiff

Report Date: 10th April 2017

Project no: 624

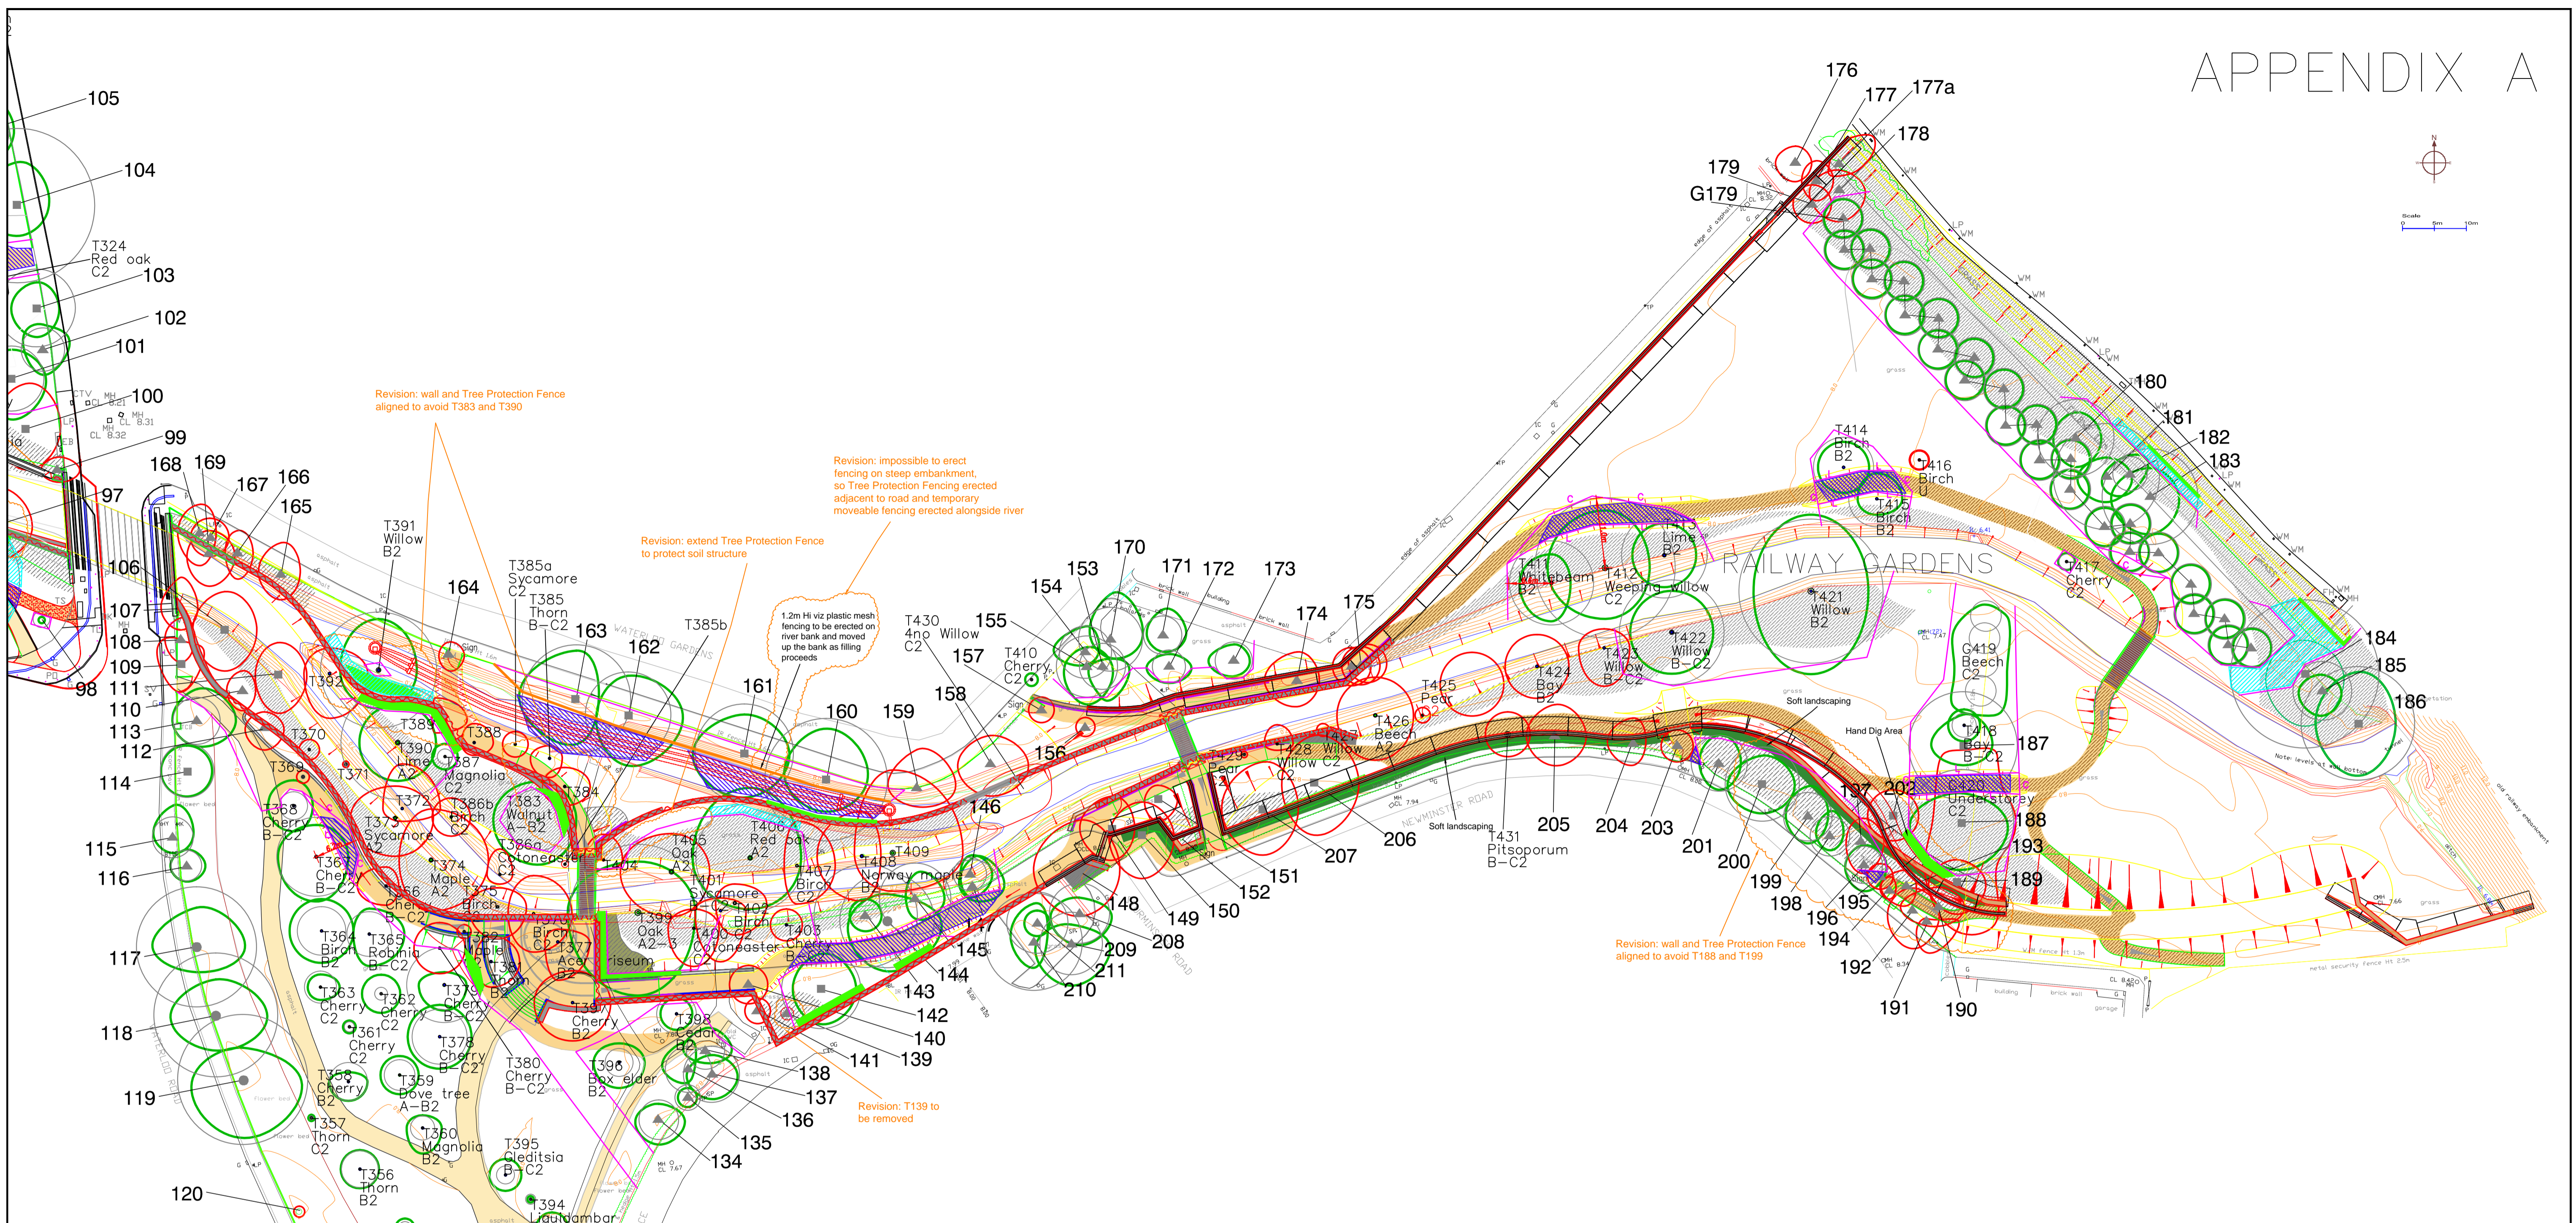
Revision: wall and Tree Protection Fence aligned to avoid T383 and T390

Revision: impossible to erect fencing on steep embankment, so Tree Protection Fencing erected adjacent to road and temporary moveable fencing erected alongside river

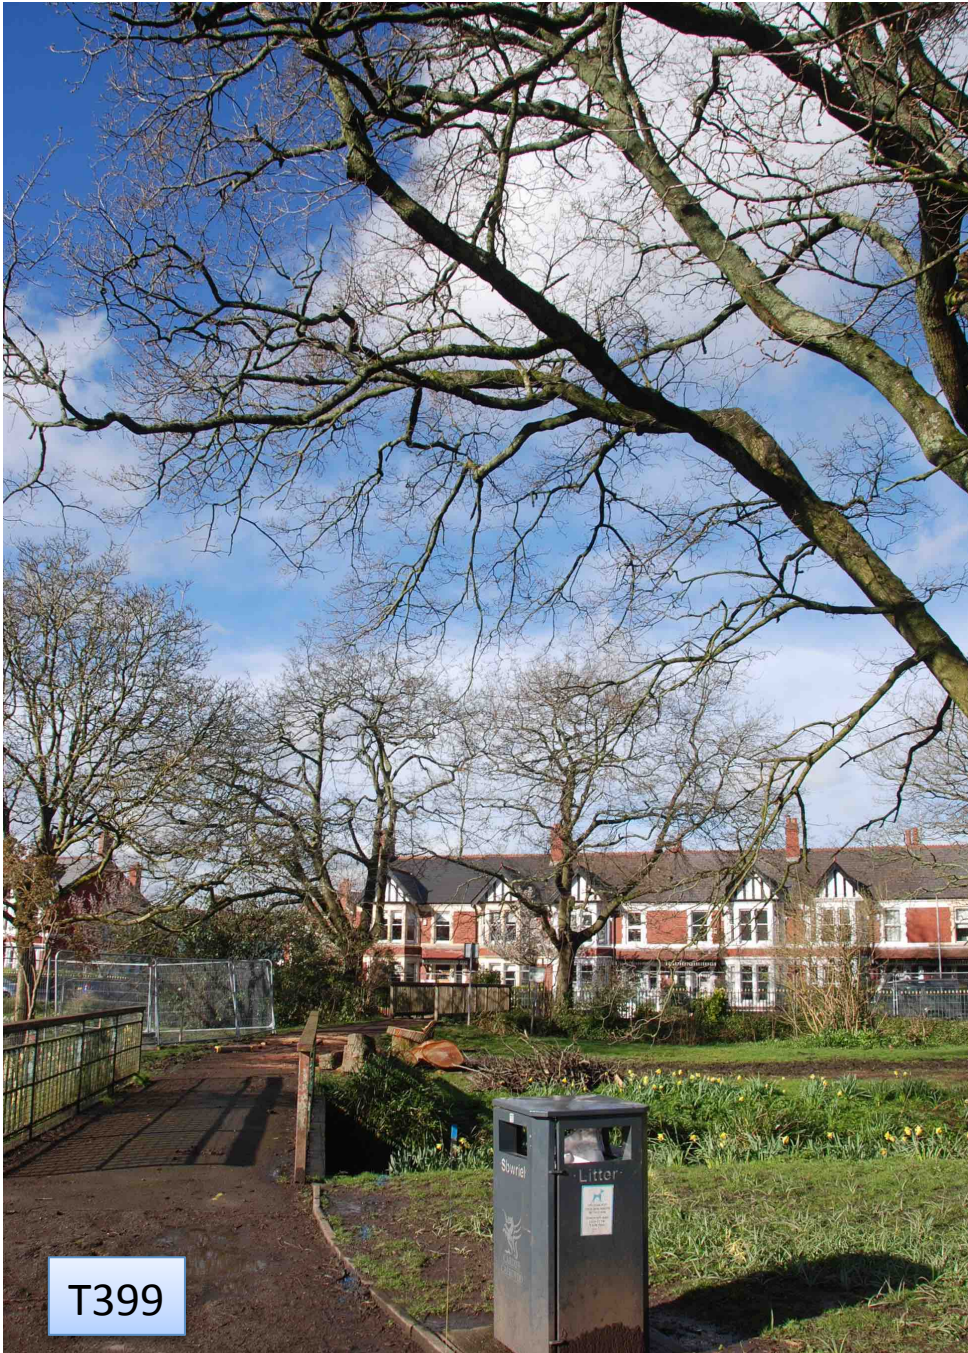
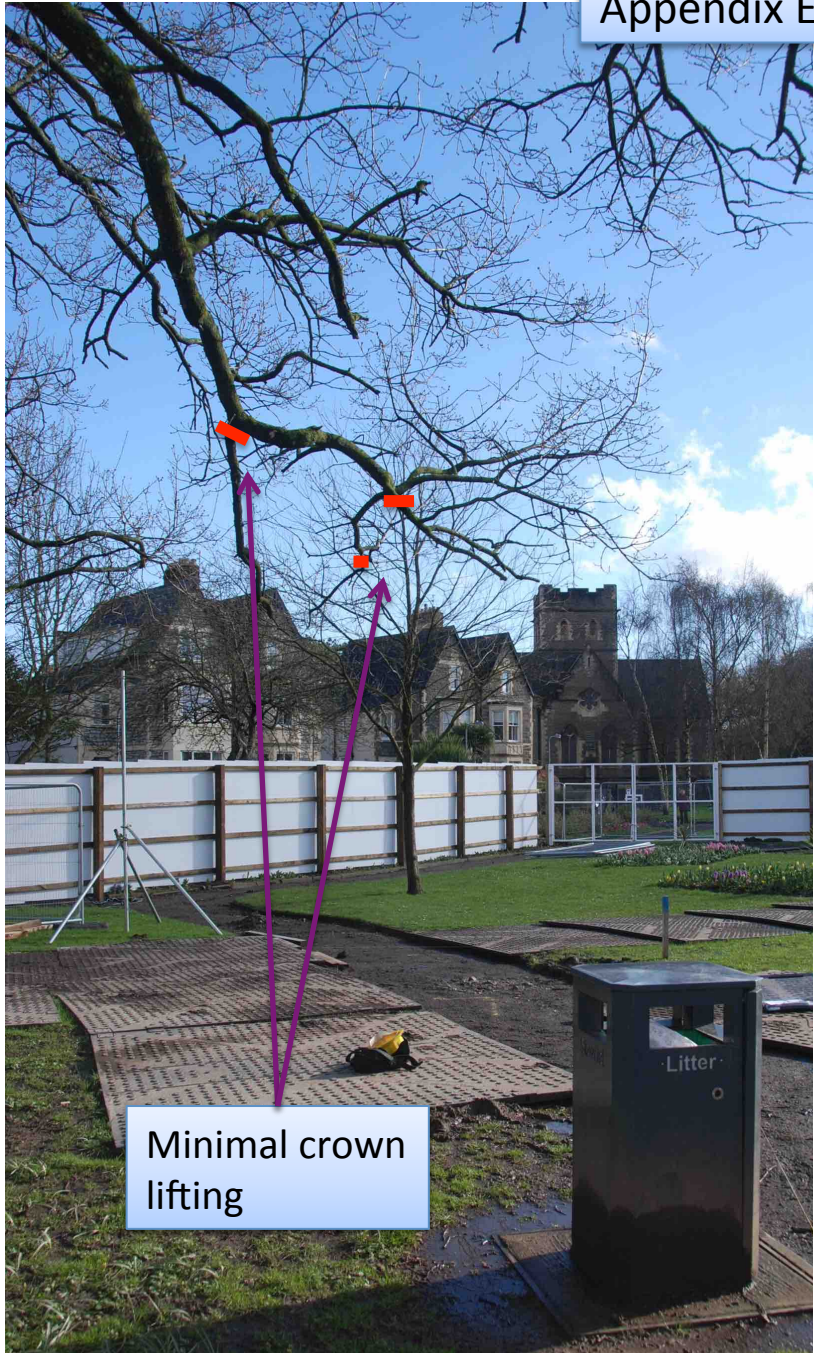
T399

Minimal crown lifting

- The Oak, T399, where there will be considerable construction activity at the edge of the Root Protection Area around an important tree for retention. Hand digging has been specified, with no roots to be cut until inspected by either the arboricultural consultant or the Tree Officer, to ensure all possible care is taken to ensure any damage is minimised.
