Arboricultural Impact Assessment

Roath Flood Risk Management Scheme
Roath Brook
Cardiff

Report Date: 10th April 2017

Project no: 624

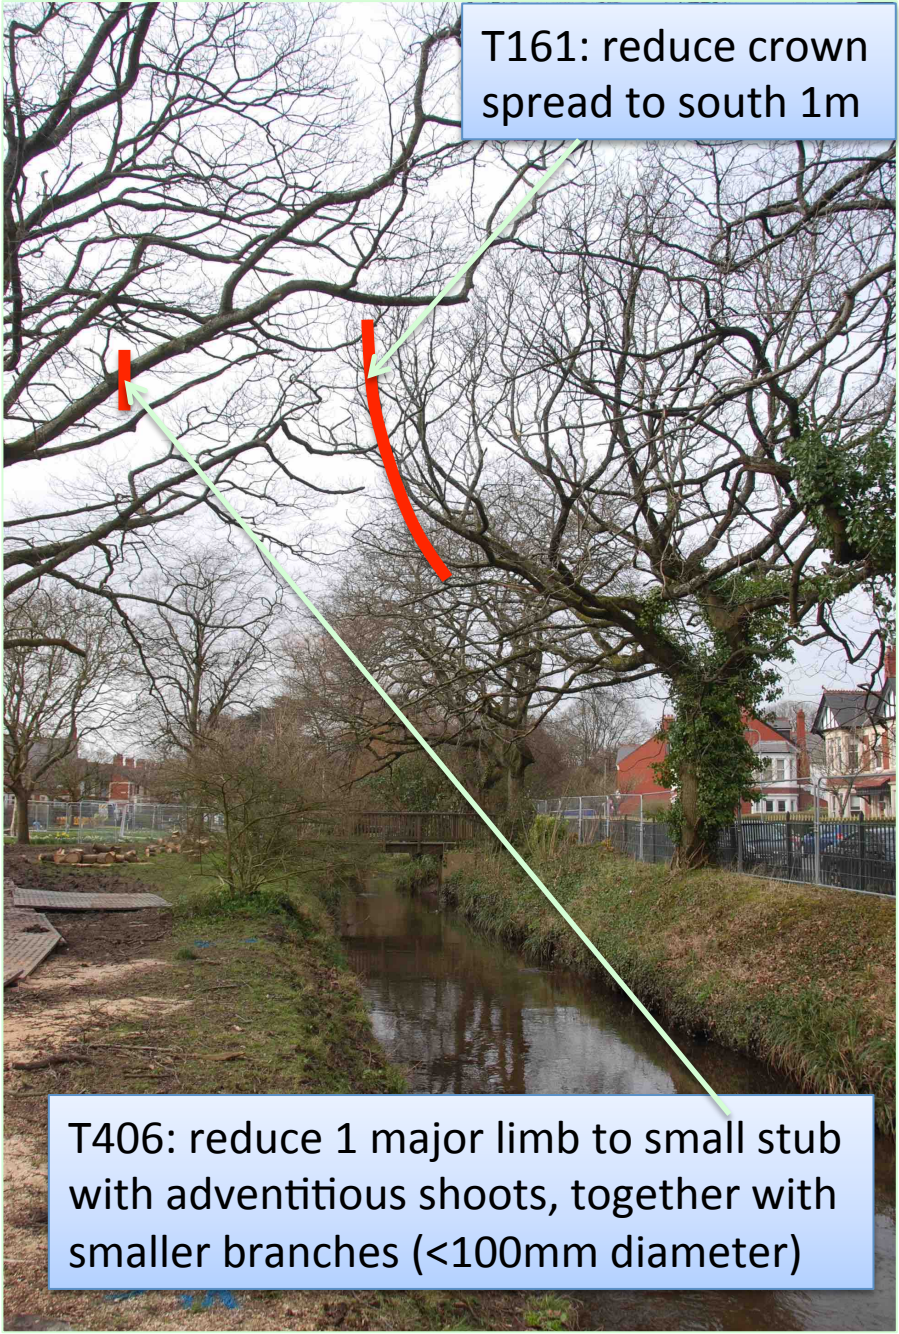
T161: reduce crown spread to south 1m
