Kenfig Phase 1 Dune Rejuvenation Works

Overview Report

Kenneth Pye Associates Ltd

Date: July 2013

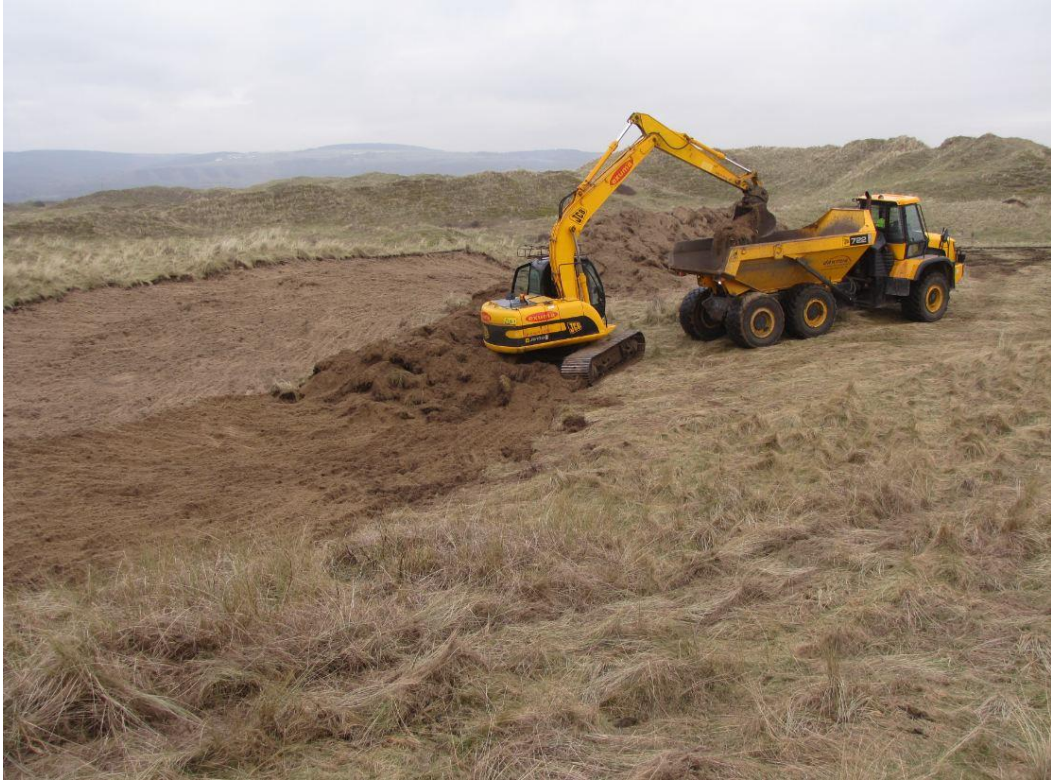
Figure 2. Turf stripping, Kenfig Phase 1, February 2012 (photograph supplied by David Carrington, Bridgend Borough Council).

The work was undertaken using two JCB diggers and two Volvo dumper trucks (Figure 2). The objective was to strip turf from an area defined by the side-walls and windward crest of a stabilised parabolic dune lying east of the haul road, and also from an area linking the seaward side of the haul road and the beach. The crest height of a sand ridge located midway between the haul road and the sea was lowered to reduce the barrier to wind flow, and the sand cliff at the back of the beach was lowered and graded to promote free movement of wind-blown sand from the beach into the dune system. The stripped turves were placed in a number of locations chosen to enhance the parabolic morphology of the main dune; these included the lower parts of southern 'arm' of the dune on either side of the haul road, and the basal part of the windward slope leading to the crest of the dune.

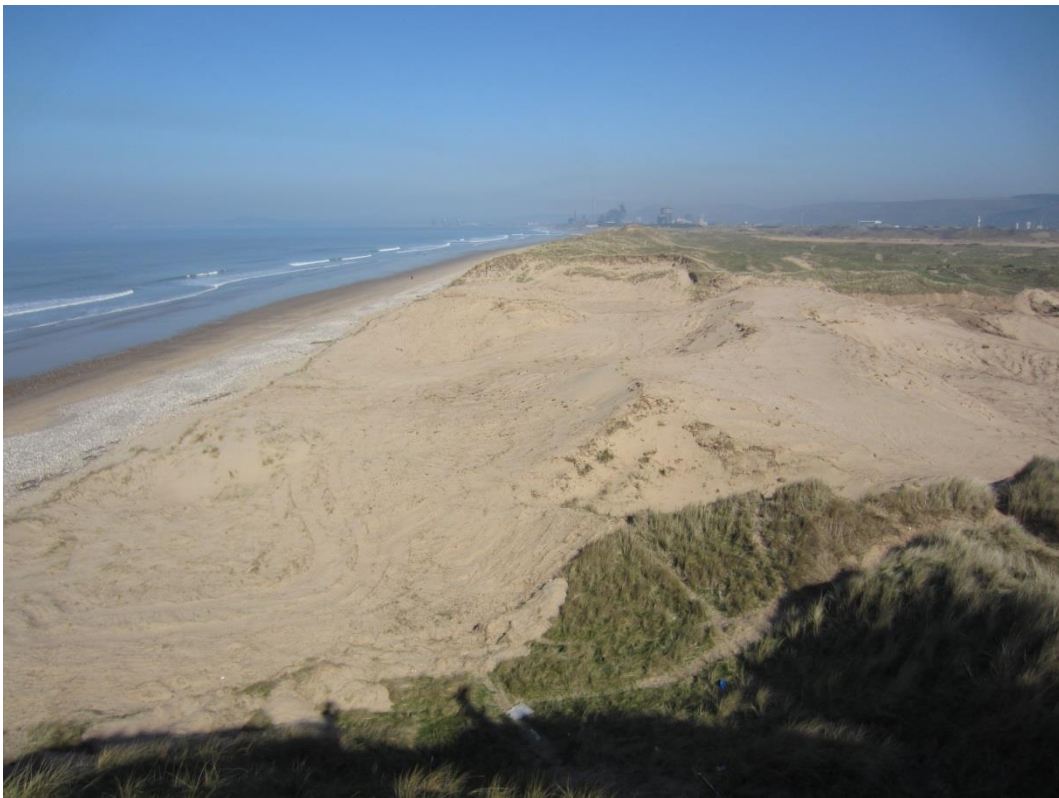
Figure 3. Completed turf stripping, seaward end of Kenfig Phase 1, March 2012 (photograph supplied by Mike Howe, NRW)

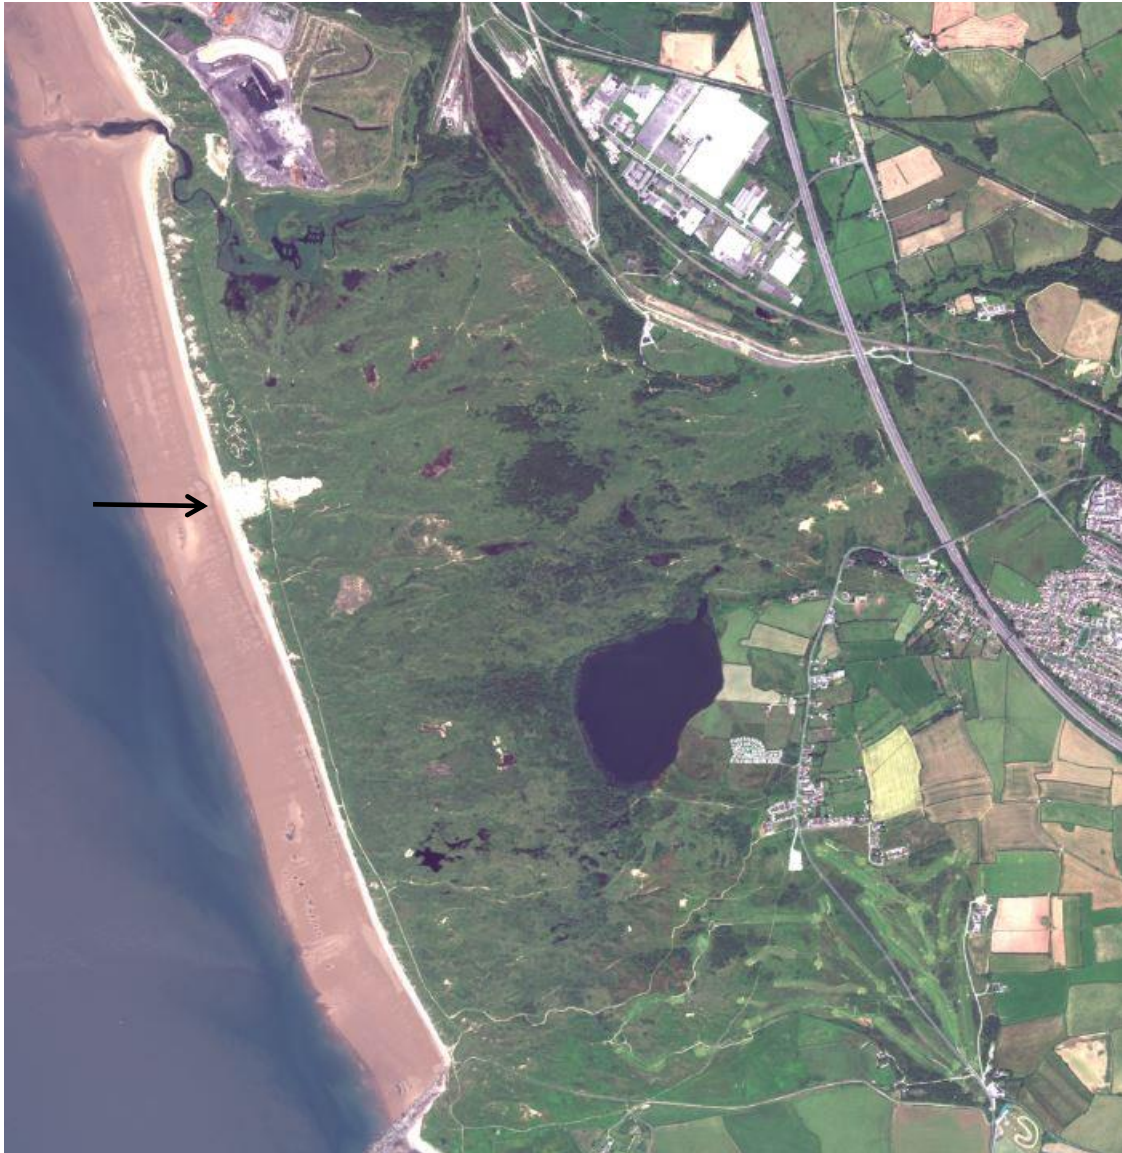
Figure 4. Aerial photograph of the Kenfig Phase 1 dune rejuvenation area (arrowed), March 2012. (photograph provided by Mike Howe, NRW)

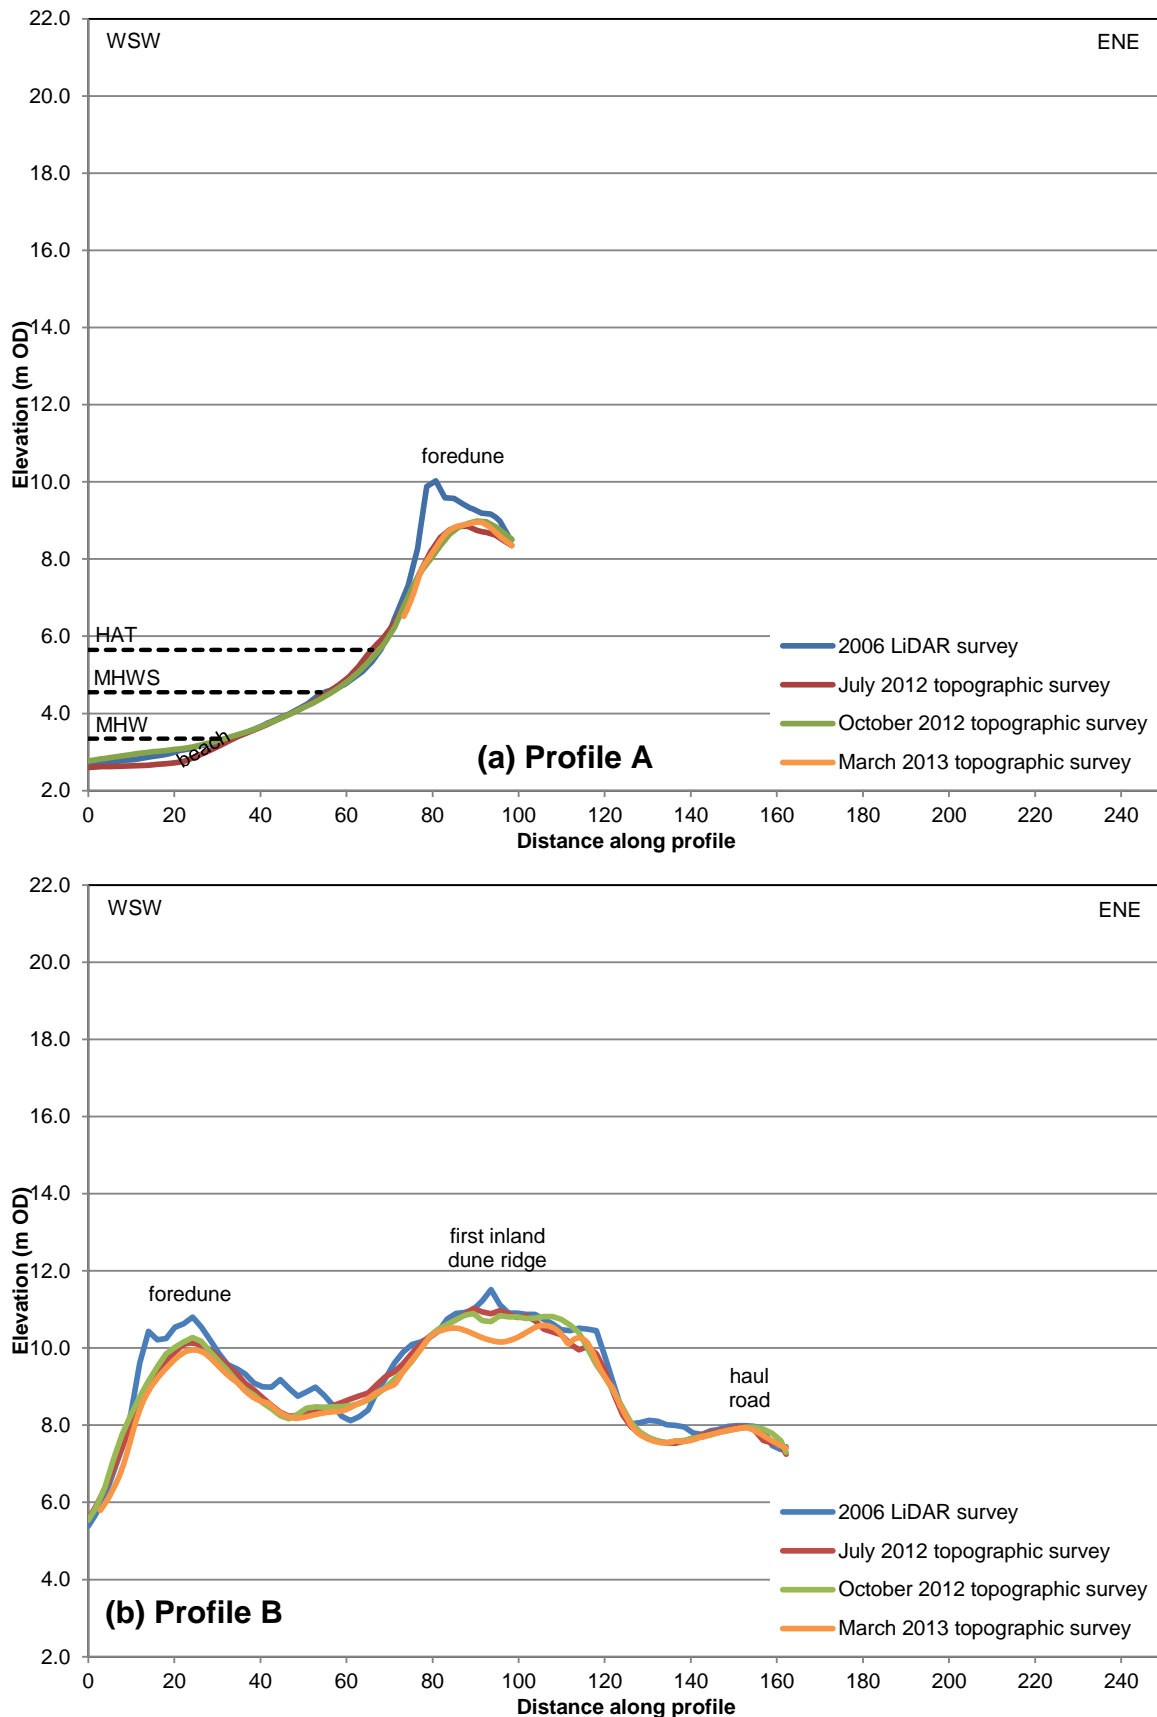
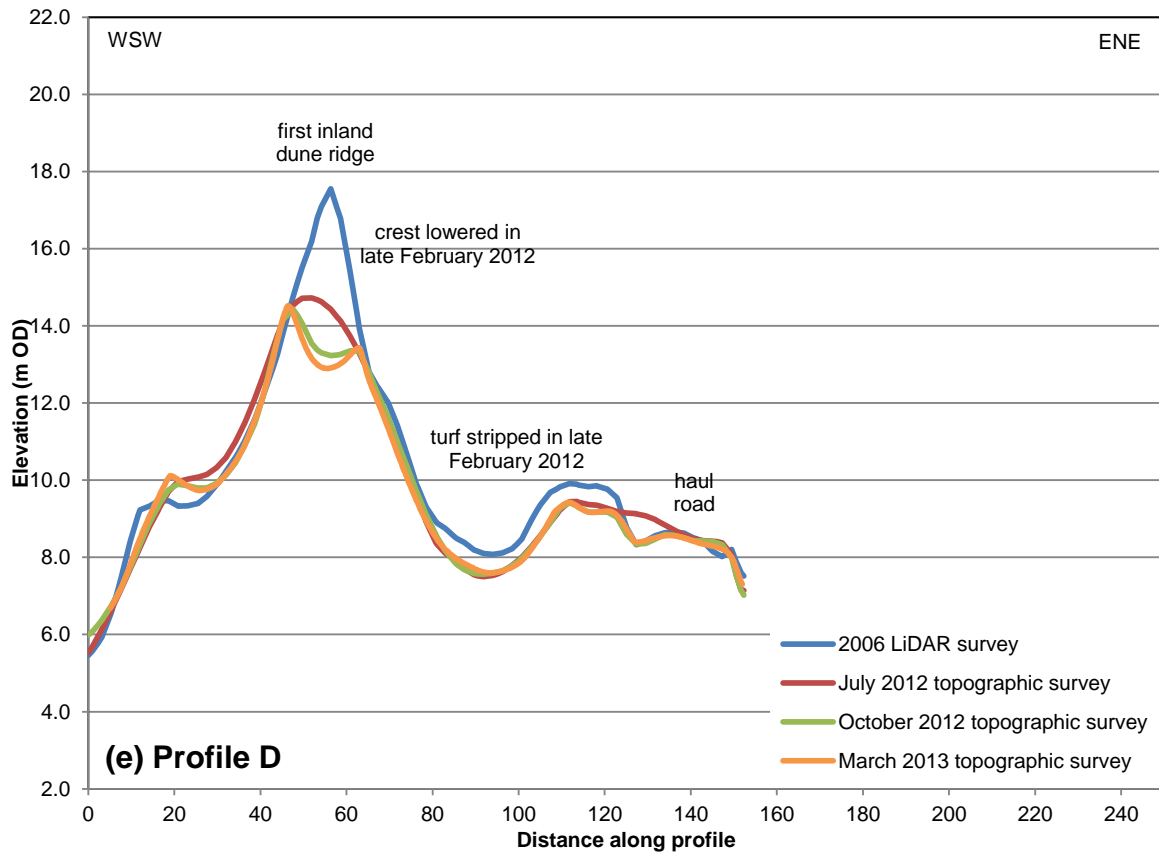
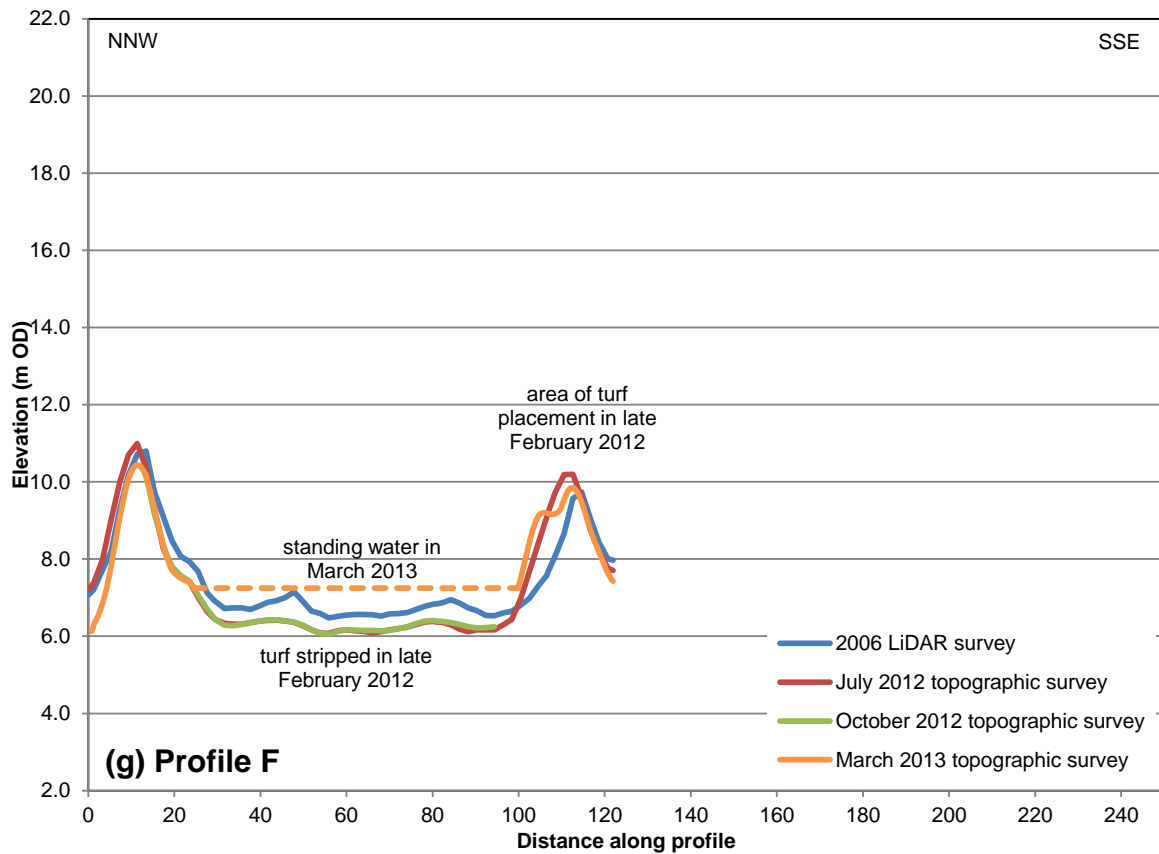
Figure 8. Sections across the Kenfig Phase 1 site, surveyed by LiDAR (26/02/2006) and RTK-GPS (17/07/2012, 09/10/2012 and 08/03/2013). Locations are shown on Figure 6.

DEMs of the rejuvenation area, based on the ground surveys in July 2012, October 2012 and March 2013, are compared in Figure 6. Difference maps showing the interpolated height differences between the 2006 LiDAR survey and the July 2012 (post rejuvenation works) survey are shown in Figure 7a. Differences between the 17 July 2012 and that of 8 October 2012 survey are shown in Figure 7b, and differences between the October 2012 and March 2013 survey are shown in Figure 7c. Elevation changes along a number of specified cross-sections are shown in Figure 8.

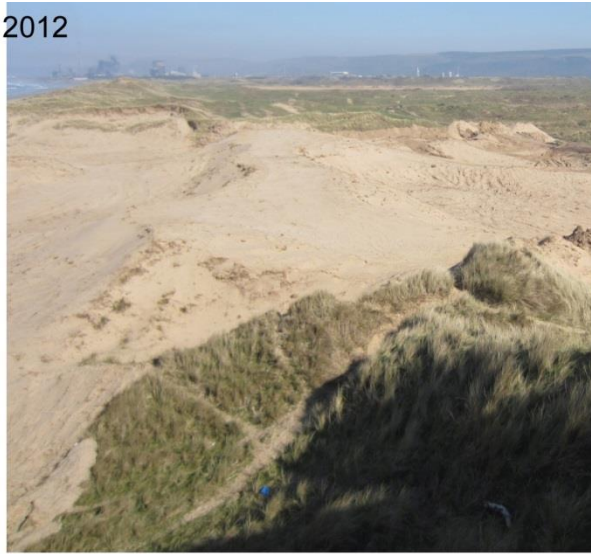
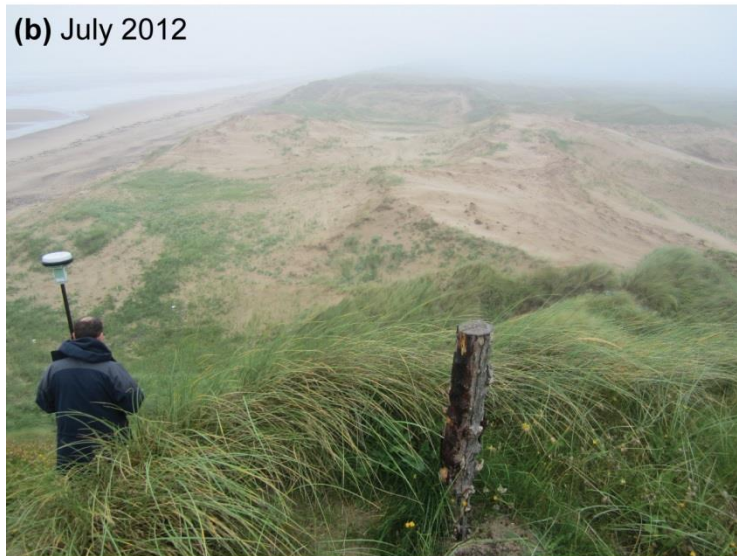
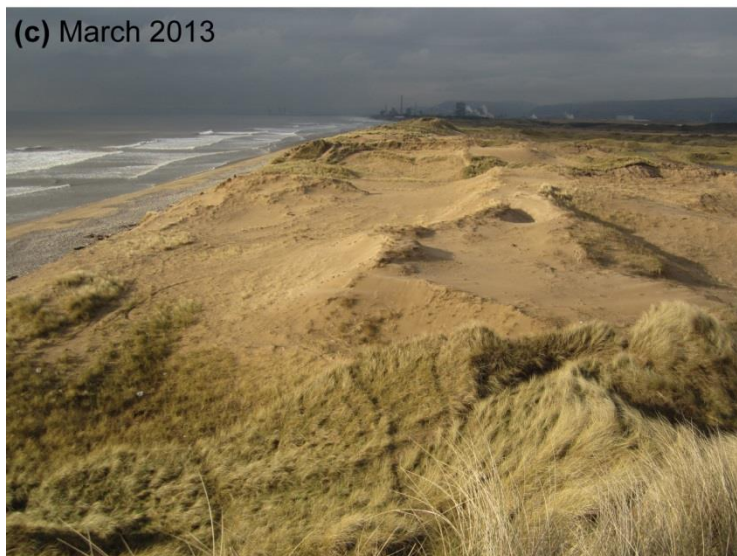
Figure 9. Photograph comparison D, taken from the crest of the summit of the high dune at the southern end of the site, looking north: (a) March 2012; (b) 17 July 2012; (c) 8 March 2013.

Photographs showing changes in the surface character and vegetation cover, viewed from a number of fixed points, are shown in Figures 9, 10, 11 & 12. On completion of the turf stripping and sand moving operation most of the area was left bare. However, by mid July 2012 significant plant regrowth had occurred, principally of bramble dewberry and marram. This reflects the facts that the turf stripping operation generally did not completely remove or kill the plant roots, and the wet spring of 2012 favoured plant recovery.

Area showing significant vegetation re-growth on the west side of the haul road were sprayed with herbicide in early July 2012, and by the time of the October 2012 survey the density of vegetation cover in this area showed an evident reduction compared with the earlier survey (Figure 9). However, regrowth from buried turves was evident within the eastern part of deflation corridor east of the haul road (Figures 11 & 12). Some of these turf blocks were physically removed during the winter of 2012-13 and placed on the margins of the site. Largely as a result of this intervention, vegetation cover within the deflation corridor and on the dune stoss slope was thin and patchy at the time of the site visits in February and March 2013, despite heavy rains which created a large area of standing water in the deeper parts of the deflation trough.

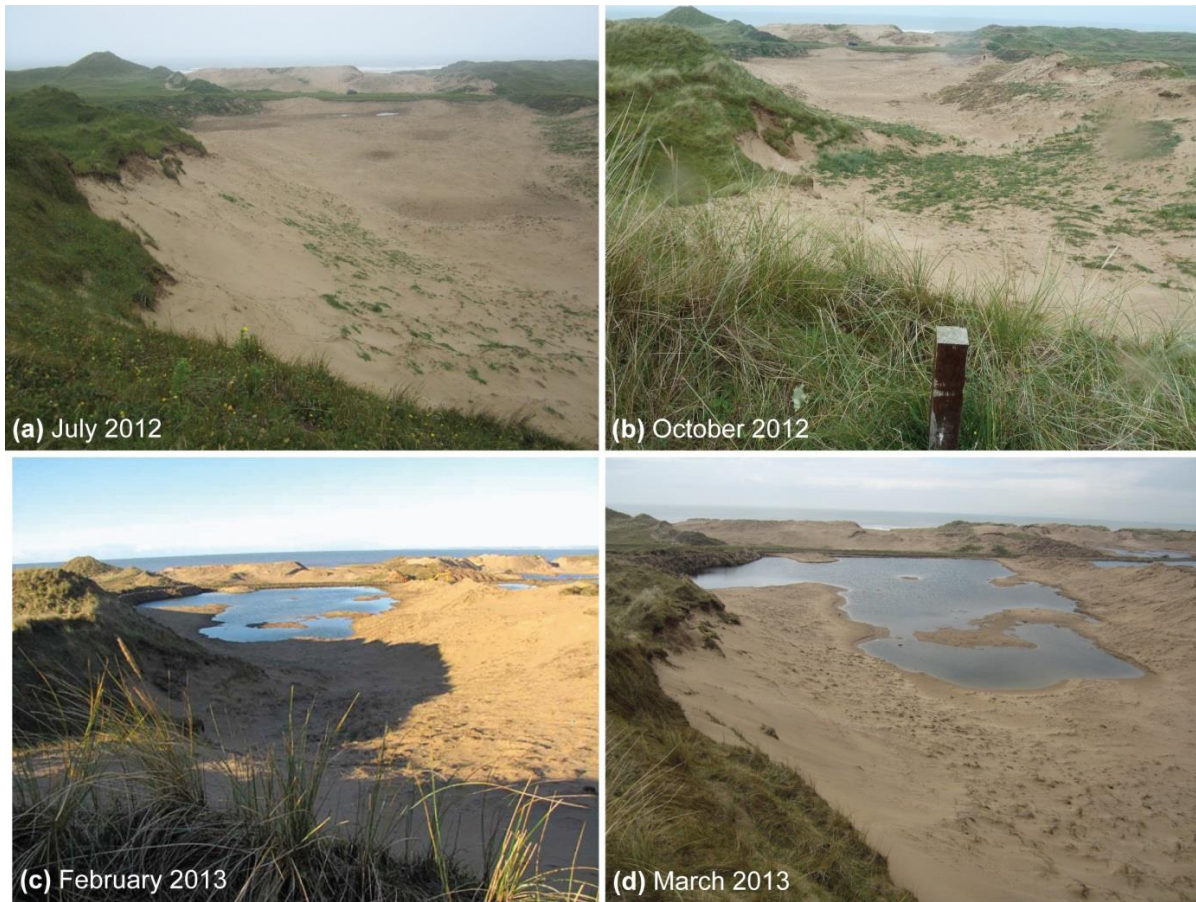
Figure 11. Photograph comparison B, taken from the crest of the inland parabolic dune looking westwards towards the sea: (a) 17 July 2012; (b) 9 October 2012; (c) February 2013; (d) 8 March 2013.

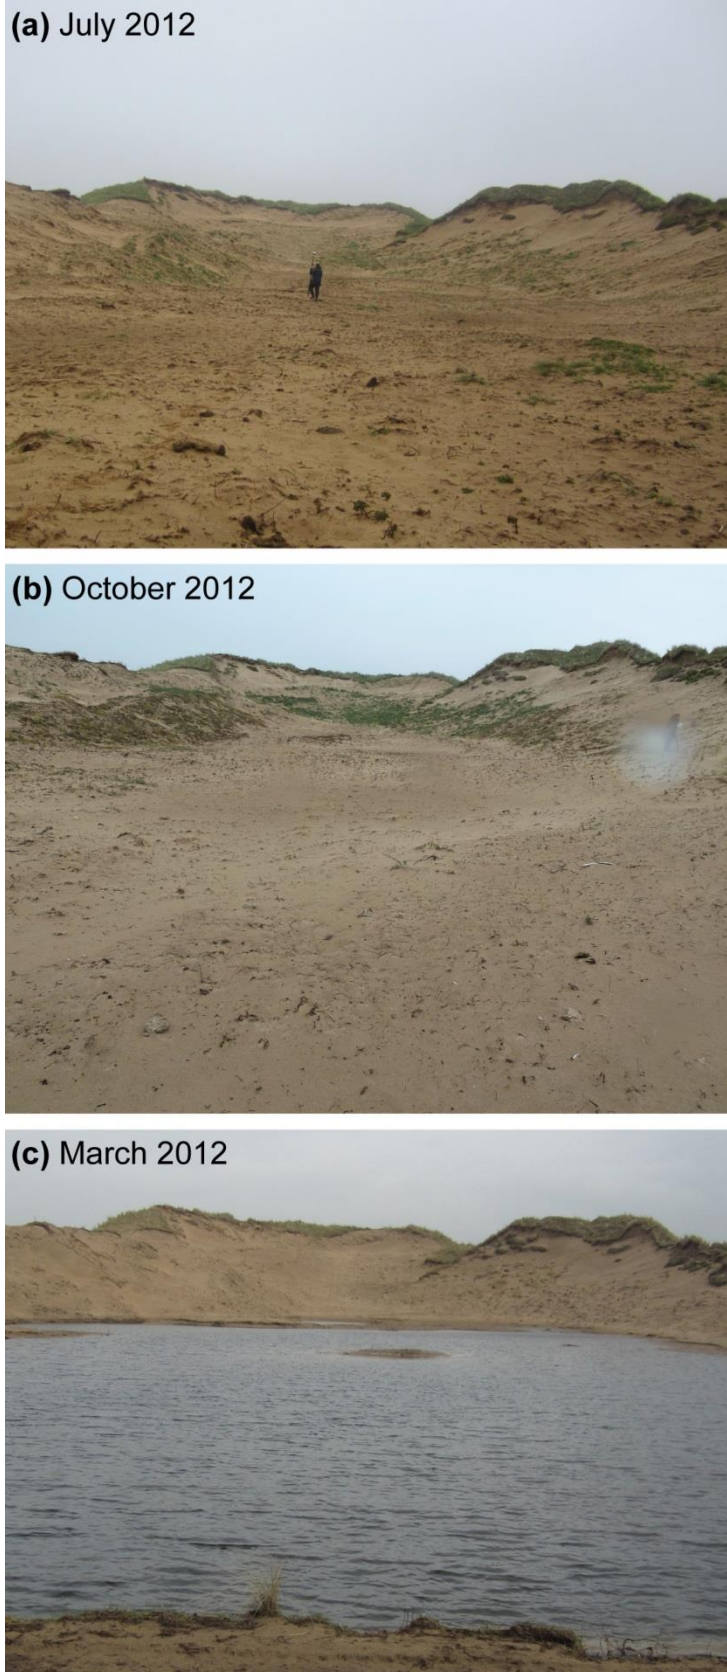
Figure 12. Photograph comparison A, taken from the haul road looking eastwards along the axis of the parabolic dune: (a) 17 July 2012; (b) 9 October 2012; and (c) 8 March 2013.
