St. Asaph Flood Risk Management Scheme Case Study:

The problem and task

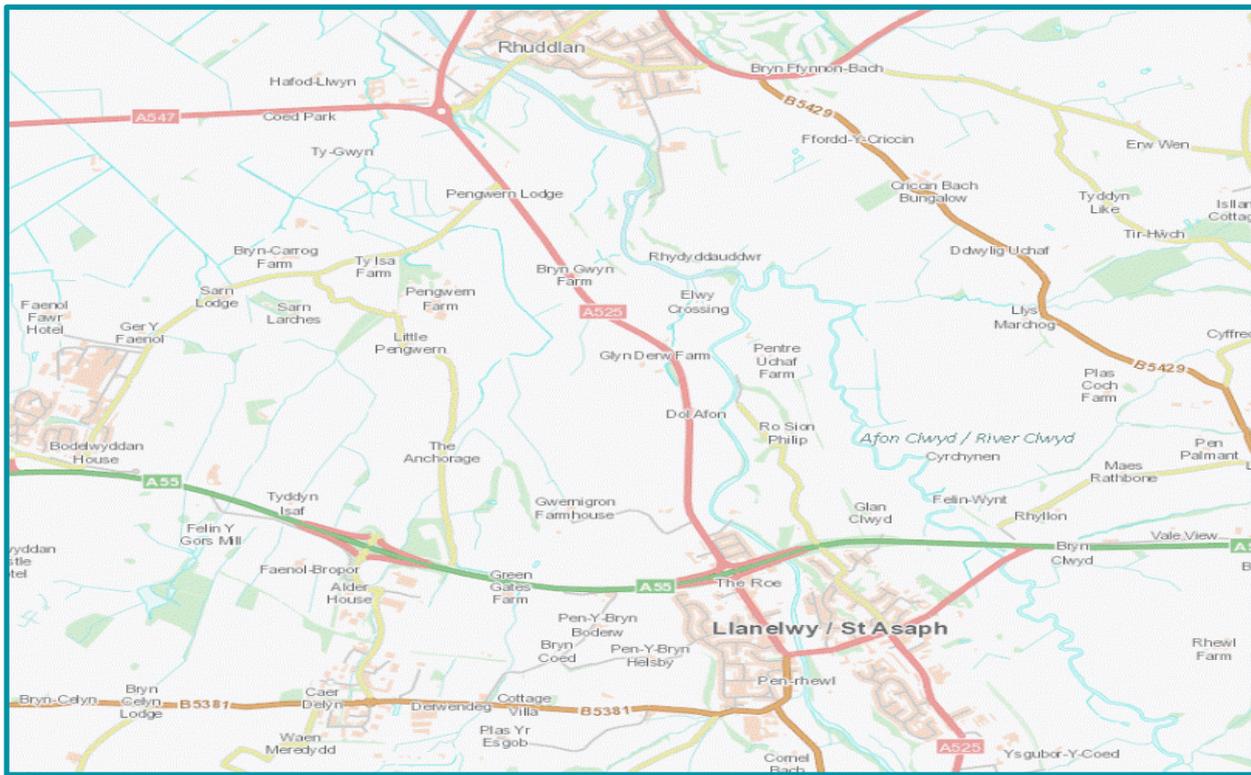
Figure 3 – Map showing the confluence of the River Clwyd and Elwy

The Clwyd meanders gently north to St. Asaph where just north of the city, the two rivers conjoin. The Afon Elwy discharges to the Clwyd 1.8km downstream of St. Asaph and the ground levels fall from around 10m above Ordnance Datum (OD) to between 6-7m Ordnance Datum. At the confluence of the Elwy and Clwyd, the river becomes tidal and enters a narrow estuary. The river channel was straightened at Rhuddlan by King Edward 1st to enable his supply barges to reach his castle at Rhuddlan. The engineered, straightened channel runs for three miles before meeting the Irish Sea at Rhyl.

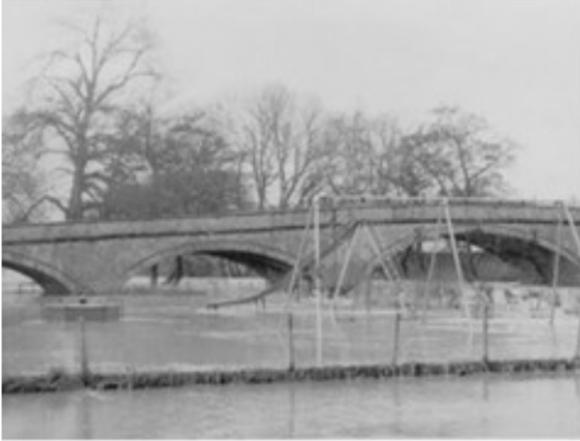
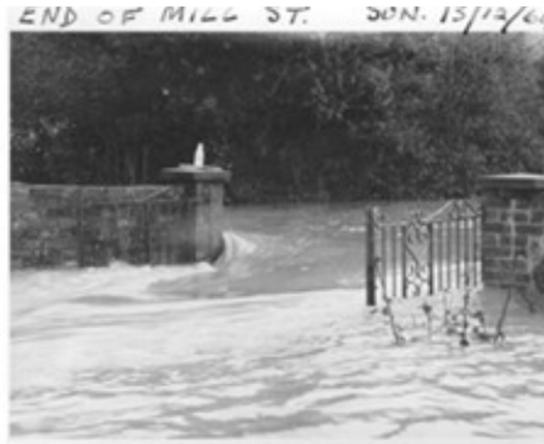
**Figure 4 -
Images
from the
1964/1965
St.Asaph
floods**

Flood risk to the city comes predominantly from raised water levels in the Elwy overtopping the city's flood defences. Historically there are entries in the Chronology of British Hydrological Events that indicate likely flooding in the vicinity of the city in 1871, 1882 and 1896. During the 20th century, flooding was reported during 1913, 1964 and 1965. This prompted construction of the original defences through the city in the 1960's. These defences were raised again during 1975. The defences withstood all flood events until the 27th November 2012.

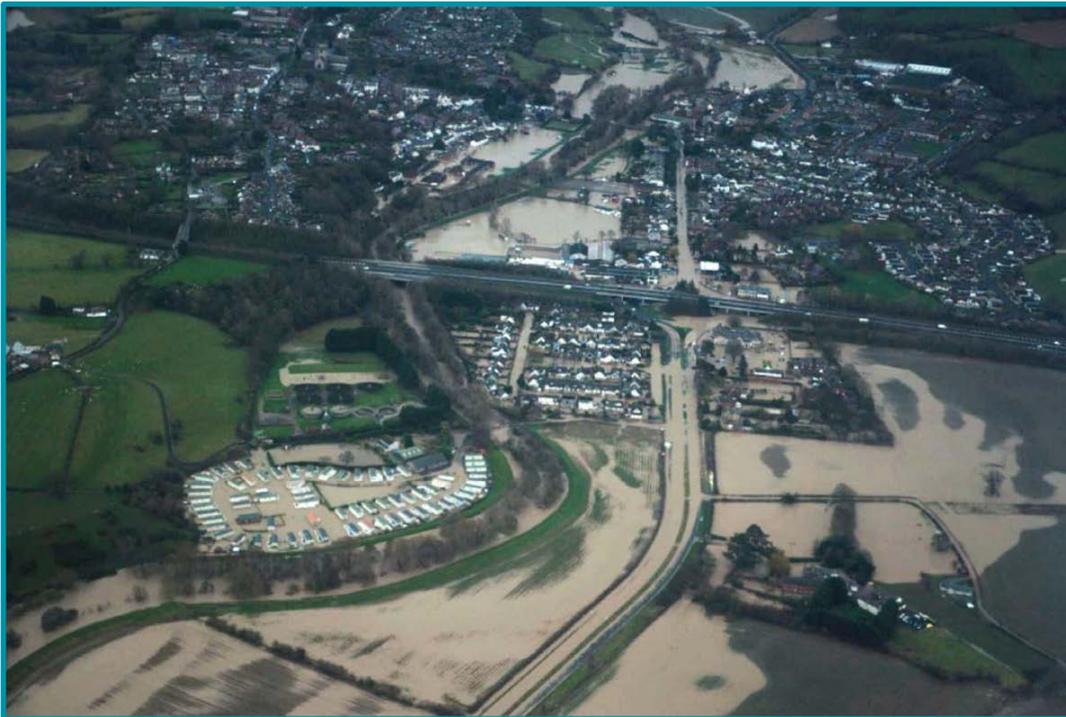
Figure 5 – photo demonstrating the breadth of flooding at St.Asaph

The flooding in November 2012 occurred when prolonged, intense rainfall fell over the catchment. During the early hours of Tuesday the 27th November 2012, the defences were overwhelmed when the Elwy rose 3 metres above its normal level. 322 homes, 32 businesses and 70 caravans within the city were flooded. A flood depth of 0.8 metres was recorded and the floods resulted in one tragic fatality. **Figure 5.** demonstrates the breadth of flooding experienced by St.Asaph.

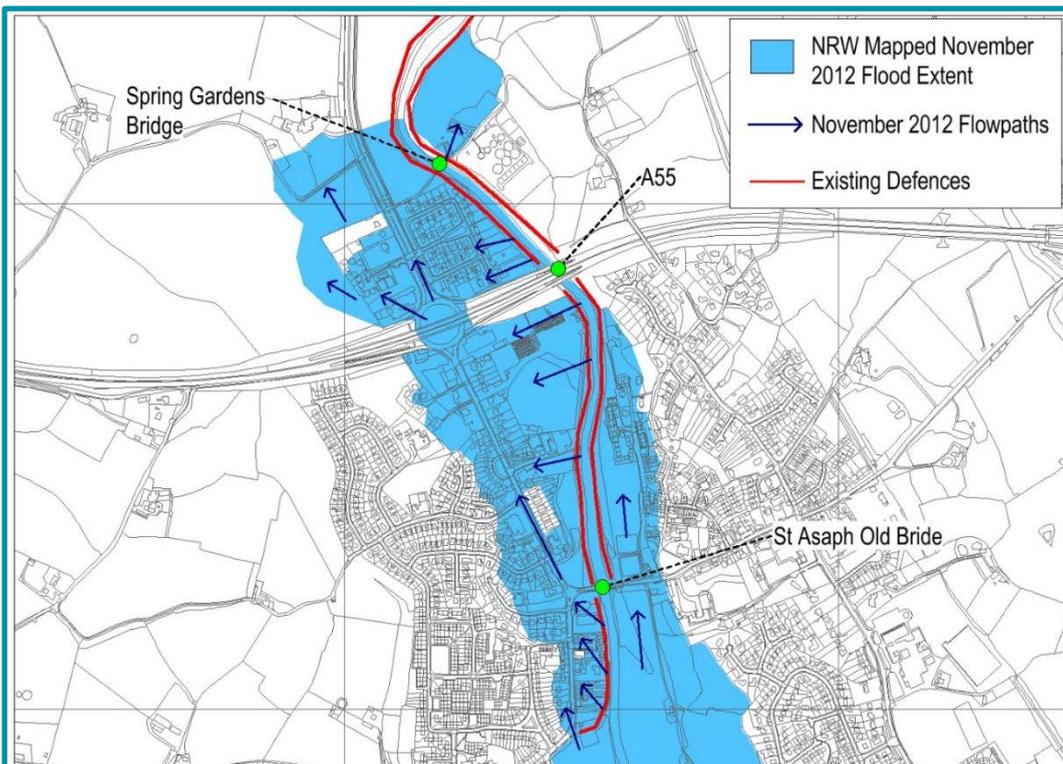
Figure 6 – map showing the November 2012 flood extent

Initial reports from site stated that flooding began to occur downstream of the A55 with water spilling into the Spring Gardens area - see **Figure 6**. This area was then cut off as upstream sections flooded. Out of bank water was fast flowing and all areas affected were quickly inundated.

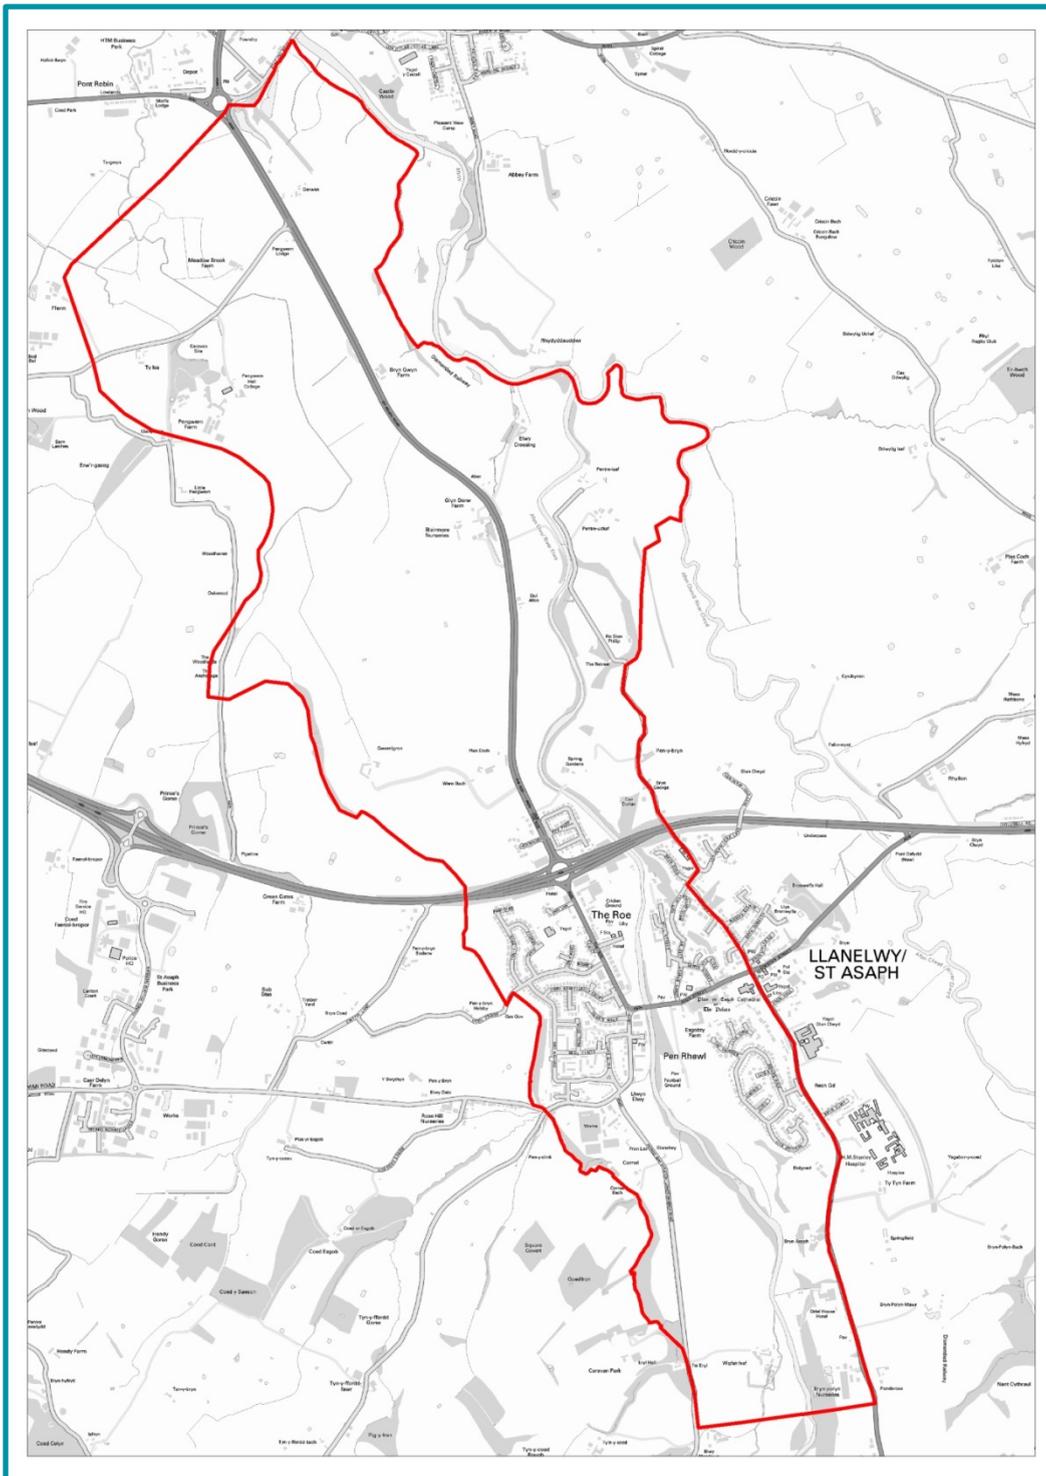
Figure 11 – St Asaph Flood Risk Management Scheme Study Area

A study area for the Flood Risk Management Scheme was identified to ensure that all properties and land which could be affected by the scheme to reduce the flood risk could be considered. The full study area for the St Asaph Flood Risk Management Scheme spread along the River Elwy from properties at Wigfair Isaf in the south to Rhuddlan in the north - see **Figure 11**.

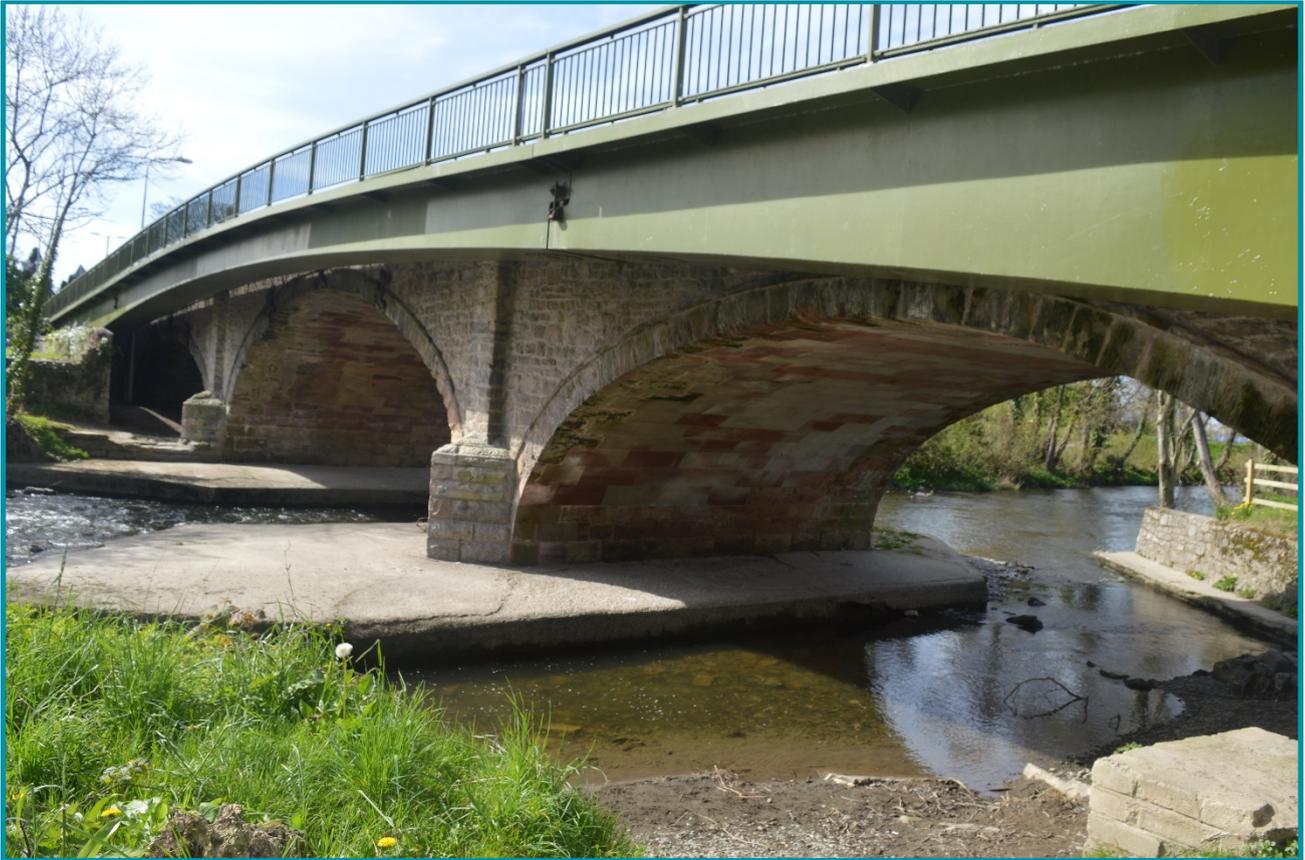
Figure 12 - St. Asaph Old Bridge – A Grade 2 listed building and Scheduled Ancient Monument

The study area contained the St Asaph Conservation Area and over 50 listed buildings in and around the city, notably, St Asaph Old Bridge – see **Figure 12**. The bridge crosses the Elwy within the scheme area and is an important landmark within the city being Grade 2 Listed and a Scheduled Ancient Monument. Existing flood defences are connected to the bridge. Works connecting to or affecting the setting of the bridge required Listed Building Consent to proceed.
