Pembrey Burrows – a geomorphological appraisal and options for dune rejuvenation

Kenneth Pye and Simon J Blott

NRW Evidence Report No. 42

External Investigation Report No. EX1502

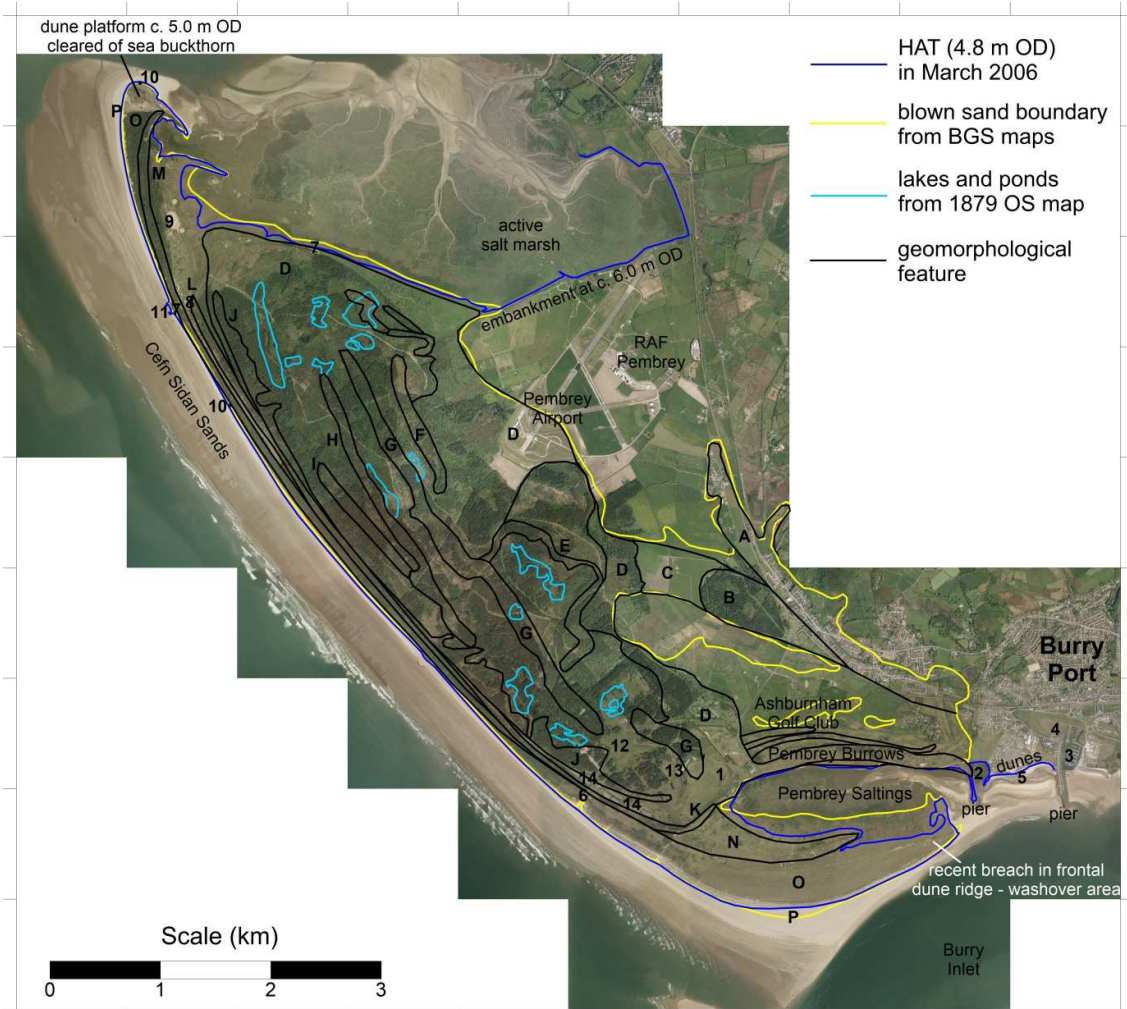
Figure 5: Geomorphological units in the Pembrey area, superimposed on 2010 aerial photography. See Table 1 for unit descriptions.

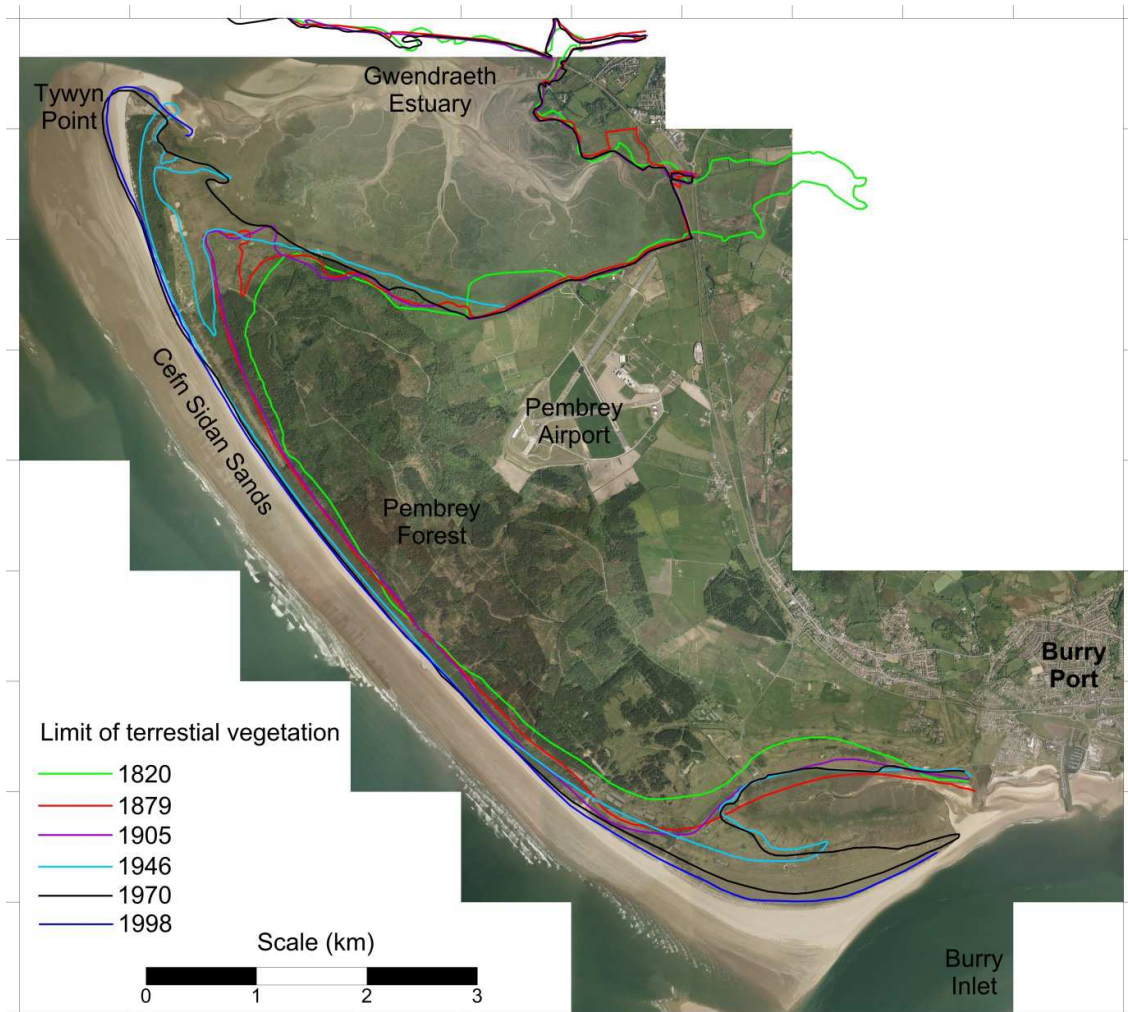
Figure 8: 2010 aerial photography of the Pembrey area with lines indicating the limits of terrestrial vegetation, based on historical OS maps (surveyed in 1820, 1879, 1905 and 1970), aerial photographs (1946 and 1998) and GPS ground surveys in February 2014.

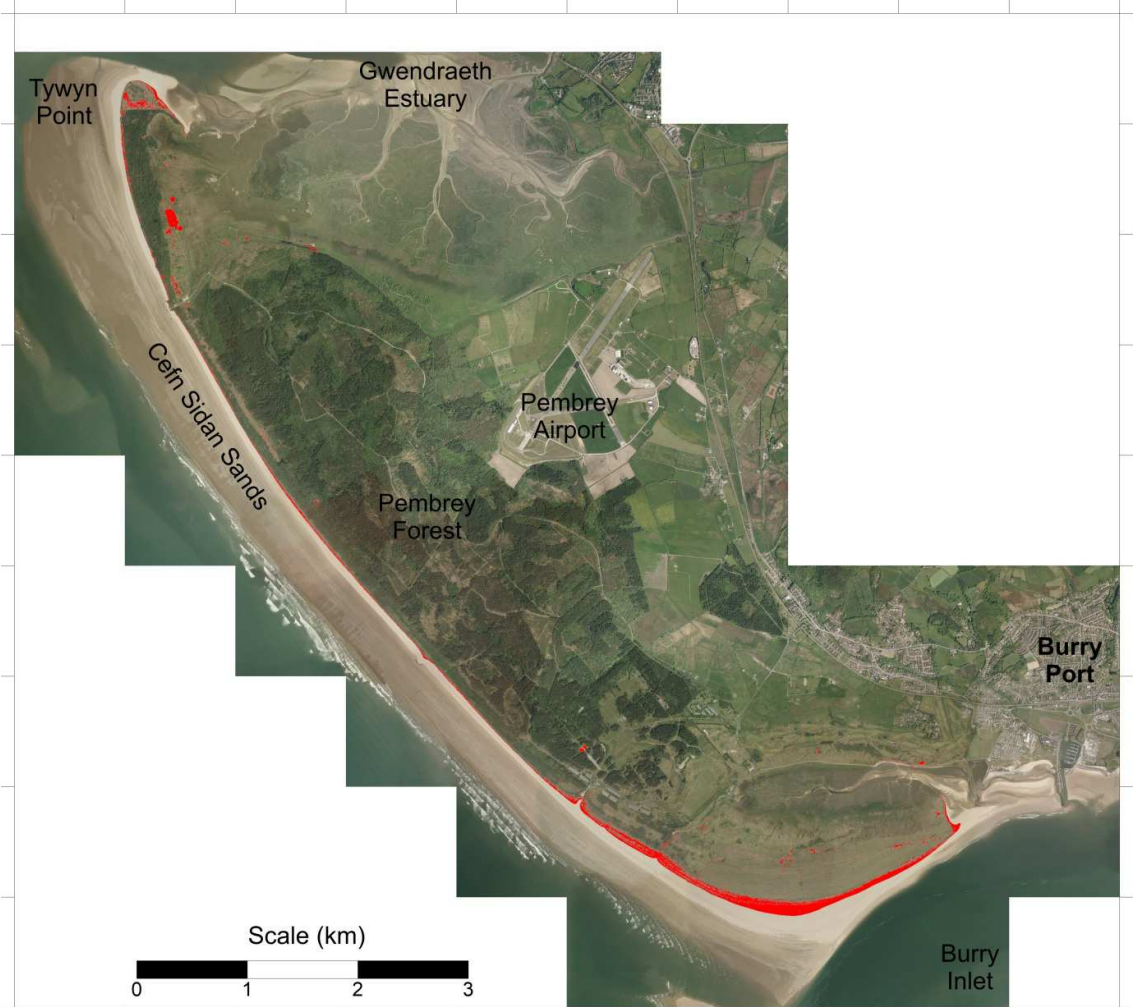
Figure 12: Bare sand areas (shown in red) mapped from the aerial photographs flown in 2010.

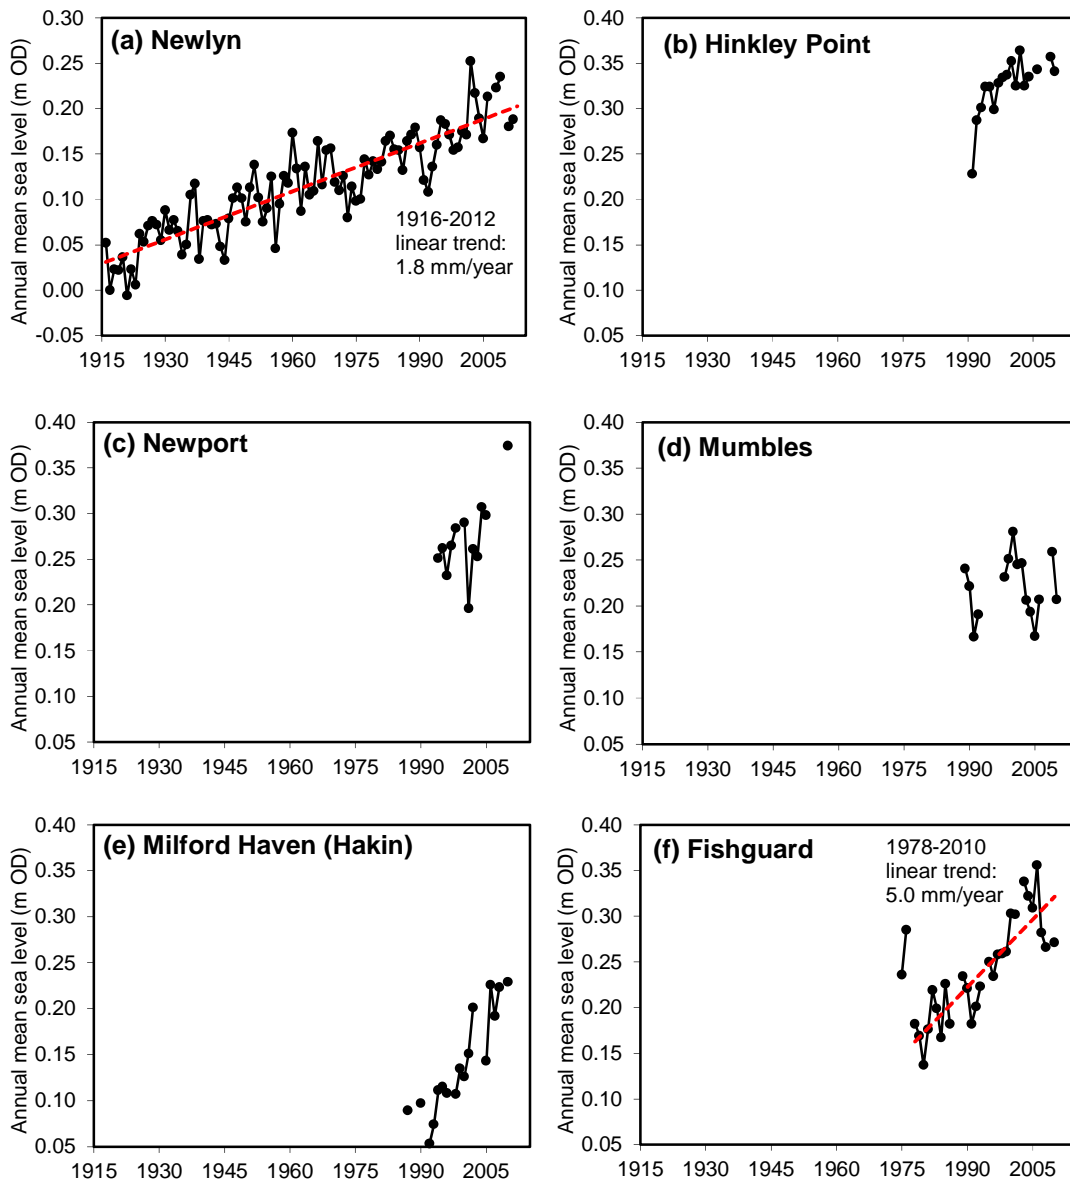
Figure 32: Changes in annual mean sea level recorded at six tide gauge stations in south-west Britain: (a) Newlyn (1916-2012); (b) Hinkley Point (1991-2010); (c) Newport (1994-2010); (d) Mumbles (1989-2010); (e) Milford Haven (Hakin) (1987-2010); and (f) Fishguard (1975-2010). Data source: PSMSL, revised to May 2014 (data from PSMSL).

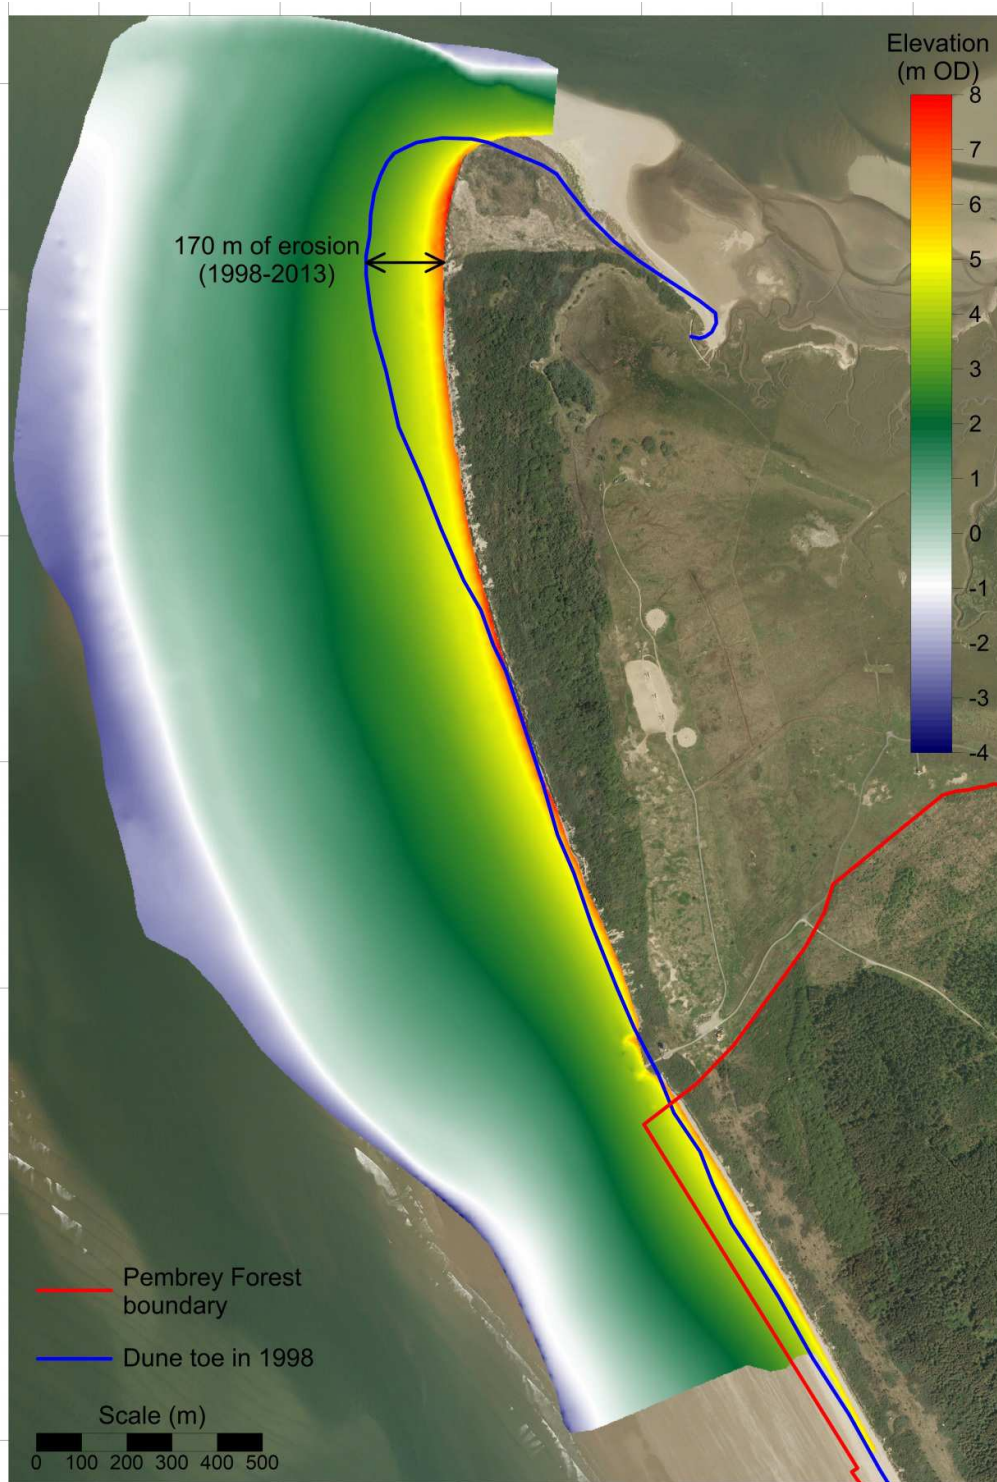
Figure A2.1: Summer 2013 DEM of the Tywyn Point area, superimposed on 2010 aerial photography. The position of the dune toe in 1998 is also shown.

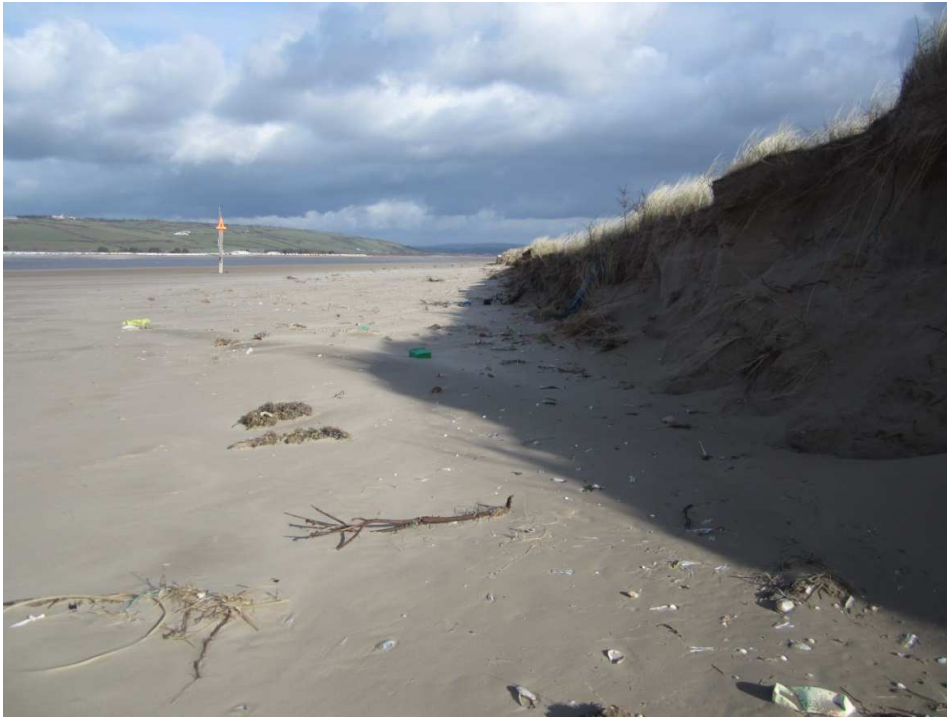
Photograph 1: Wave-eroded dune cliffs at the northern end of Tywyn Point.

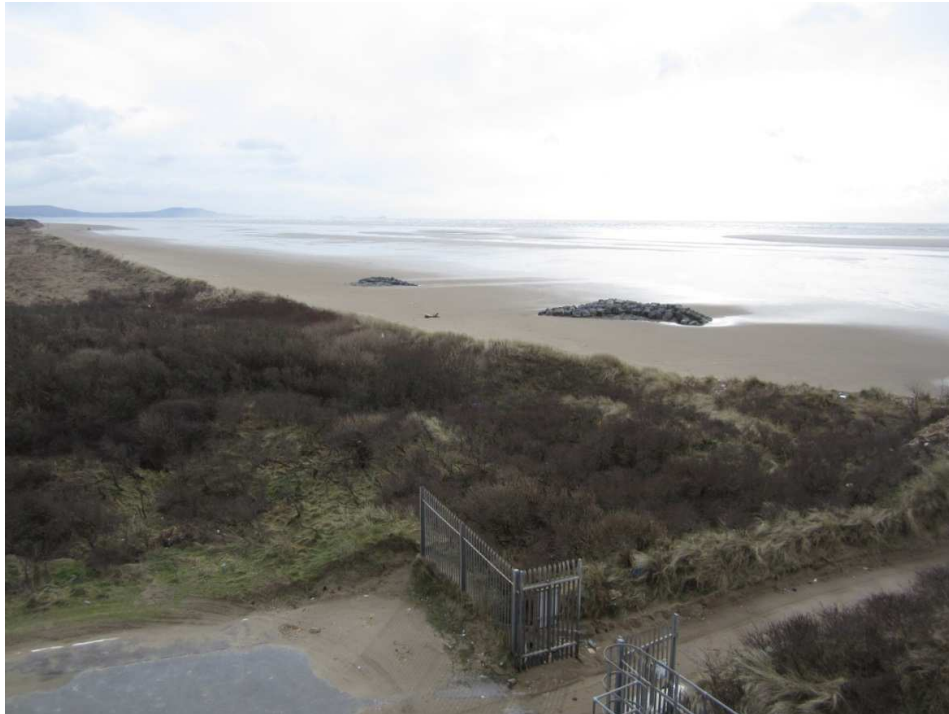
Photograph 9: Rock armour protection near the Pembrey Sands control tower; view looking southwest.

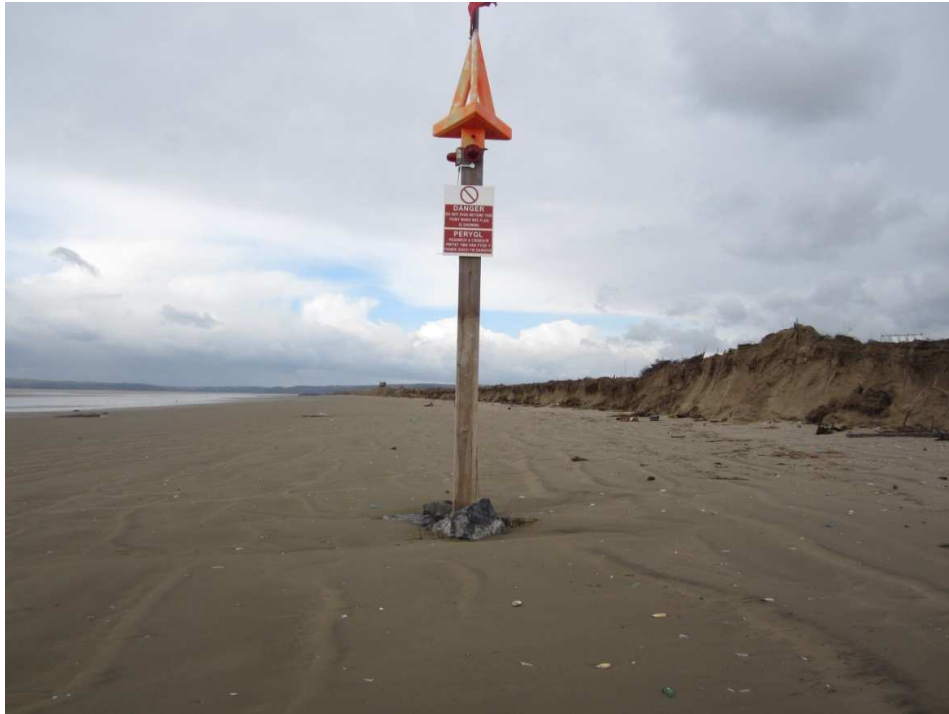
Photograph 11: Wave-eroded dunes at the southern end of the beach landing area, south of Tywyn Point.

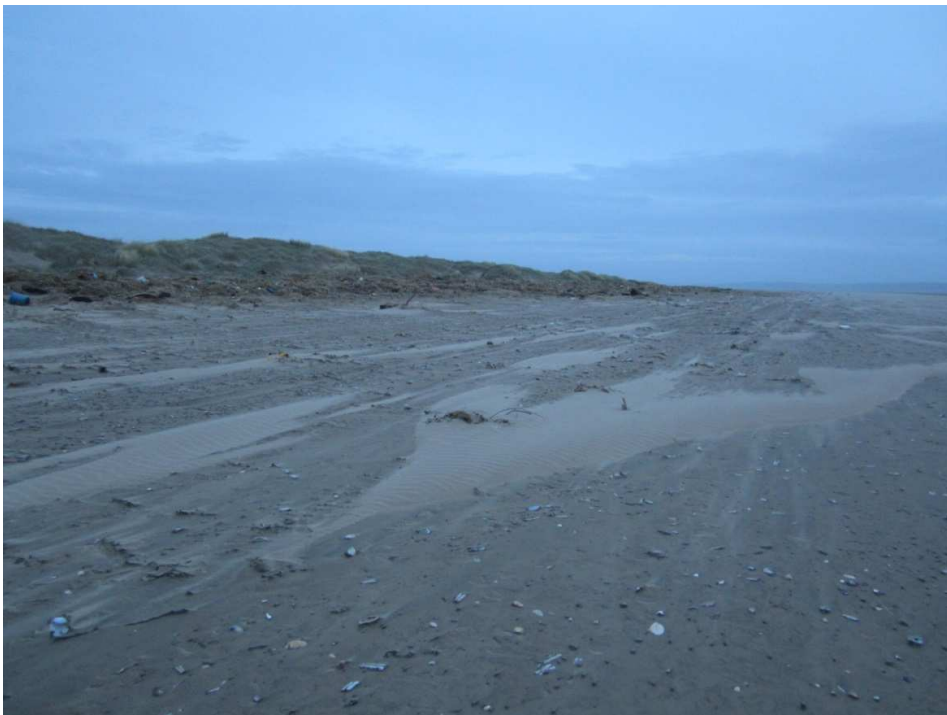
Photograph 20: Migrating barchanoid megaripples and linear sand streaks on an area of accreting beach at the southern end of Pembrey Country Park; recent embryo dunes and accreting foredune ridge in the background - view looking east.

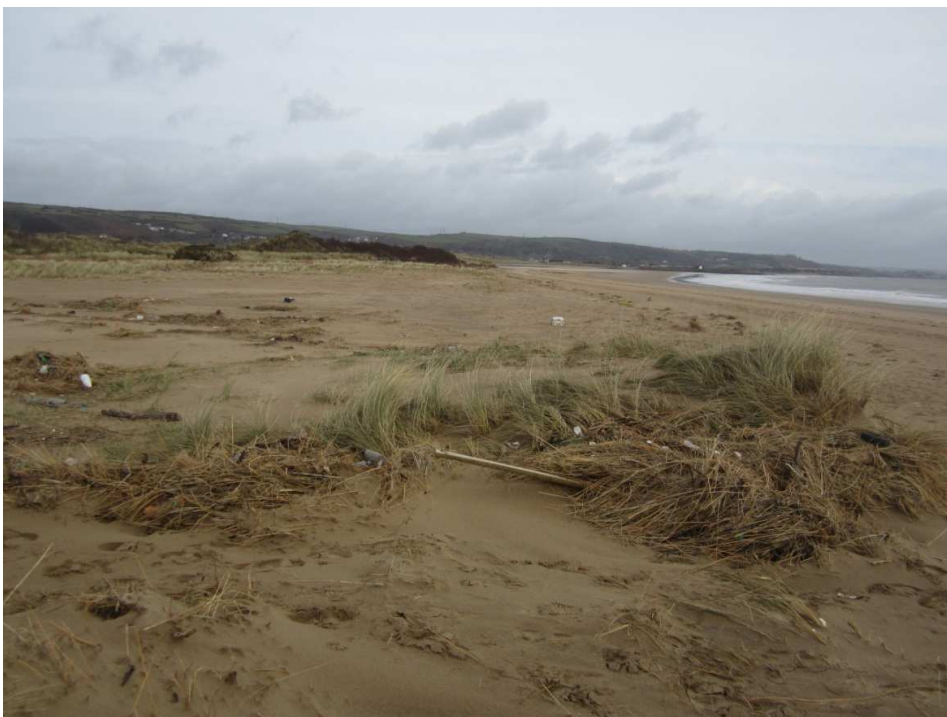
Photograph 22: Tidal / wave washover area where recent erosion has breached the frontal dune ridge at the eastern end of Pembrey Burrows LNR. This area was breached after 2010 due to landward movement of the low water channel, which has caused steepening of the beach, and was enlarged during the stormy winter of 2013-14 which brought a number of high tides and periods of strong wave action.

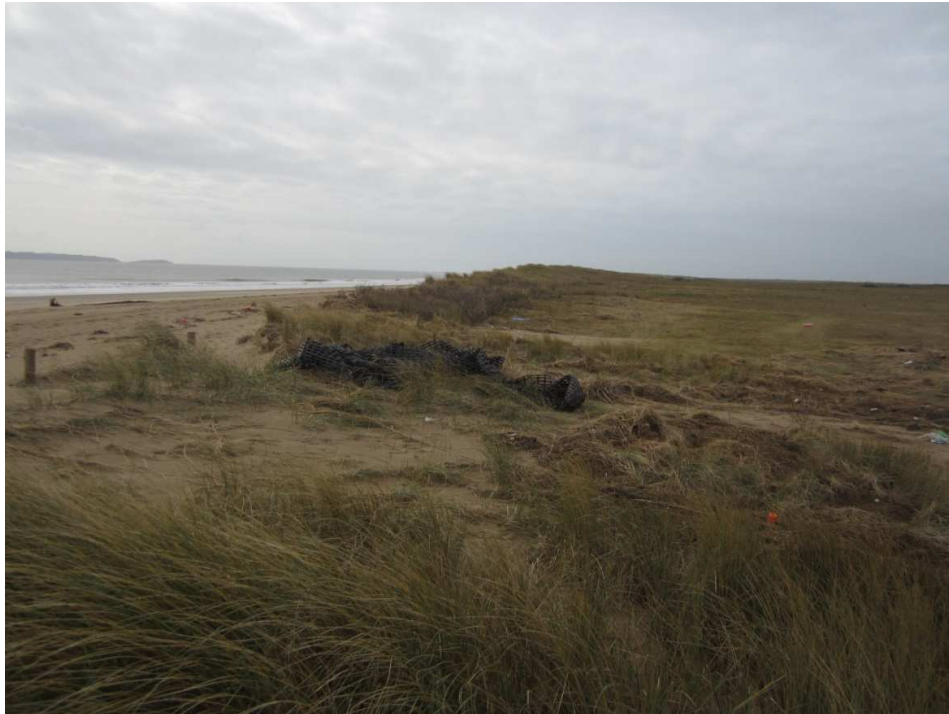
Photograph 23: View west at the point where the frontal dune ridge has been breached by recent erosion, Pembrey Burrows LNR.
