# Newborough Warren Phase 1 Dune Rejuvenation Works Topographic Survey Report

**Kenneth Pye & Simon J. Blott**

Kenneth Pye Associates Ltd

Date: March 2015

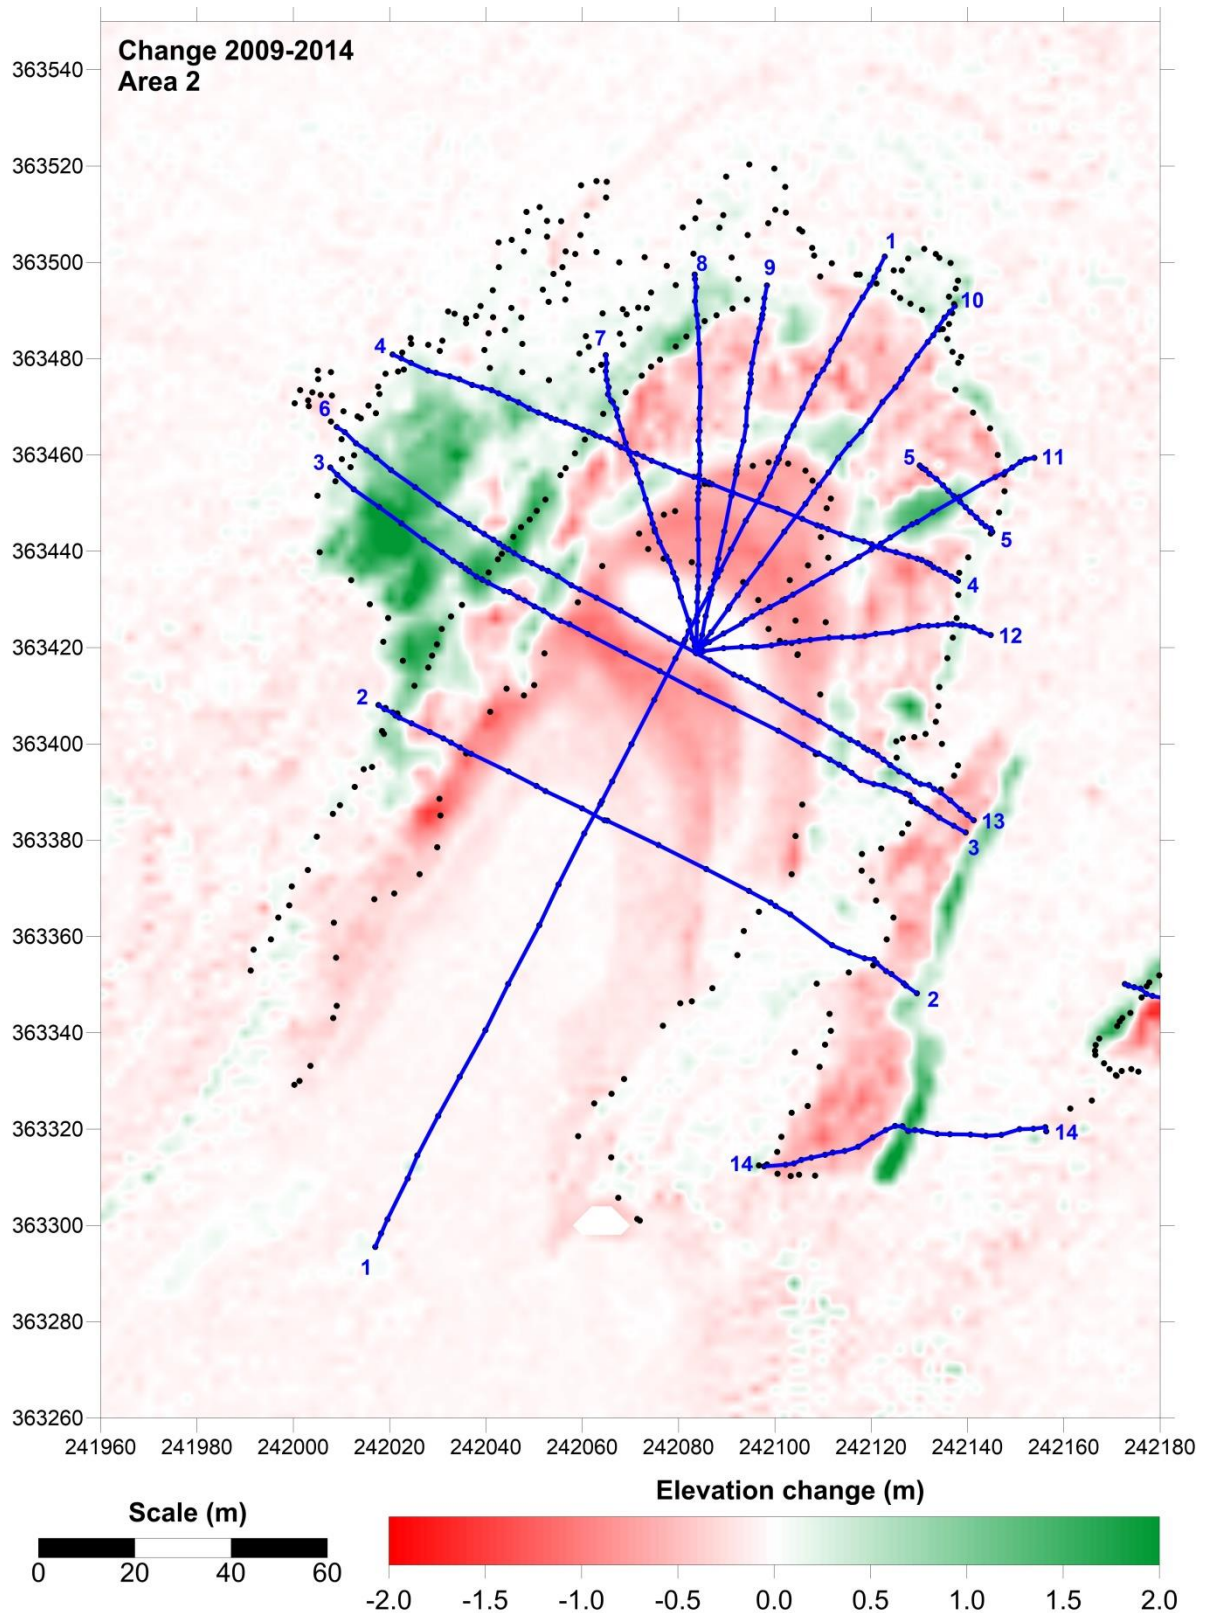
**Figure 6.** Change in elevation in Area 2 between the LiDAR surveys on 12 May 2009 and 9 April 2014. Locations of March 2015 data points (black dots) and cross-profiles (blue lines) are also shown.

The locations of survey profile lines within Area 2 are shown in Figures 4 and 5. A summary of the changes between the LiDAR surveys in May 2009 and April 2014 is shown in Figure 6. The main features (base and crests of dune ridges, standing water, and areas of blown sand) mapped in the field are shown in Figure 7. Topographic profiles recorded during the March 2015 survey are compared with those of the May 2013 and March 2014 surveys in Figure 8.

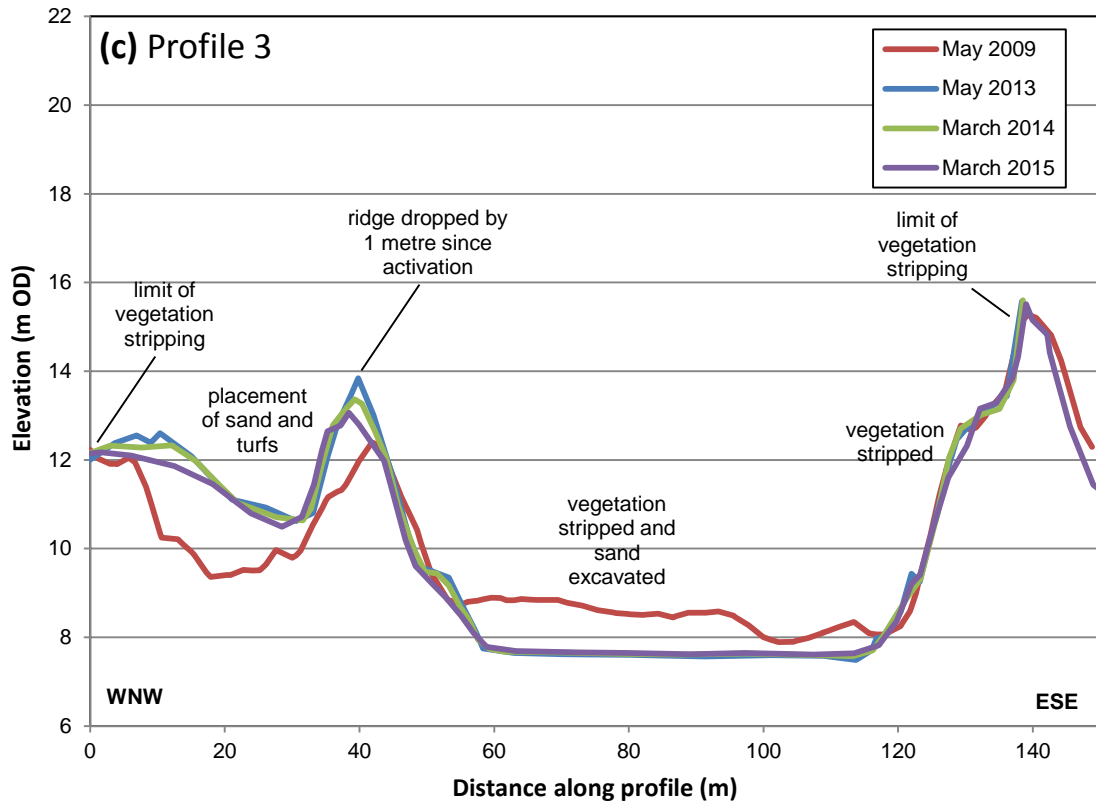
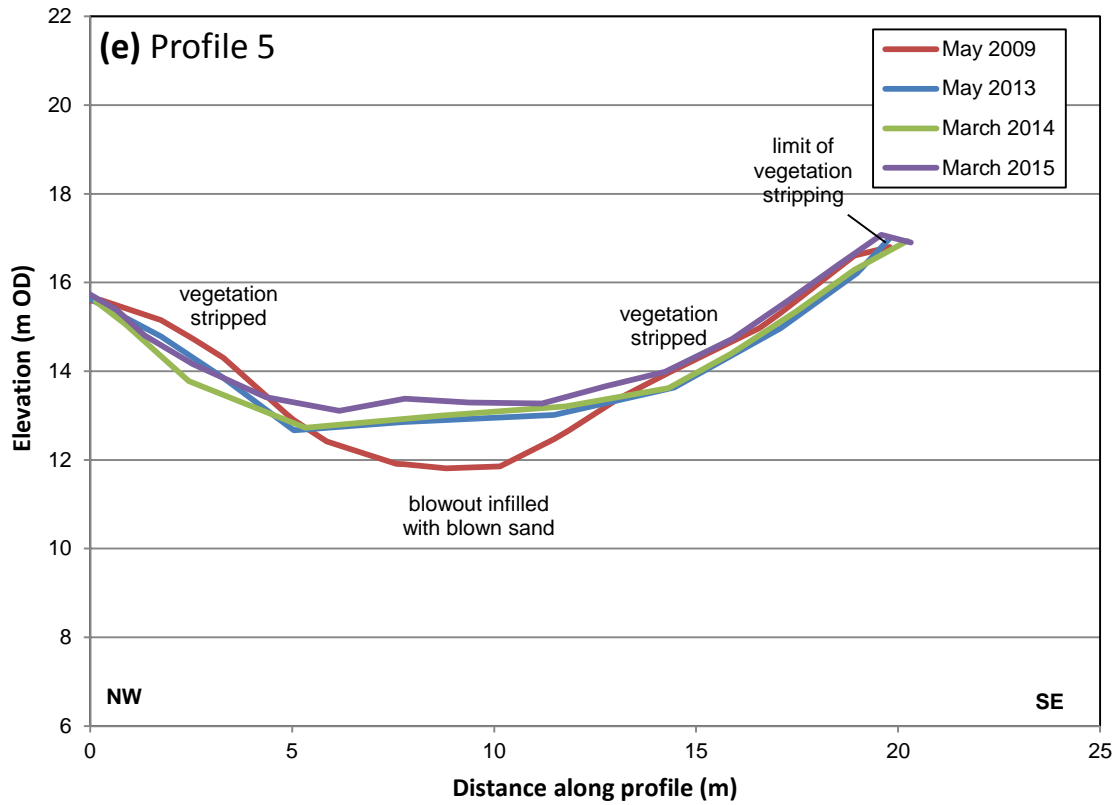
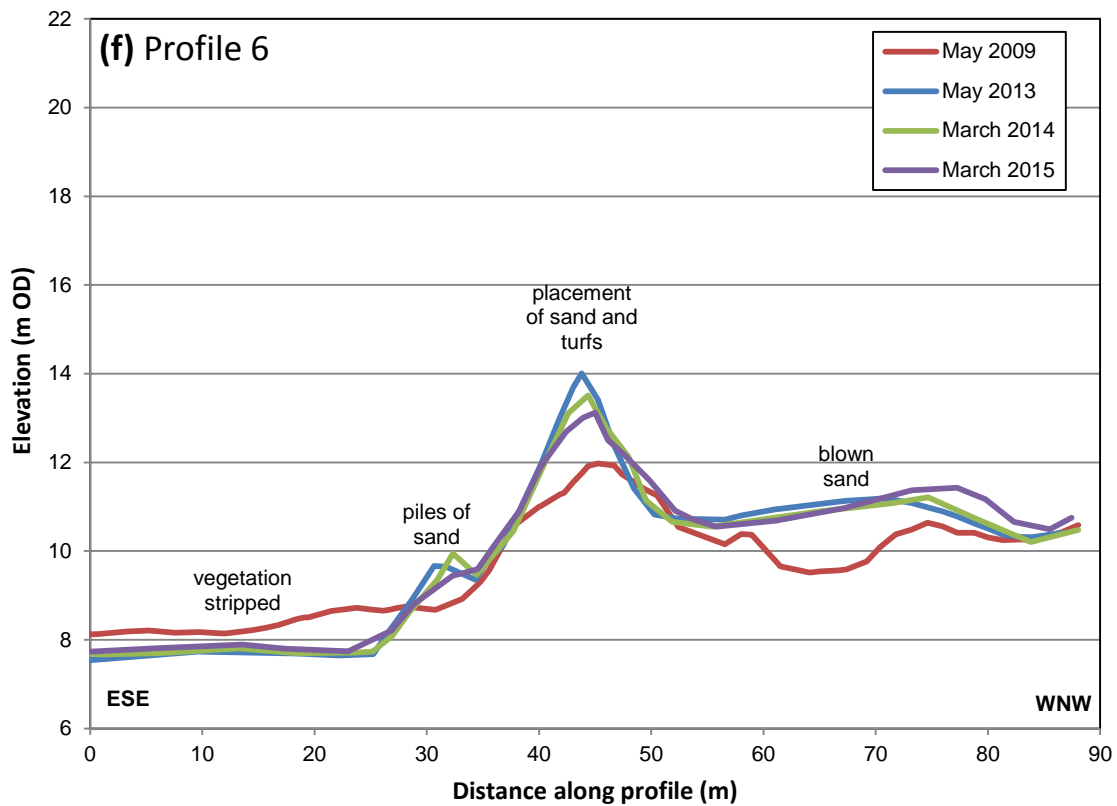
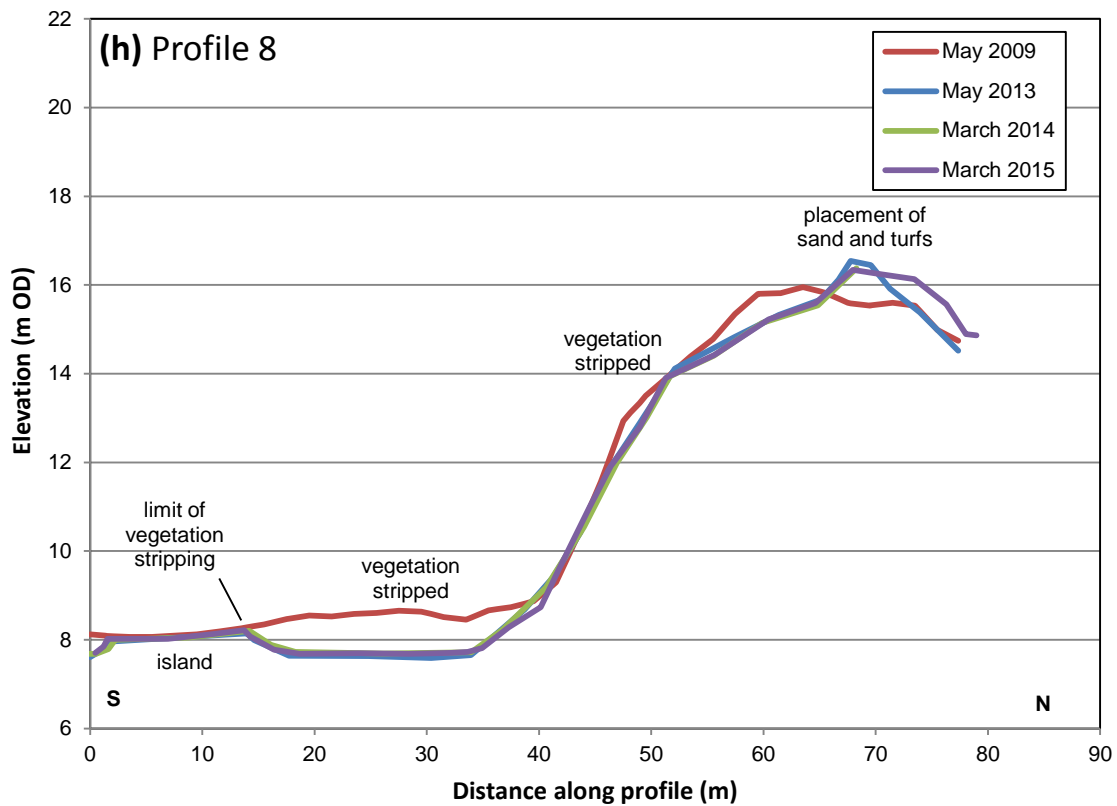
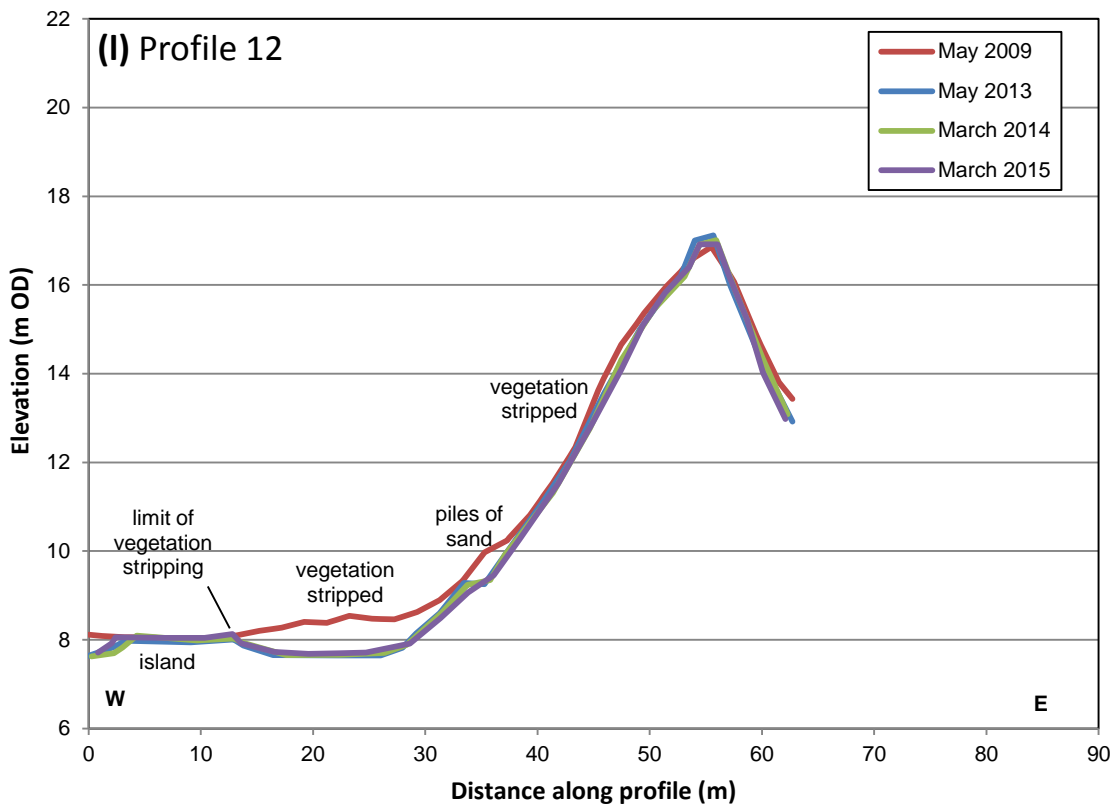
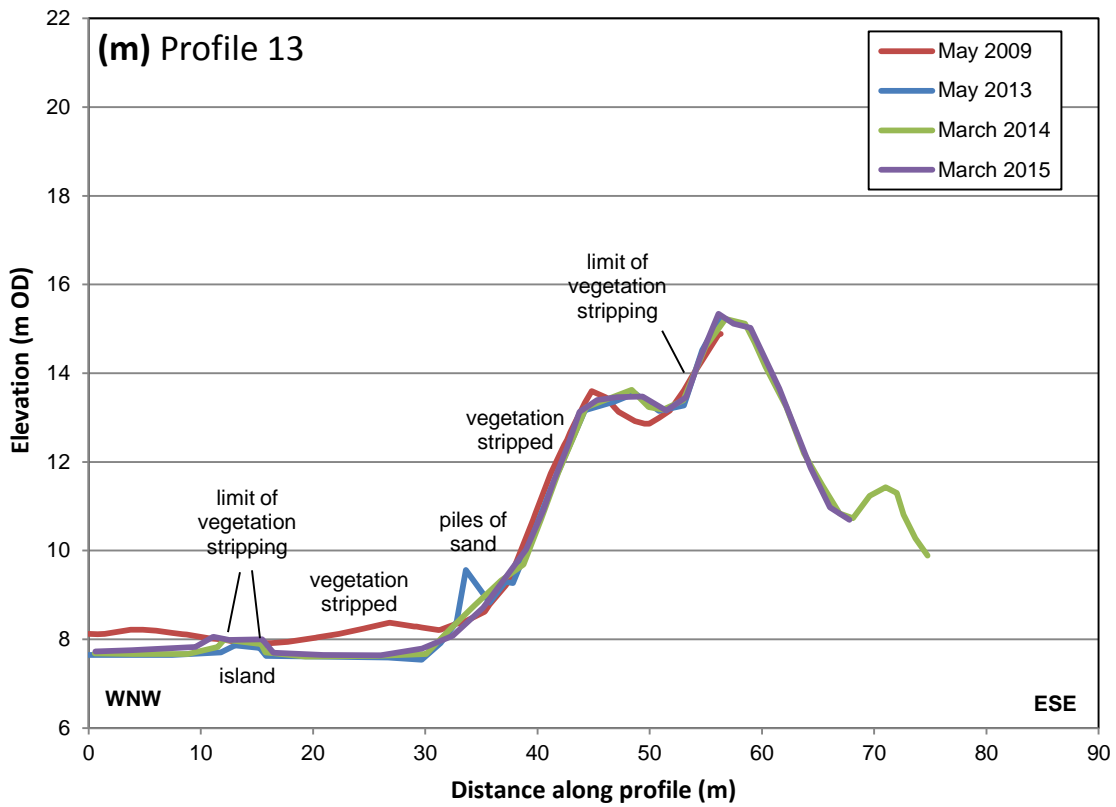
**Figure 8.** Comparison of surface levels at profiles 1 and 2 in Area 2, indicated by LiDAR survey on 12 May 2009 (pre-works) and ground surveys on 16 May 2013, 13 March 2014 and 27 March 2015.

**Figure 8 (continued).** Comparison of surface levels at profiles 3 and 4 in Area 2, indicated by LiDAR survey on 12 May 2009 (pre-works) and ground surveys on 16 May 2013, 13 March 2014 and 27 March 2015.

**Figure 8 (continued).** Comparison of surface levels at profiles 5 and 6 in Area 2, indicated by LiDAR survey on 12 May 2009 (pre-works) and ground surveys on 16 May 2013, 13 March 2014 and 27 March 2015.

**Figure 8 (continued).** Comparison of surface levels at profiles 7 and 8 in Area 2, indicated by LiDAR survey on 12 May 2009 (pre-works) and ground surveys on 16 May 2013, 13 March 2014 and 27 March 2015.

**Figure 8 (continued).** Comparison of surface levels at profiles 9 and 10 in Area 2, indicated by LiDAR survey on 12 May 2009 (pre-works) and ground surveys on 16 May 2013, 13 March 2014 and 27 March 2015.

**Figure 8 (continued).** Comparison of surface levels at profiles 11 and 12 in Area 2, indicated by LiDAR survey on 12 May 2009 (pre-works) and ground surveys on 16 May 2013, 13 March 2014 and 27 March 2015.

**Figure 8 (continued).** Comparison of surface levels at profiles 13 and 14 in Area 2, indicated by LiDAR survey on 12 May 2009 (pre-works) and ground surveys on 16 May 2013, 13 March 2014 and 27 March 2015.

The changes in elevation along most of the profiles were relatively small, amounting to less than 10 cm on the margins of the deflation troughs and the greater part of the side walls. Greater lowering was evident on the raised dune ridge on the western arm, where it is crossed by Profile 6, and on the dune crest in the NE corner of the site, where it is crossed by Profile 11. Further windblown sand has accumulated in the NW margin of the trial area, transported from the adjoining upwind area by southwesterly and southerly winds. This area remains largely free from vegetation, and the unconsolidated sand is deep enough to become mobile during periods of high wind activity to form megaripples and small barchan features.

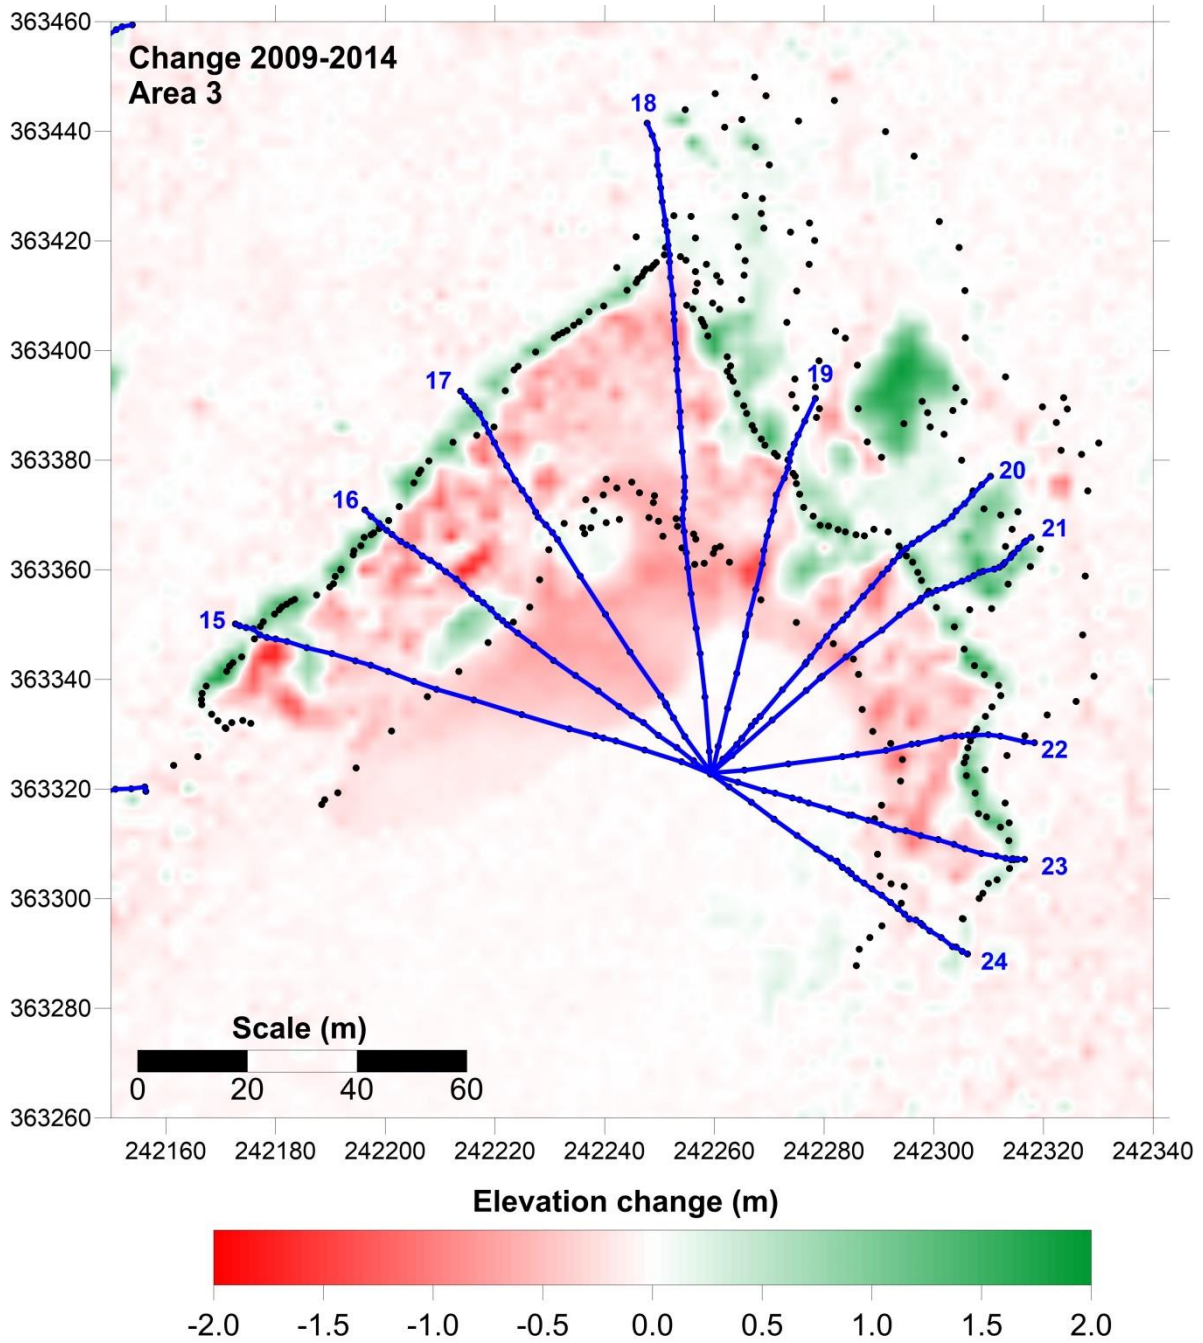
**Figure 11.** Change in elevation in Area 3 between the LiDAR surveys on 12 May 2009 and 9 April 2014. Locations of March 2015 data points (black dots) and cross-profiles (blue lines) are also shown.

The locations of survey profile lines within Area 3 are shown in Figures 9 and 10. A summary of the changes between the LiDAR surveys in May 2009 and April 2014 is shown in Figure 11. The main features (base and crests of dune ridges, standing water, and areas of blown sand) mapped in the field are shown in Figure 12. Topographic profiles recorded during the March 2015 survey are compared with those of the May 2013 and March 2014 surveys in Figure 13.

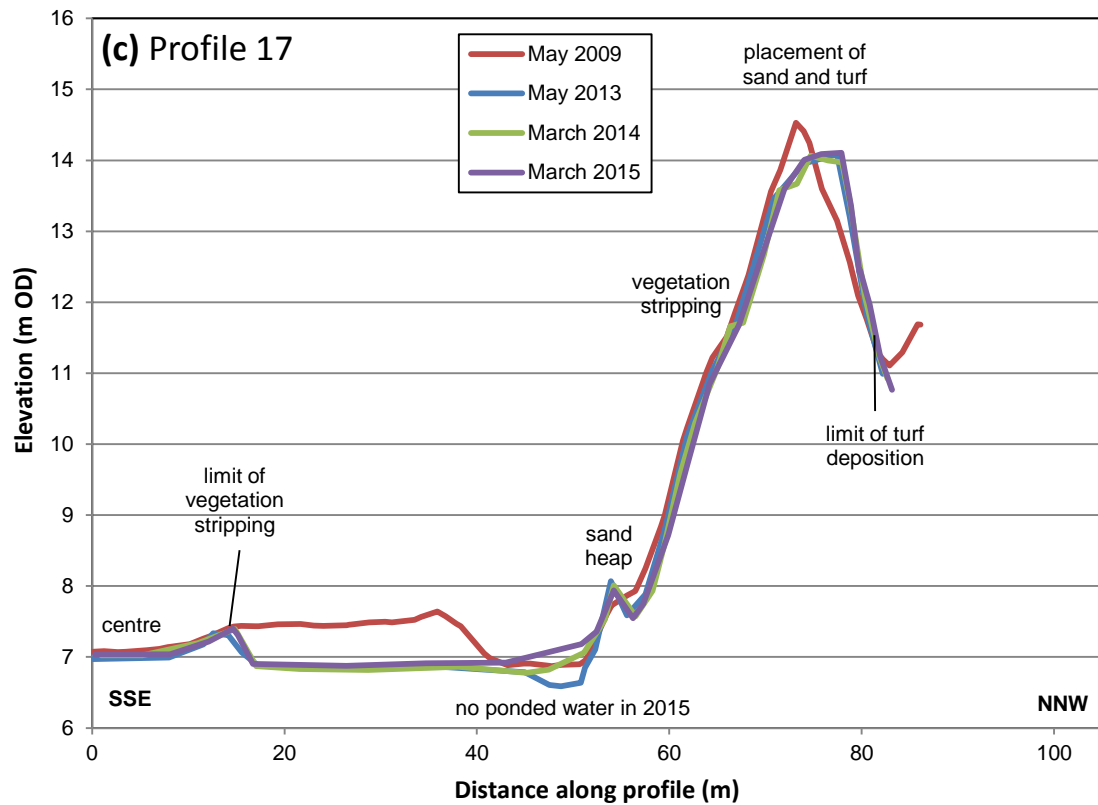
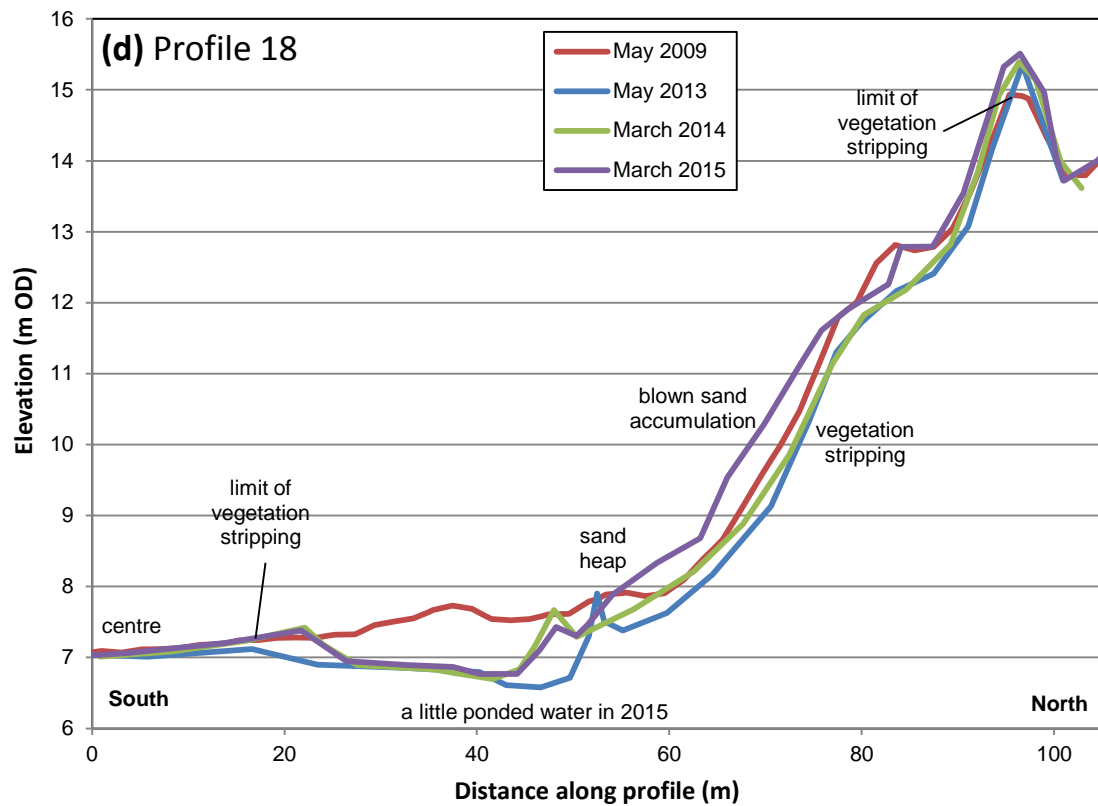
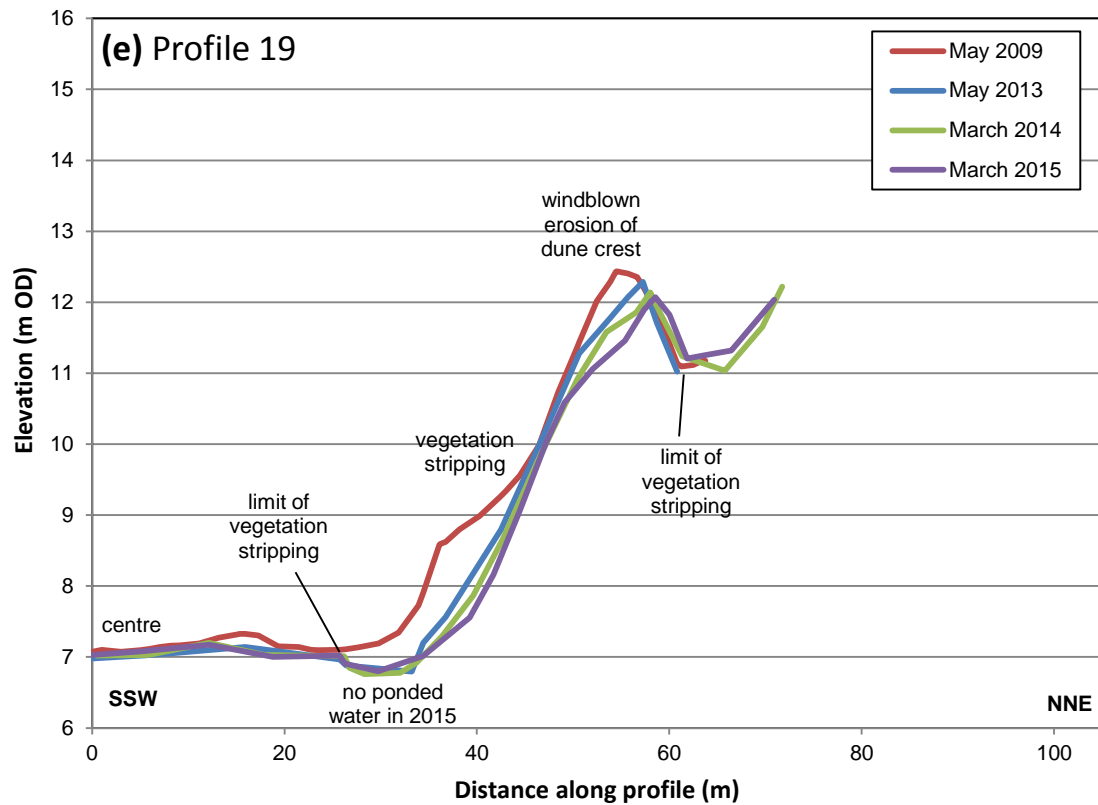
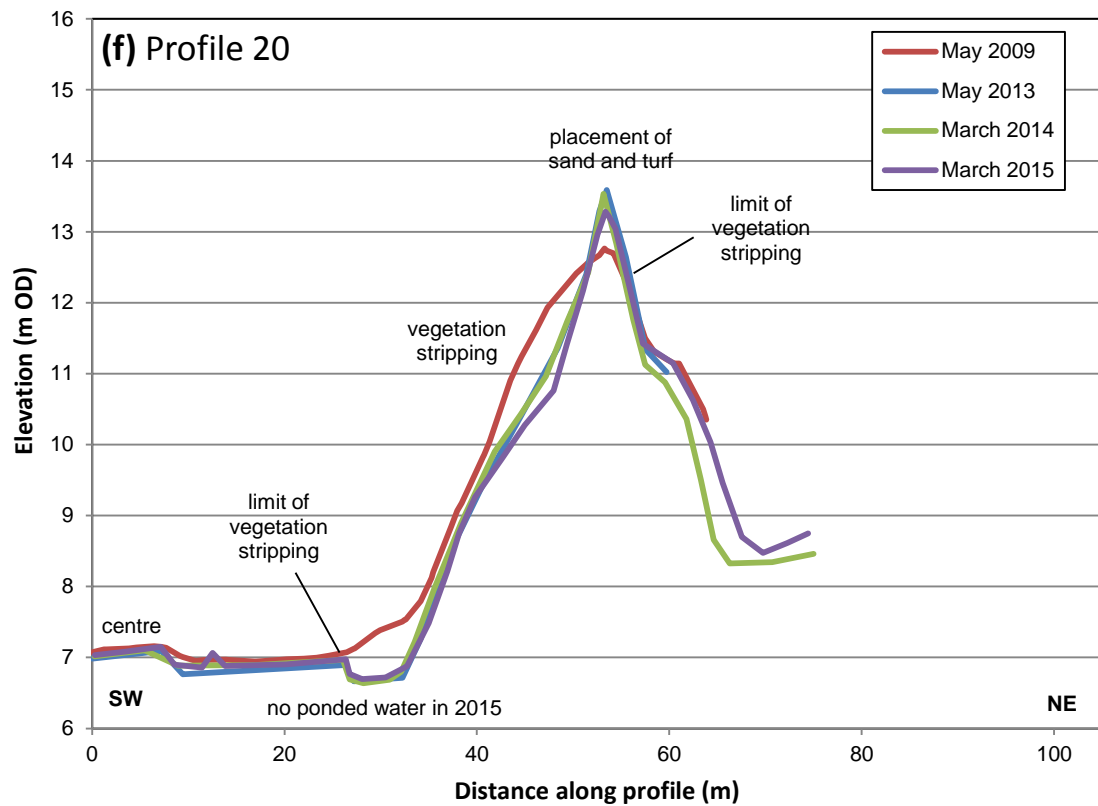
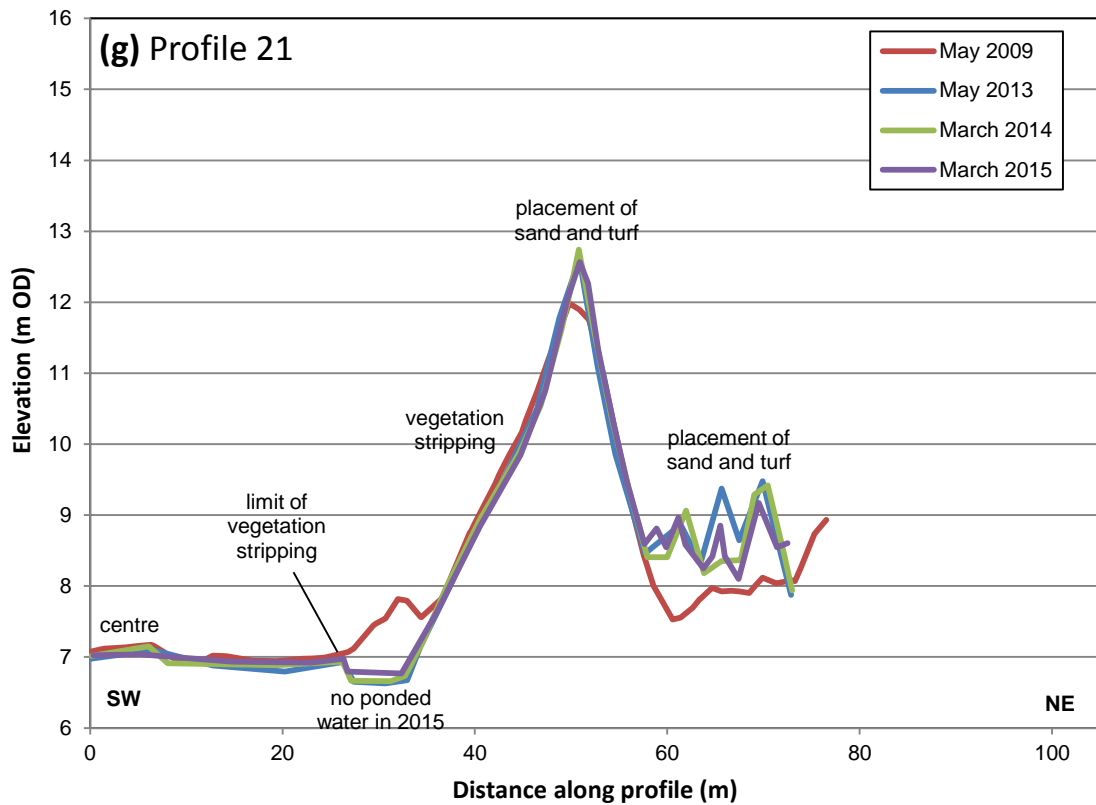
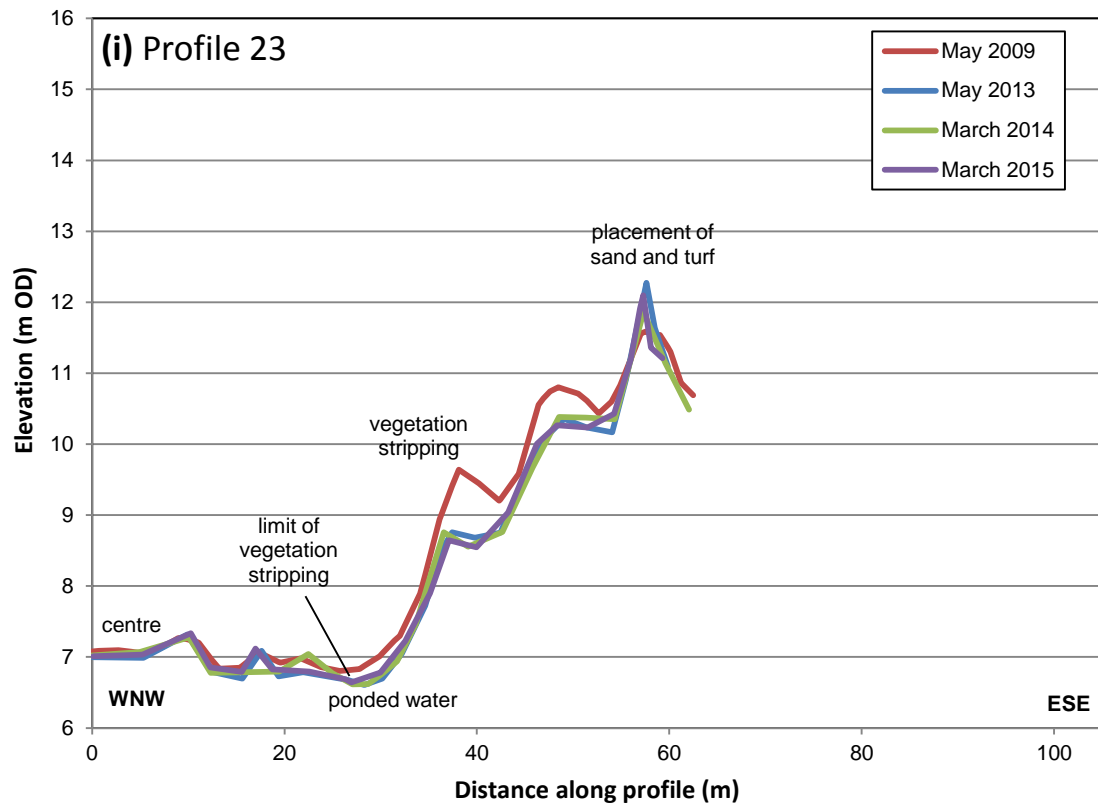
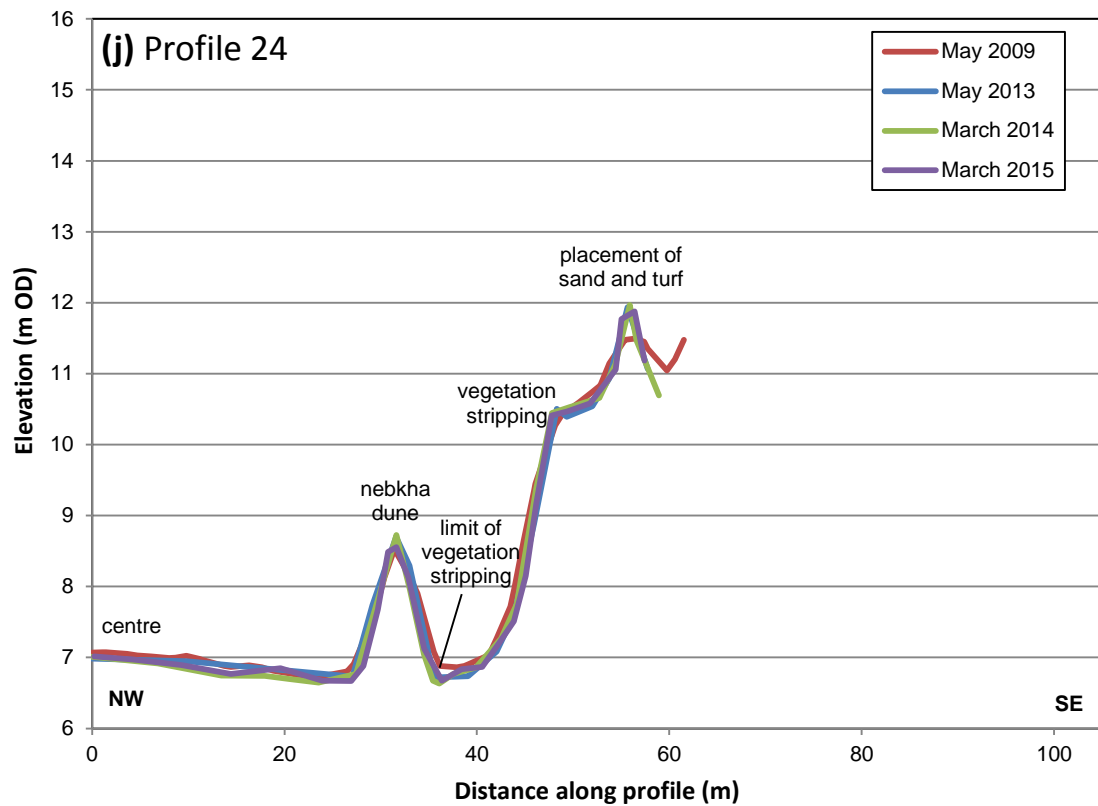
**Figure 13.** Comparison of surface levels at profiles 15 and 16 in Area 3, indicated by LiDAR survey on 12 May 2009 (pre-works) and ground surveys on 17 May 2013, 13 March 2014 and 27 March 2015.

**Figure 13 (continued).** Comparison of surface levels at profiles 17 and 18 in Area 3, indicated by LiDAR survey on 12 May 2009 (pre-works) and ground surveys on 17 May 2013, 13 March 2014 and 27 March 2015.

**Figure 13 (continued).** Comparison of surface levels at profiles 19 and 20 in Area 3, indicated by LiDAR survey on 12 May 2009 (pre-works) and ground surveys on 17 May 2013, 13 March 2014 and 27 March 2015.

**Figure 13 (continued).** Comparison of surface levels at profiles 21 and 22 in Area 3, indicated by LiDAR survey on 12 May 2009 (pre-works) and ground surveys on 17 May 2013, 13 March 2014 and 27 March 2015.

**Figure 13 (continued).** Comparison of surface levels at profiles 23 and 24 in Area 3, indicated by LiDAR survey on 12 May 2009 (pre-works) and ground surveys on 17 May 2013, 13 March 2014 and 27 March 2015.

Changes in elevation since March 2014 were again small (generally less than 10 cm), depending on location. The main areas of lowering due to deflation were in the NE part of the site (i.e. most exposed to southwesterly winds), on profiles 19 and 20. A substantial portion of this sand appears to have accumulated in the northern corner of the site where Profile 18 has exhibited up to 1 metre of accretion along most of the profile from the base to the crest. A thick layer (generally 1-15 cm) of largely unvegetated sand was evident on the downwind side of the dune crest, having been transported there by southwesterly winds, with a thinner spread of sand extending some 50 metres NE of the de-vegetated dune crest.

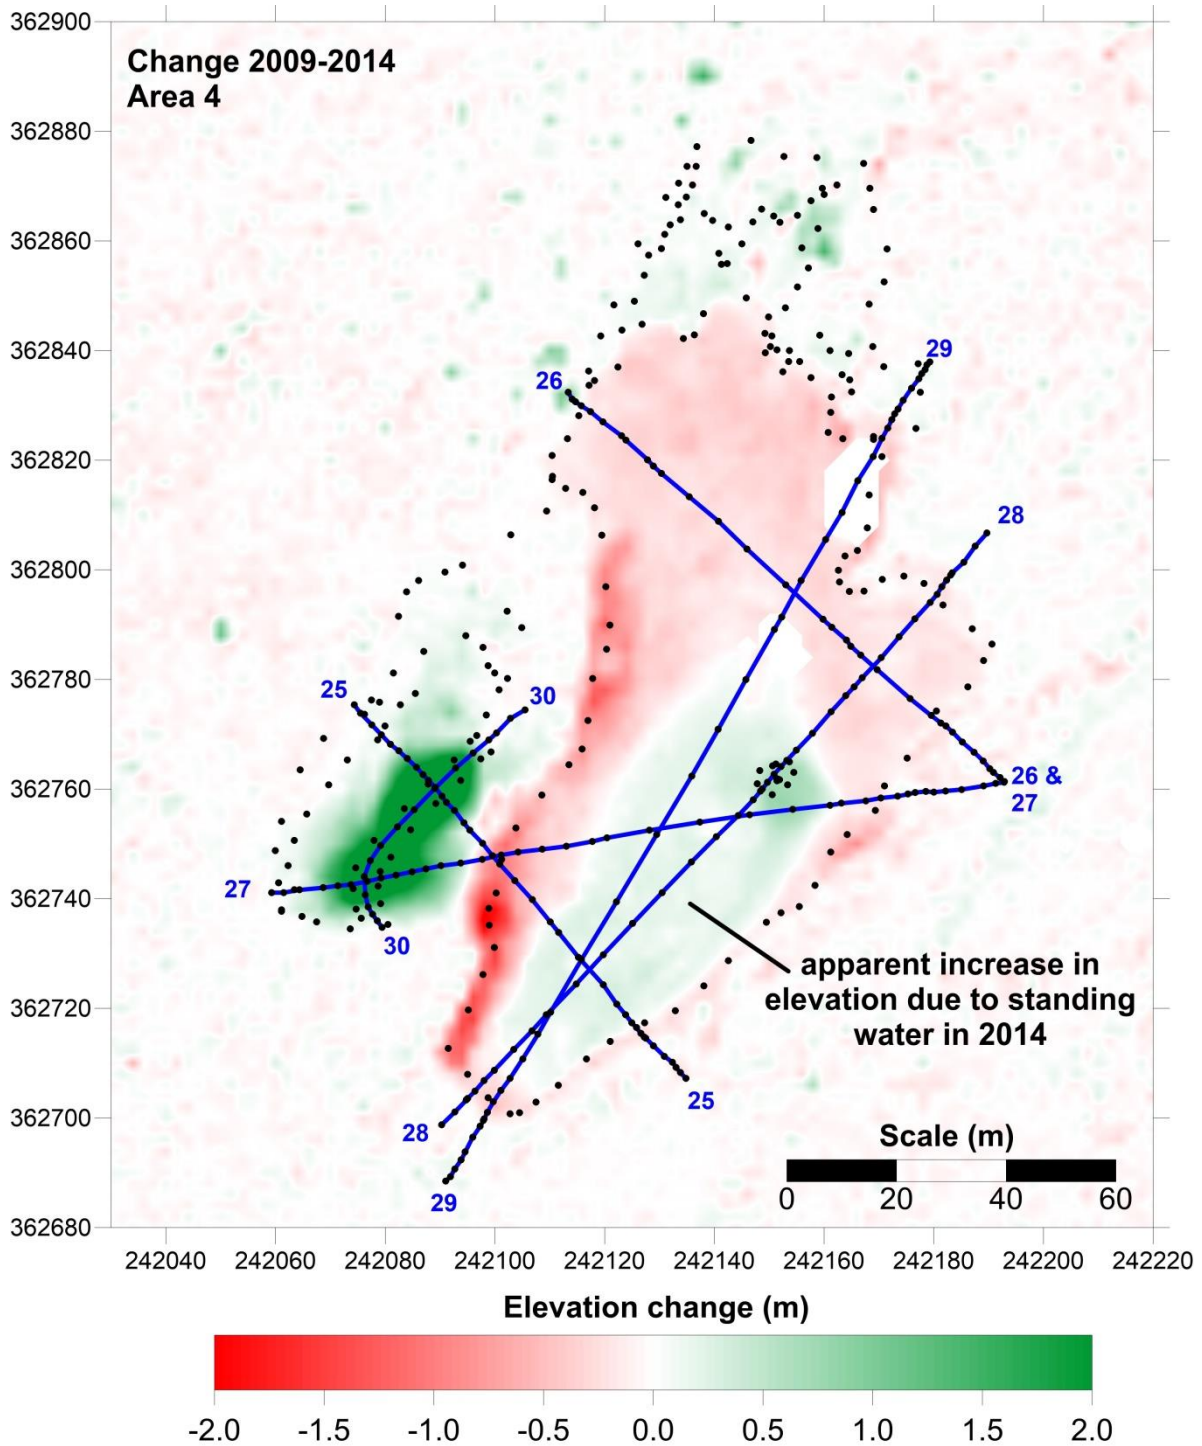
**Figure 16.** Change in elevation in Area 4 between the LiDAR surveys on 12 May 2009 and 9 April 2014. Locations of March 2015 data points (black dots) and cross-profiles (blue lines) are also shown. Note that the apparent increase in elevation in the deflation trough between 2009-2014 is due to the April 2014 LiDAR survey measuring the surface of standing water (the winter of 2013/14 was particularly wet), and the true land surface in April 2014 would have been lower in elevation than indicated.

The locations of survey profile lines within Area 4 are shown in Figures 14 and 15. A summary of the changes between the LiDAR surveys in May 2009 and April 2014 is shown in Figure 16. The main features (base and crests of dune ridges, standing water, and areas of blown sand) mapped in the field are shown in Figure 17. Topographic profiles recorded during the March 2015 survey are compared with those of the May 2013 and March 2014 surveys in Figure 18.

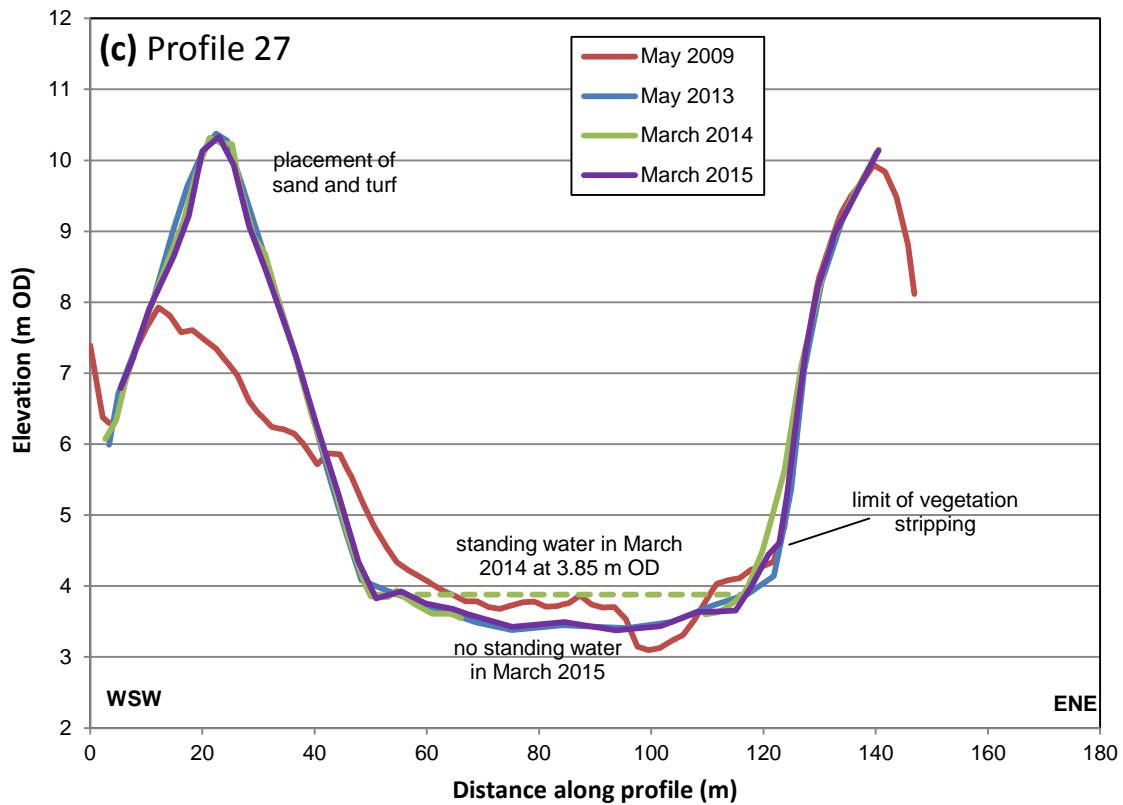
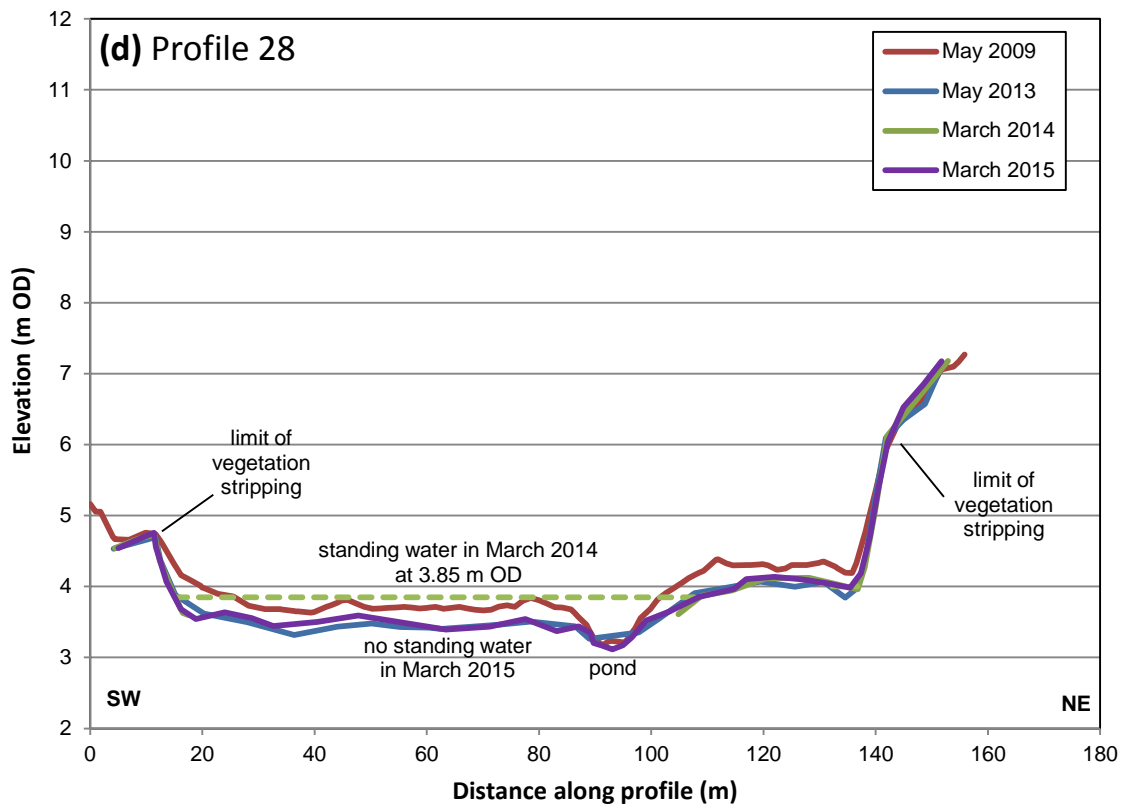
**Figure 18.** Comparison of surface levels at profiles 25 and 26 in Area 4, indicated by LiDAR survey on 12 May 2009 (pre-works) and ground surveys on 17 May 2013, 13 March 2014 and 27 March 2015.

**Figure 18 (continued).** Comparison of surface levels at profiles 27 and 28 in Area 4, indicated by LiDAR survey on 12 May 2009 (pre-works) and ground surveys on 17 May 2013, 13 March 2014 and 27 March 2015.

**Figure 18 (continued).** Comparison of surface levels at profiles 29 and 30 in Area 4, indicated by LiDAR survey on 12 May 2009 (pre-works) and ground surveys on 17 May 2013, 13 March 2014 and 27 March 2015.

Only very small elevation differences are evident on the vegetation-stripped areas around Area 4, including the new ridge in the SW part of the site which has exhibited remarkably

little change. Sand continues to spread northwards on the downwind side of the trial area, forming a largely unvegetated 0-10cm thick layer, probably sourced from a former artificial sand mound and very little sand deflation is evident anywhere else in Area 4.

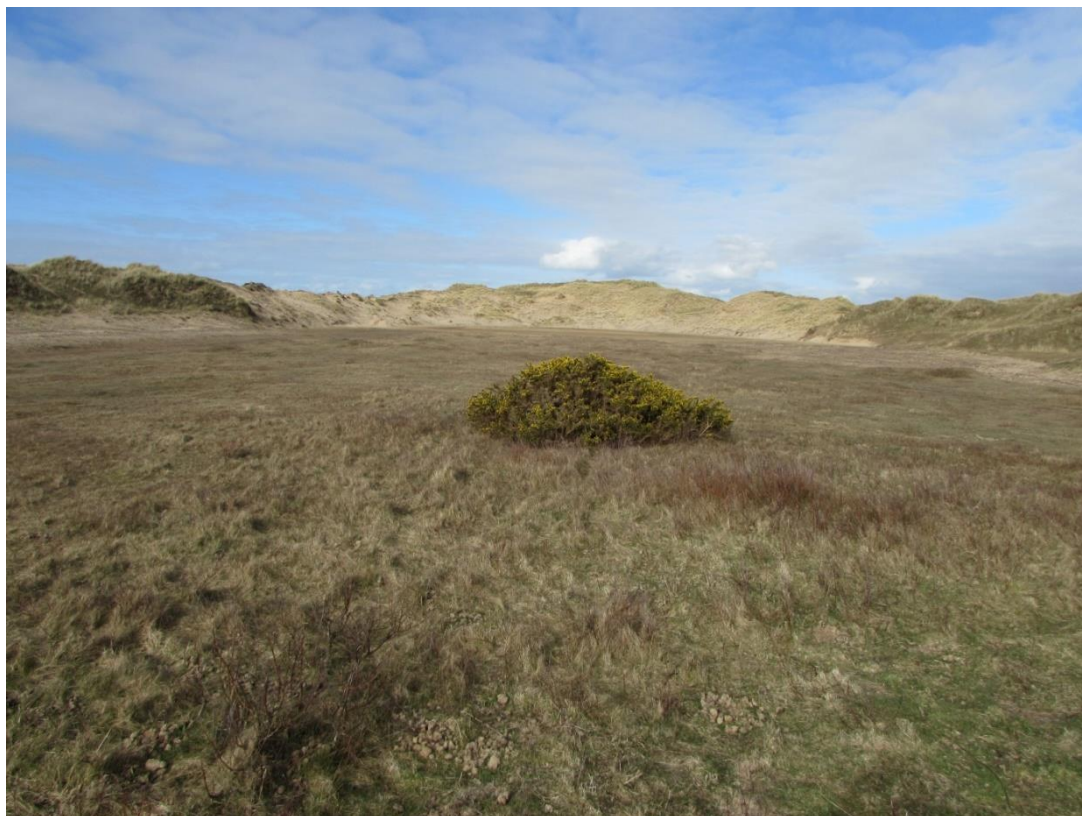
**Photograph 1.** Central axis of the Area 2, looking NE

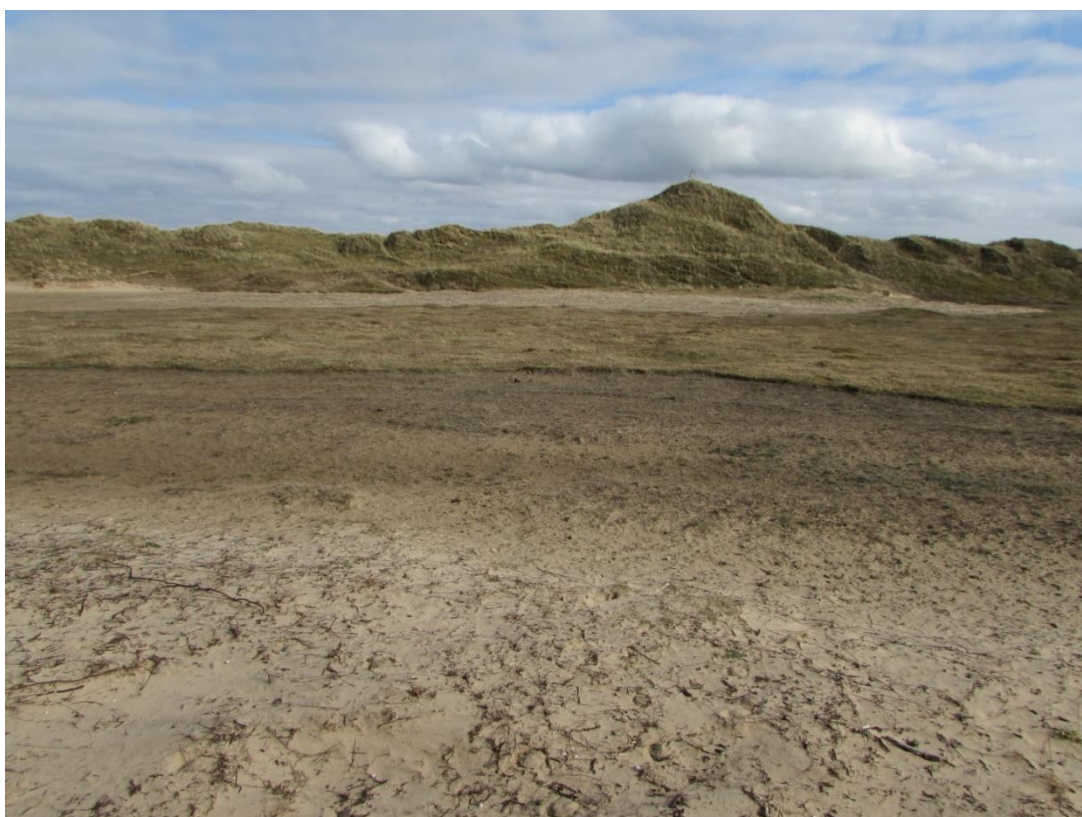
**Photograph 2.** View across deflation trough of Area 2, looking SE
