# Newborough Warren Phase 1 Dune Rejuvenation Works Topographic Survey Report

**Kenneth Pye & Simon J. Blott**

Kenneth Pye Associates Ltd

Date: March 2015

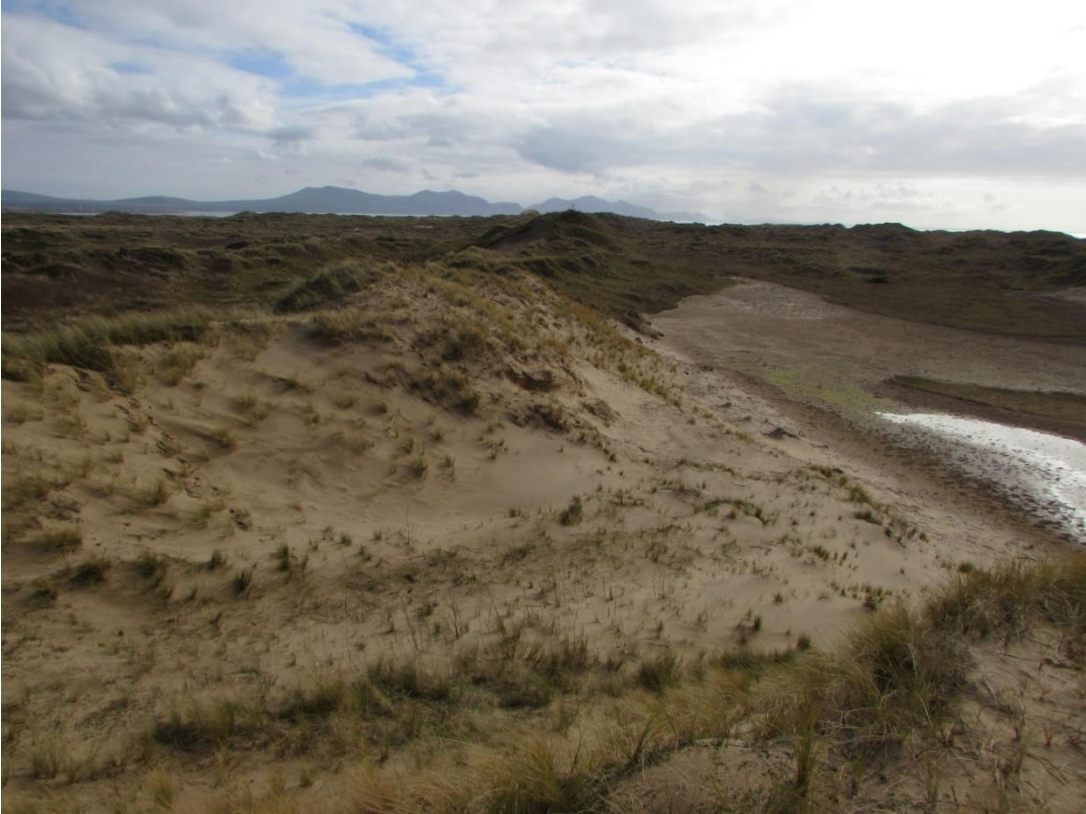
**Photograph 3.** Southern ‘arm’ of Area 2, looking seawards

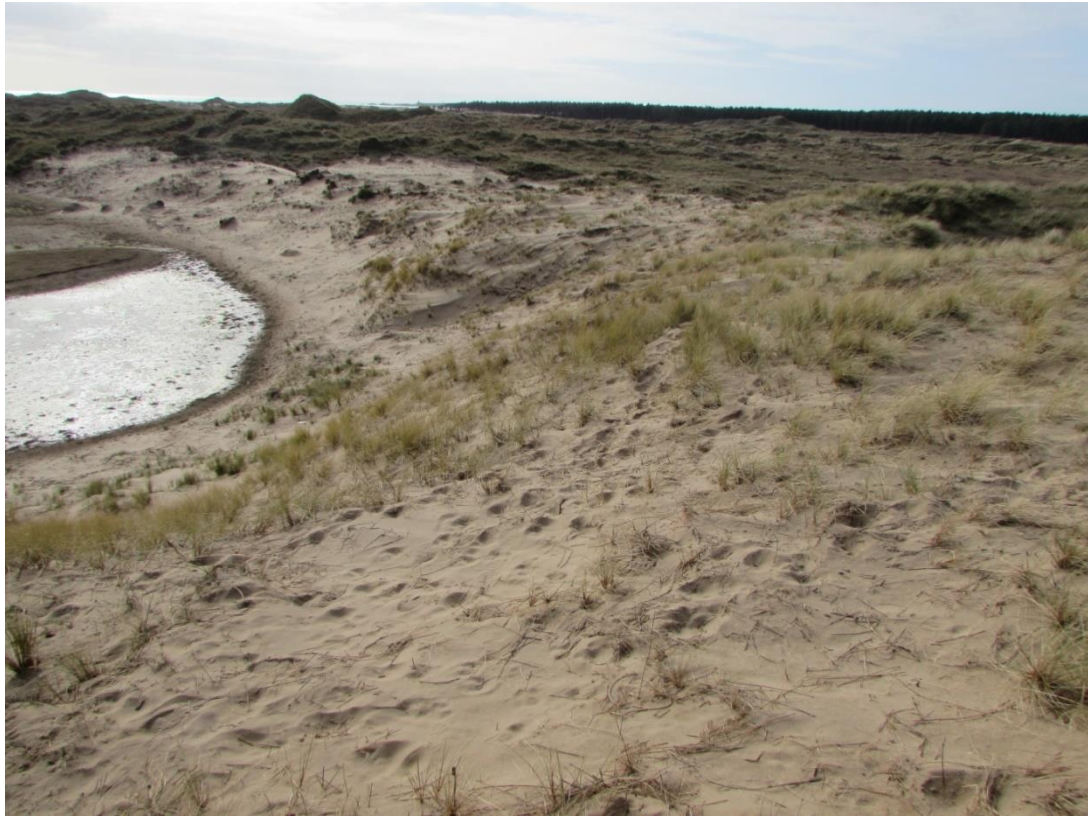
**Photograph 5.** Northern 'arm' of Area 2, looking W

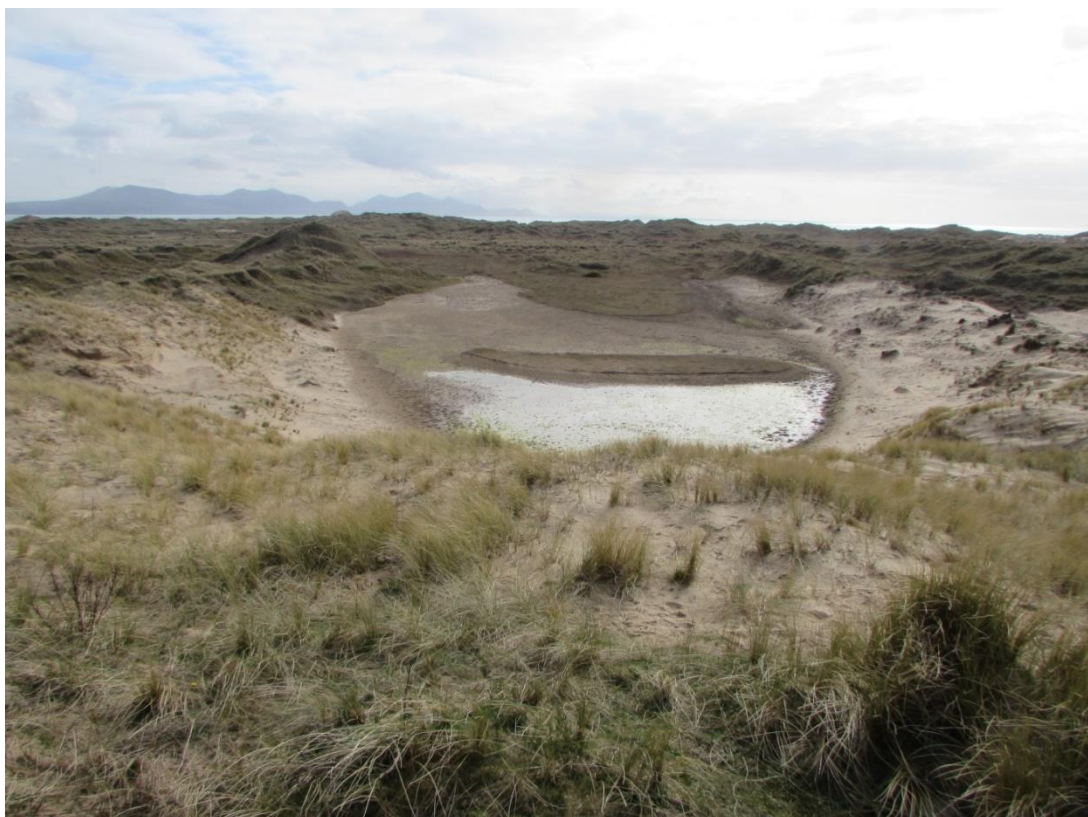
**Photograph 6.** Central axis of the Area 2, looking SW

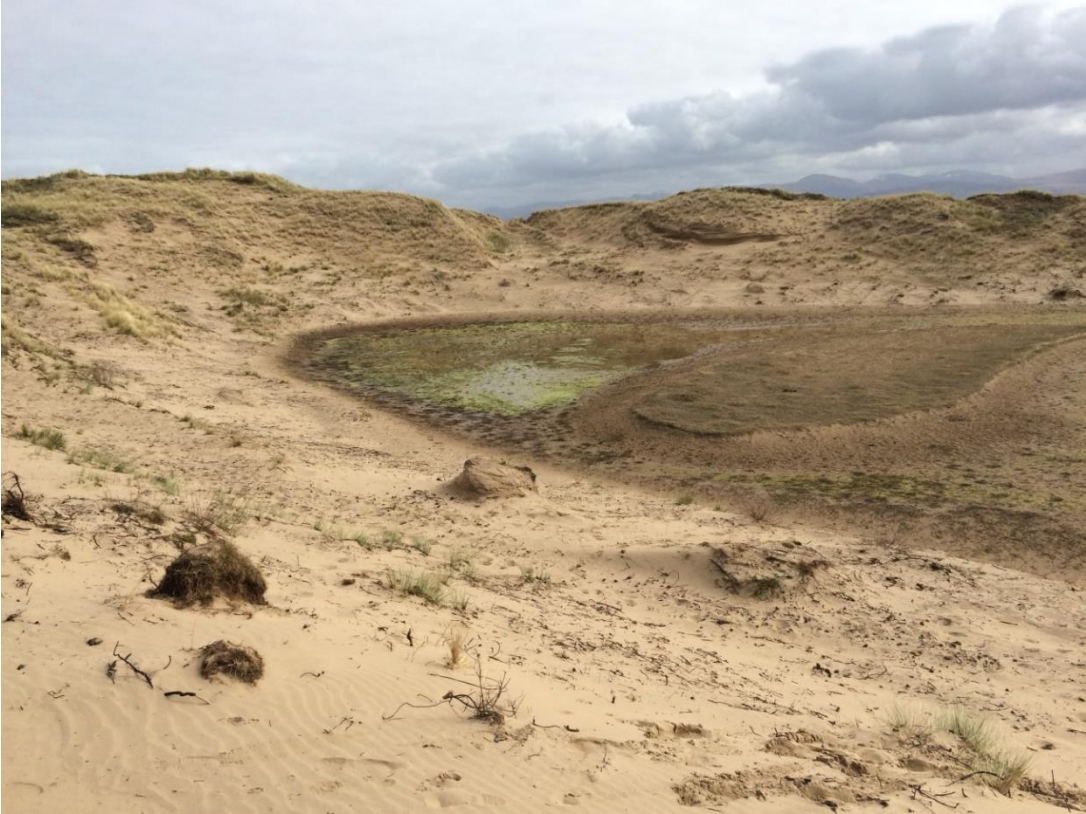
**Photograph 7.** Deflation corridor of Area 2, looking NE

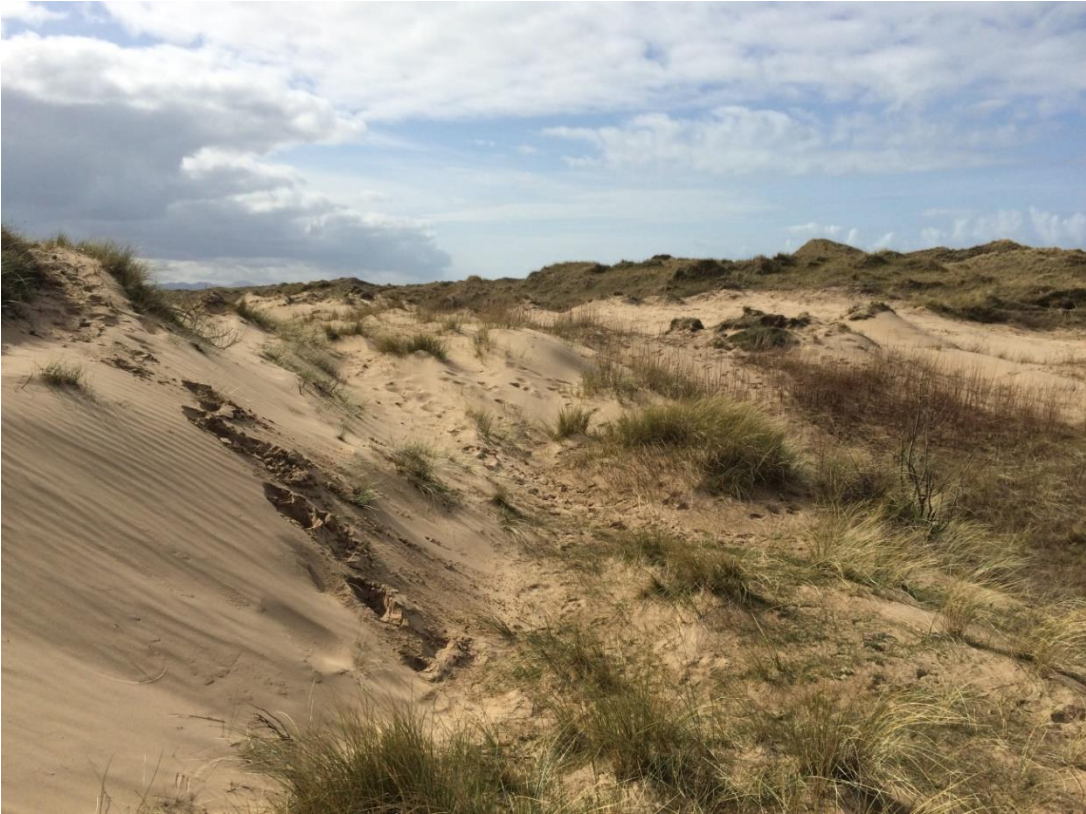
**Photograph 8.** Area of sand blowing on the western side of Area 2

Within all three areas some vegetation regrowth and development of surface algal crusts was evident between the 2014 and 2015 surveys, but significant areas of actively moving sand remain, particularly near the crests and on the upper parts of the dune 'arms', and a thin layer of windblown sand continues to form in the vegetated areas downwind (see photographs in Appendix 1).

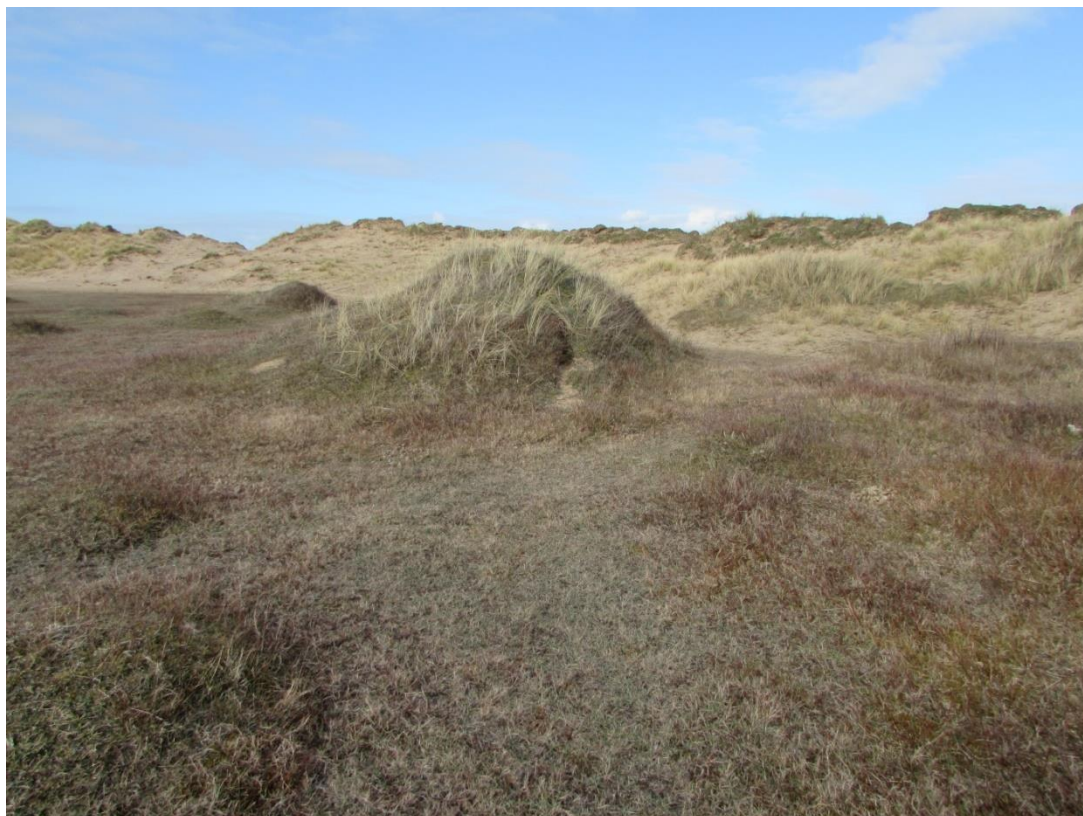
**Photograph 9.** 'Hedgehog' dune in Area 3, looking N

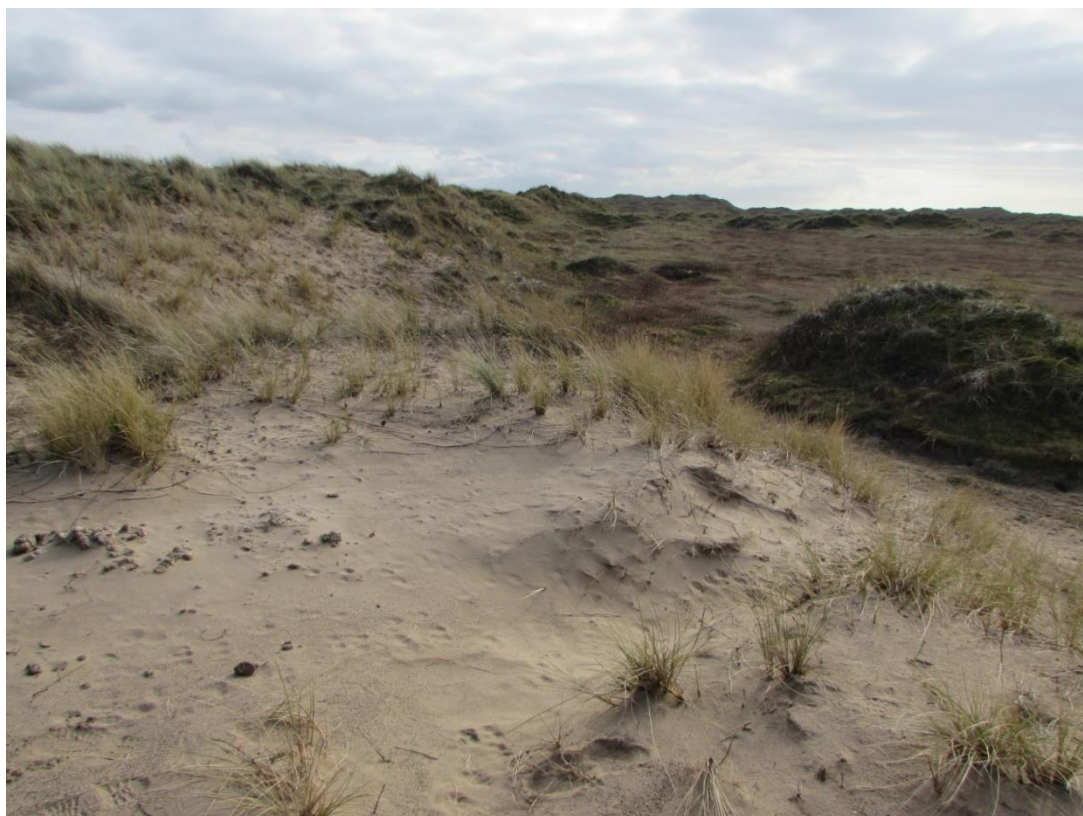
**Photograph 10.** SE corner of Area 3, showing vegetation colonisation, looking S

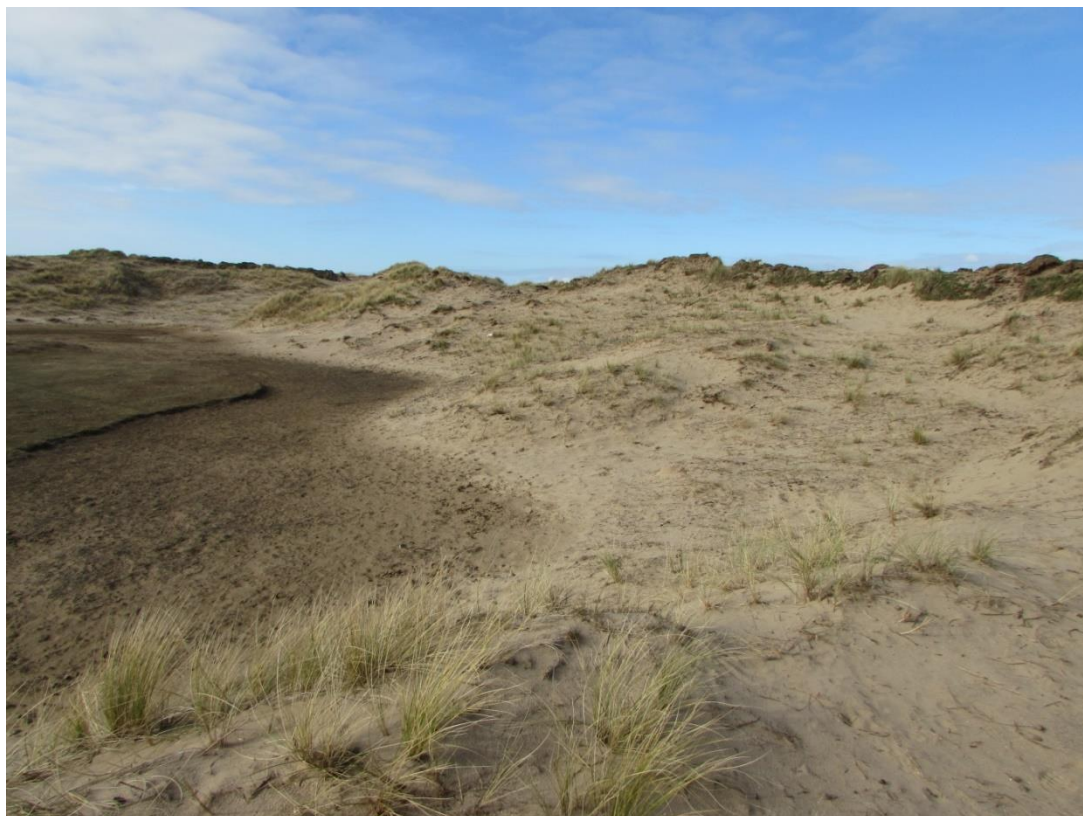
**Photograph 11.** SE corner of Area 3, showing vegetation colonisation, looking S

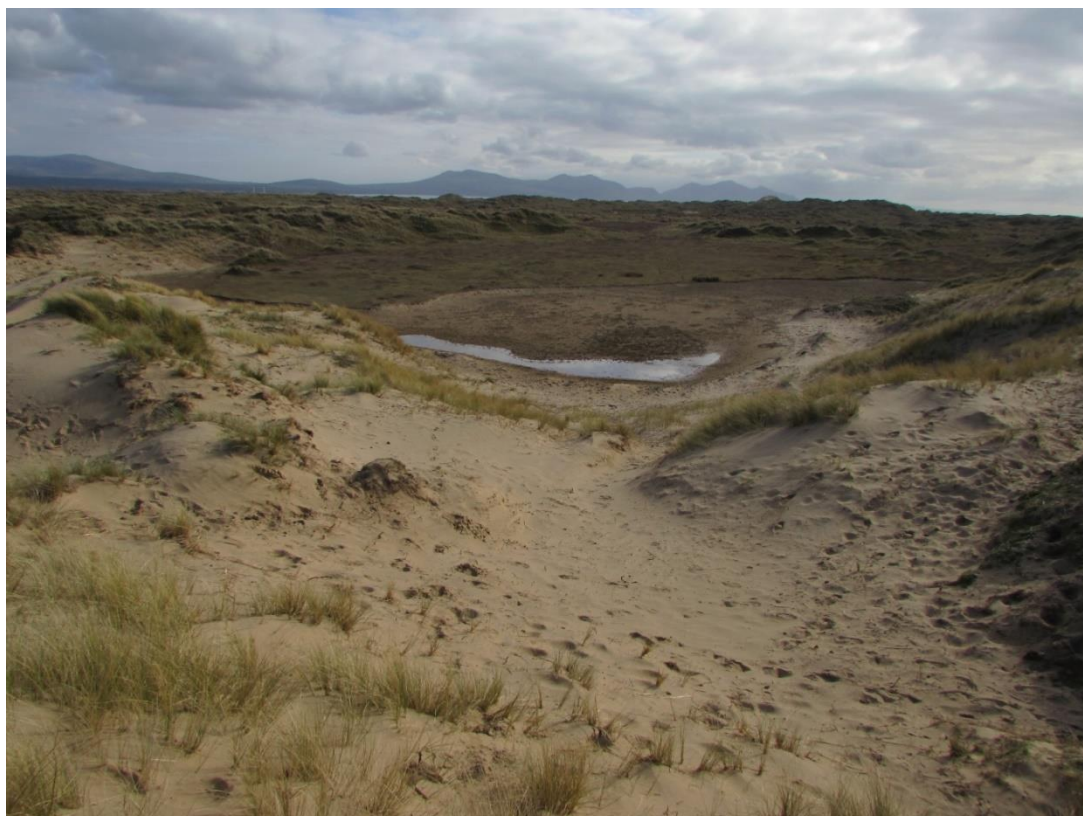
**Photograph 12.** Oblique view across the deflation trough of Area 3, looking S

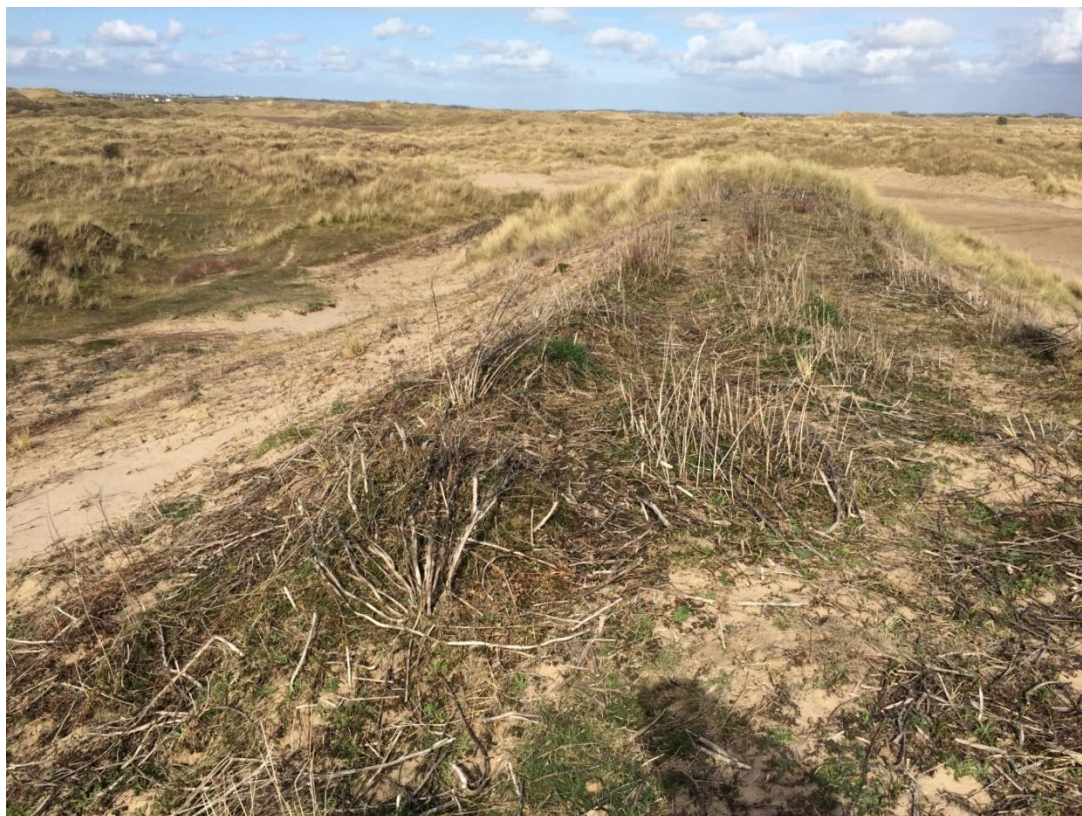
**Photograph 13.** View along the constructed ridge on the western side of Area 4, looking NE

Only very small elevation differences are evident on the vegetation-stripped areas around Area 4, including the new ridge in the SW part of the site which has exhibited remarkably

little change. Sand continues to spread northwards on the downwind side of the trial area, forming a largely unvegetated 0-10cm thick layer, probably sourced from a former artificial sand mound and very little sand deflation is evident anywhere else in Area 4.

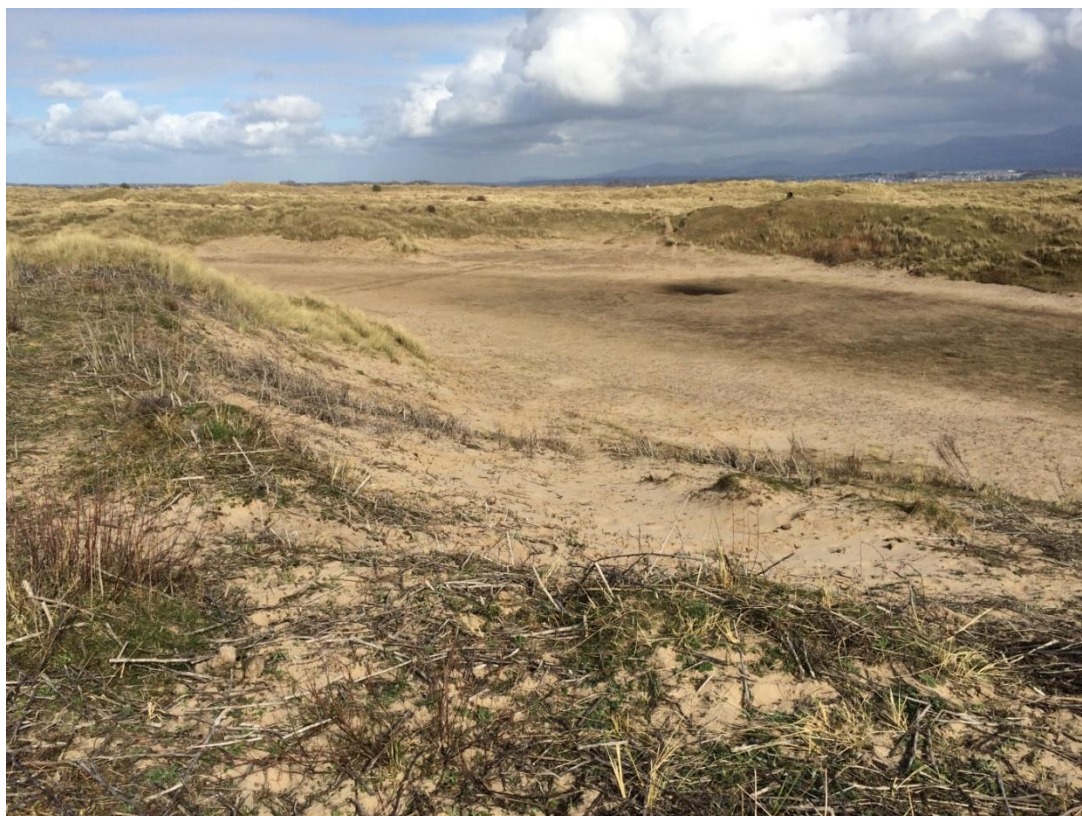
**Photograph 14.** View across the deflation trough of Area 4, looking E

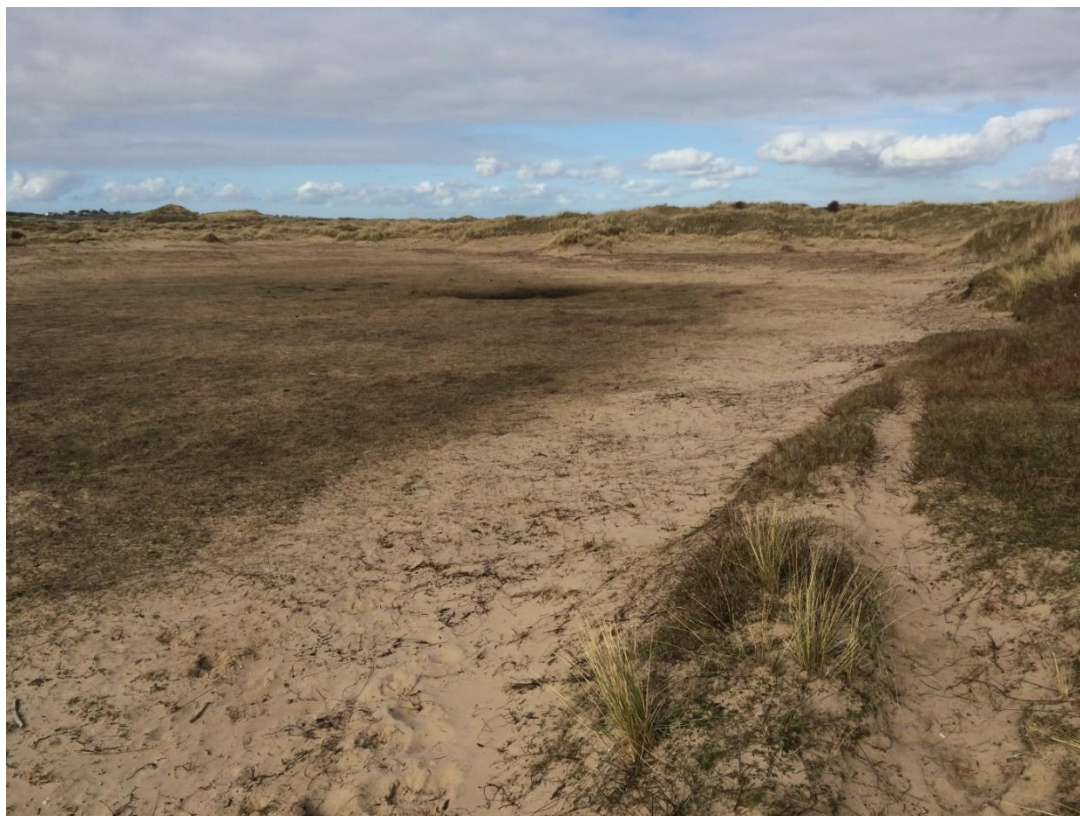
**Photograph 15.** View along the deflation trough of Area 4, looking NE

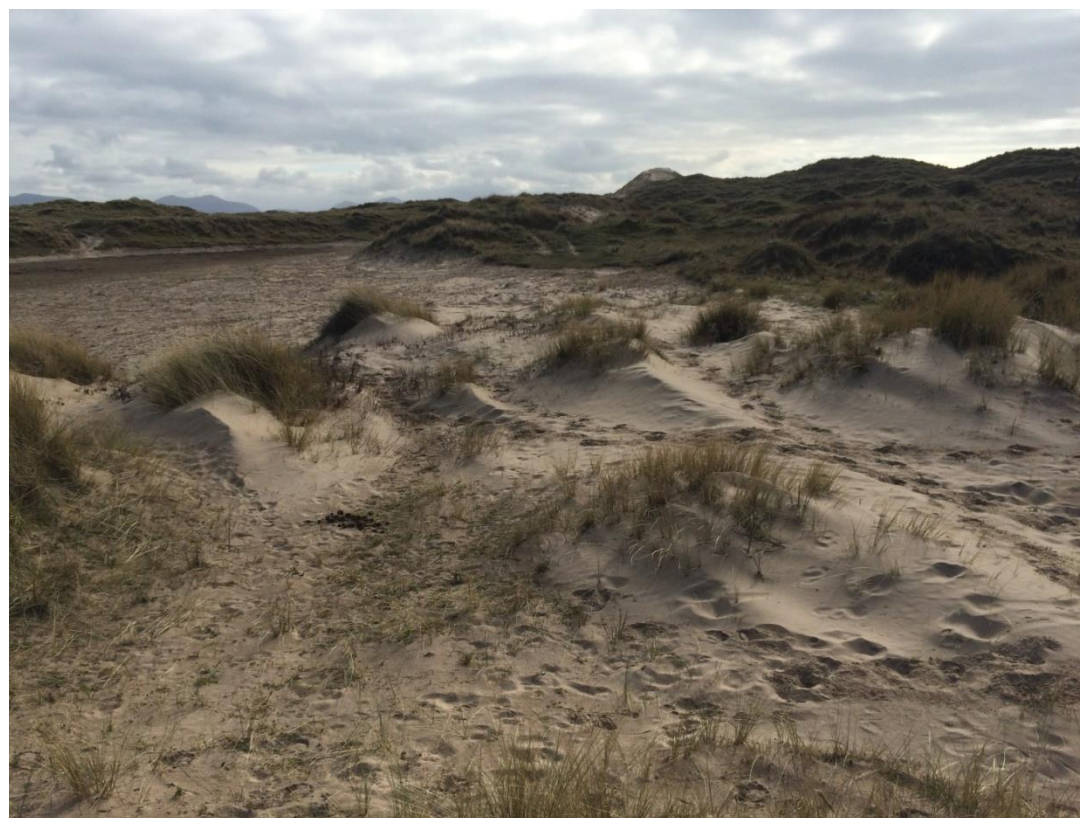
**Photograph 16.** Area of sand blowing to the north of the deflation trough of Area 4, looking S
