Kenfig Phase 1 Dune Rejuvenation Works Topographic Survey Report

Kenneth Pye Associates Ltd

Report No: 98

Date: May 2014

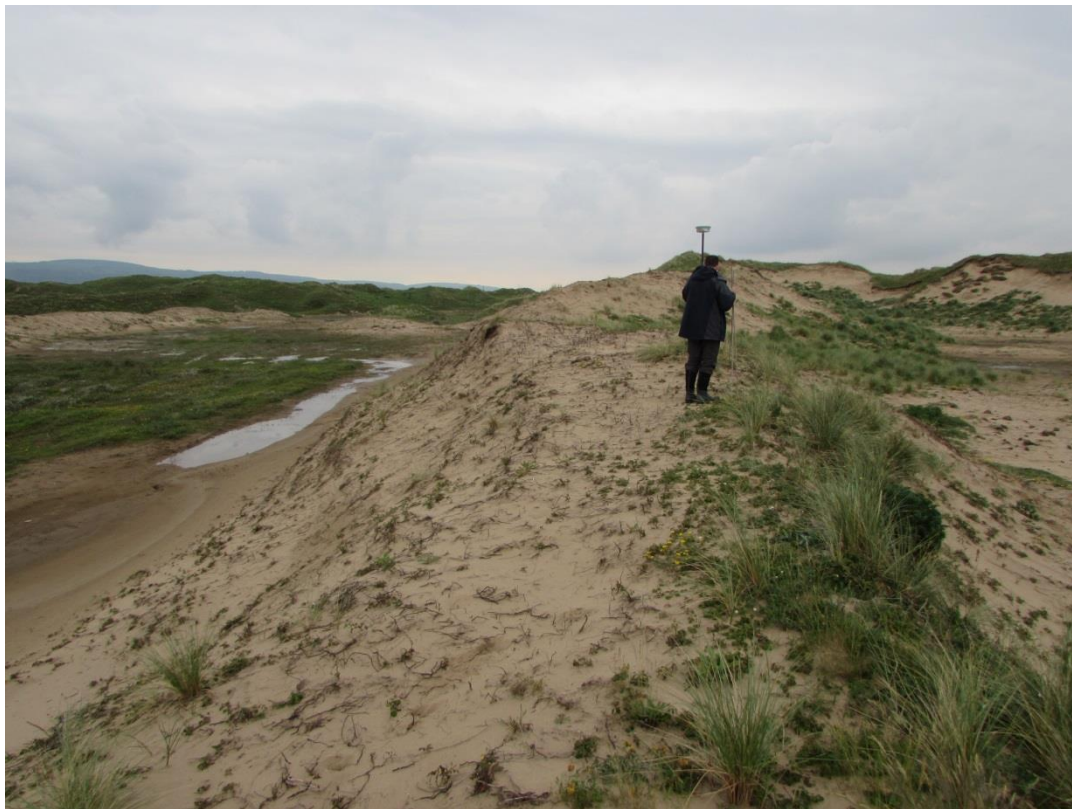
Photograph 1. Slight wave trimming of frontal dunes and gravel upper beach between Notch 1 and Notch 2

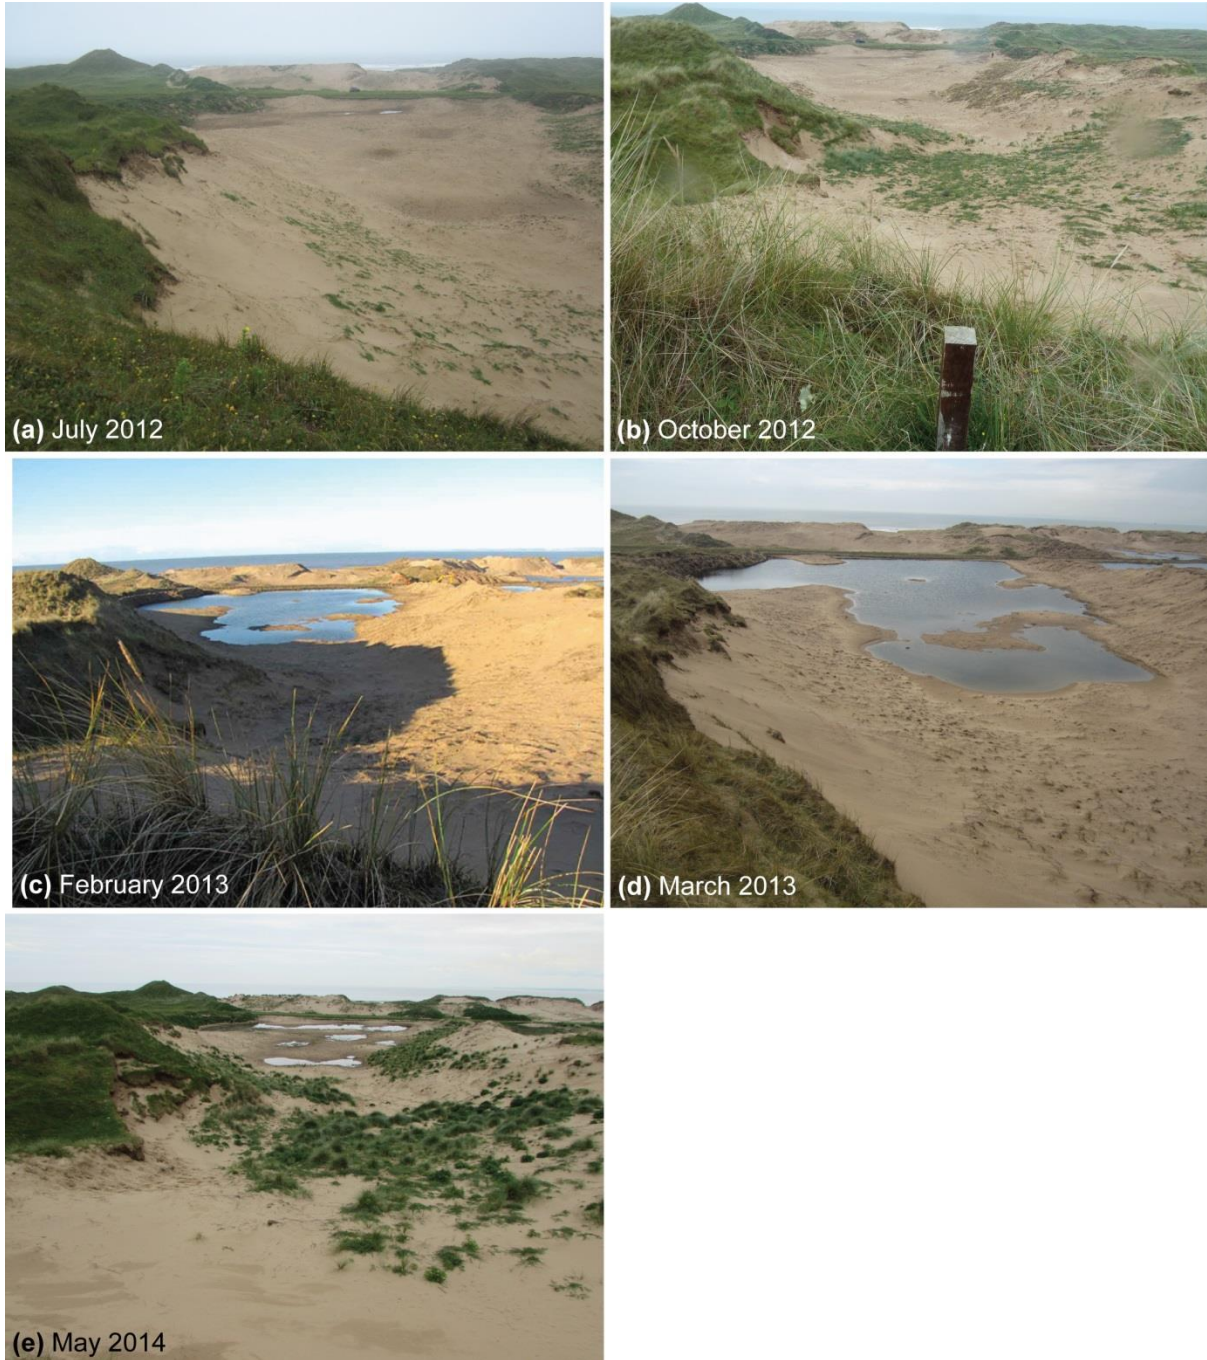
Photograph Comparison B. Taken from the crest of the inland parabolic dune looking westwards towards the sea: (a) 17 July 2012; (b) 9 October 2012; (c) February 2013; (d) 8 March 2013; (e) 27 May 2014.

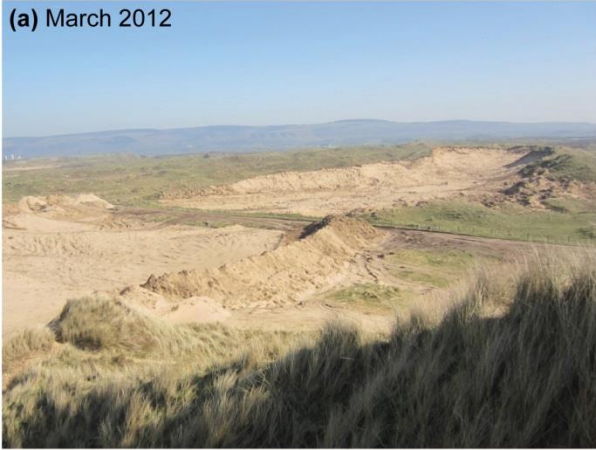
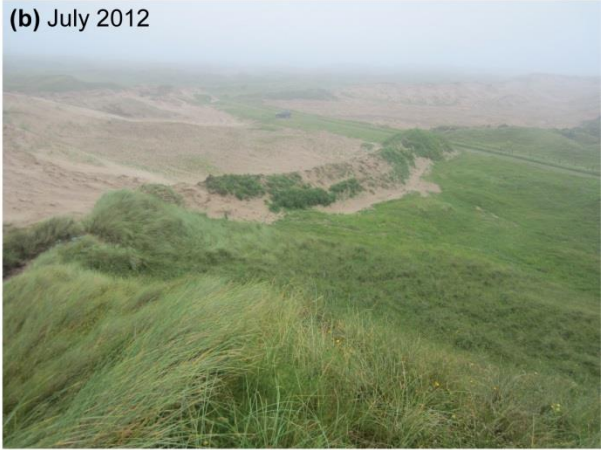
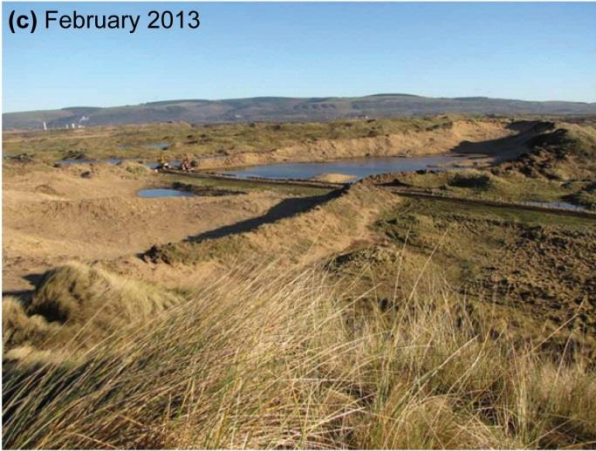
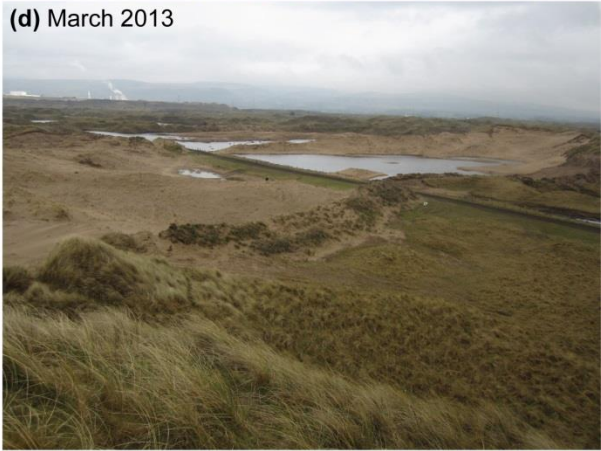
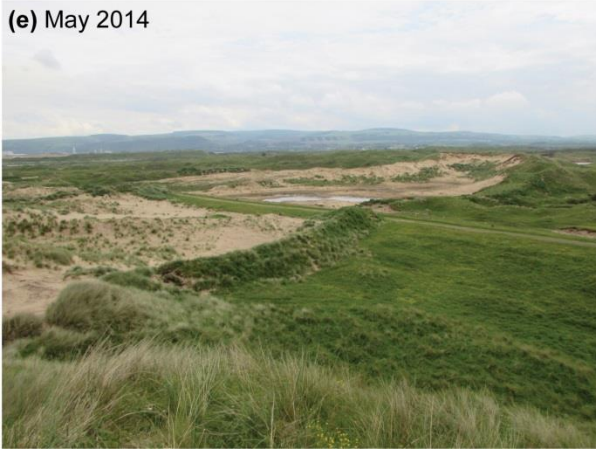
Photograph Comparison C. Taken from the crest of the summit of the high dune at the southern end of the site, looking north-west: (a) March 2012, shortly after the works were completed, supplied by David Carrington (Bridgend Council); (b) 17 July 2012; (c) February 2013; (d) 8 March 2013; (e) 27 May 2014.

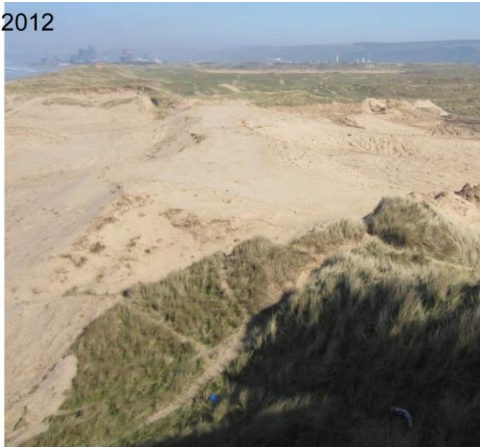
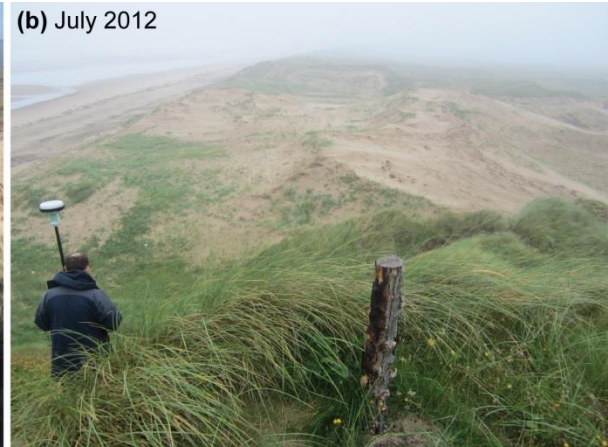
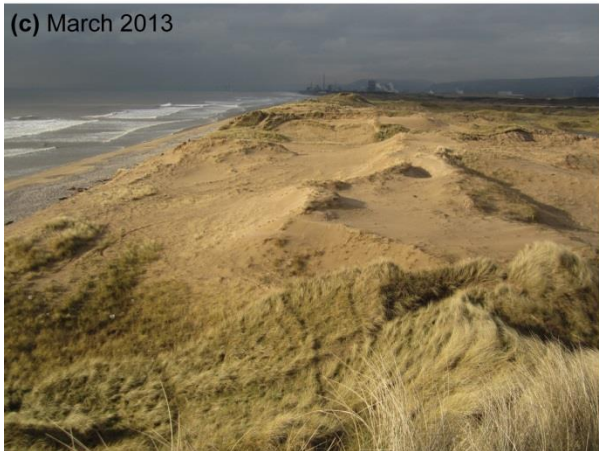
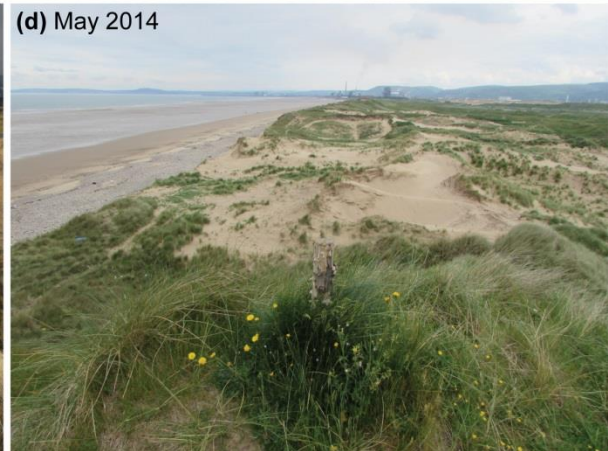
Photograph Comparison D. Taken from the crest of the summit of the high dune at the southern end of the site, looking north: (a) March 2012; (b) 17 July 2012; (c) 8 March 2013; (d) 27 May 2014.
