**PROSIECT LIFE+ CORSYDD MÔN A LLŶN  
ANGLESEY AND LLŶN FENS LIFE+ PROJECT  
LIFE 07 NAT UK 000948**

**RESTORATION OF A KEY GROUNDWATER SUPPLY  
PATHWAY AND RELATED HYDROLOGICAL RESTORATION  
WORK AT CORS BODEILIO NATIONAL NATURE RESERVE**

**Final Report of the Anglesey & Llyn Fens LIFE Project: Technical Report No. 2.**

<b>Version</b>	<b>1</b>
<b>Authors</b>	<b>Peter Jones, Justin Hanson, Rhoswen Leonard and Janine Guest</b>
<b>Date</b>	<b>23 December 2014</b>

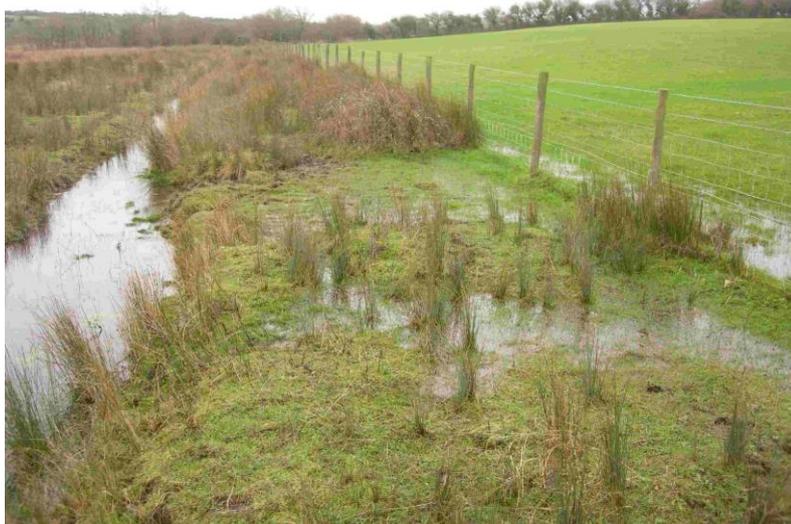
Particular attention was given to examination of ditch water levels and adjacent upslope ground levels along ditch section D-E-F (Figures 1 and 12, Table 4) based on the PM Surveys topographic survey. The survey results indicate a height difference of between 45 and 57 cm, with ditch water levels at point E lying 41 cm above the water level at point A. Given the relationship between peat surface and ditch water level elevations between point A and D, these observations rule out any possible nuisance flooding to neighbouring land resulting from water level changes at point A. As Figure 12 shows, surface ponding of water along the field boundary close to ditch E-F occurs already during very wet periods.

**Figure 12.** Boundary fence between ditch D-E and adjoining agricultural land to the west – looking S. Photo taken at peak winter time water levels after heavy rain caused surface runoff from the field into the fen. Photo taken January 2008. The T4 boundary ditch datum point is just out of sight to the L.

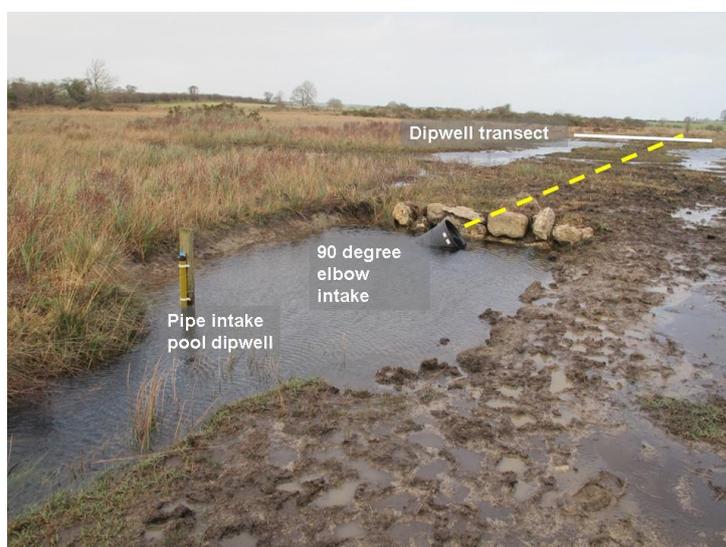
**Figure 15.** View looking NNE from point A down the alignment of the buried pipe (yellow dashed line). The adjustable U bend pipe intake is visible and also the dipwell located in the pipe intake pool. Photo taken 6 January 2014. Original image number IMG\_3859.

The 90 degree bend pipe intake was initially set to yield high but not quite bank-full levels in the upstream section of ditch (section A-D-E).

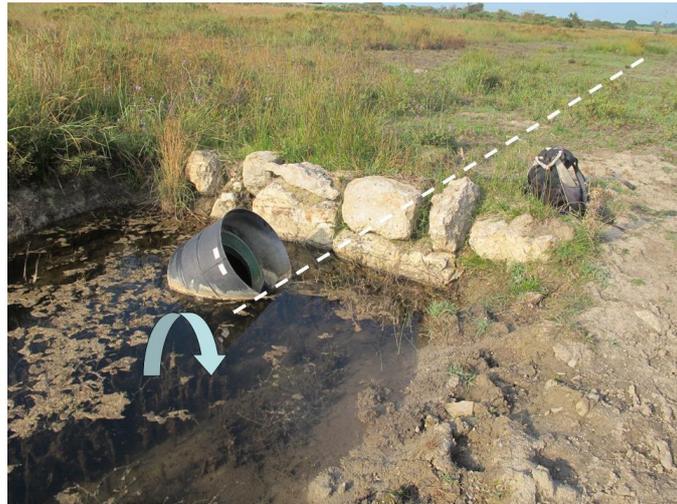
**Figure 16.** Close up of adjustable U bend inlet of bypass pipe; this also shows the approximate alignment of the buried pipe. Photo taken 22 December 2013, Original image number IMG\_7456.

The 90 degree elbow on the bypass pipe intake can be adjusted to raise or lower ditch water levels upstream (Figure 16). At the lowest (horizontal) setting of the elbow, the large diameter of the pipe should ensure free drainage at all times, with no sustained rise in ditch water levels upstream (other than perhaps temporary effects during very high rainfall) compared to the original ‘open ditch’ condition. However, as discussed above, the elbow has been angled to support higher water levels. The subsequent upstream ditch water level regime has been assessed against a series of pre-intervention manual stage measurements.

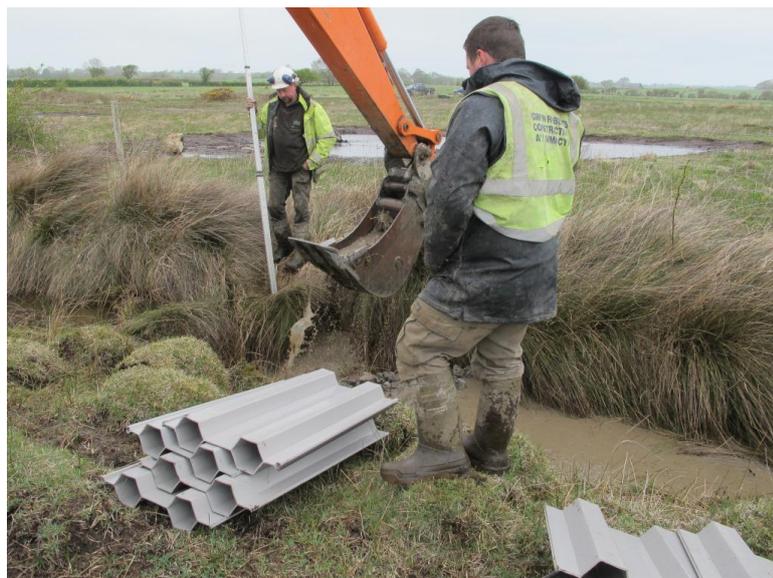
**Figure 17.** Installation of hexagonal section plastic dams in ditch section B-C, 10 May 2013. The machine bucket is removing sediment and water from a trench excavated ready to receive the lengths of piling. Note the dense *Schoenus nigricans* strip on the N side of the ditch bank and one of the two newly created peat cuttings in compartment CB1NE beyond. Original image IMG\_8178.

Complete infill and continuation of the bypass pipe into section B-C was considered but ultimately rejected for the following reasons, (i) it would have buried some dense patches of *Schoenus* (especially in the N bank of the ditch – see Figure 17), (ii) because of the lack of strong groundwater discharge either from the N or S, thus complete infill would not have yielded significant groundwater reconnection benefits, (iii) levelled profiles across the section had demonstrated that the areas which might benefit from any reconnection of groundwater seepage across the drain were topographically limited, and (iv) the need to retain open sections of ditch with flanking *Schoenus* tussocks for invertebrate interest. The option chosen for this section was to raise the ditch water level by installing plastic piling dams in pre-excavated trenches notched into each bank to prevent leakage, and cut deep enough to enable the dams to be set into the underlying clay-rich drift. The contractor elected to use 0.5 m wide interlocking hexagonal piling in 0.5 m wide sections which proved extremely robust and resistant to buckling.

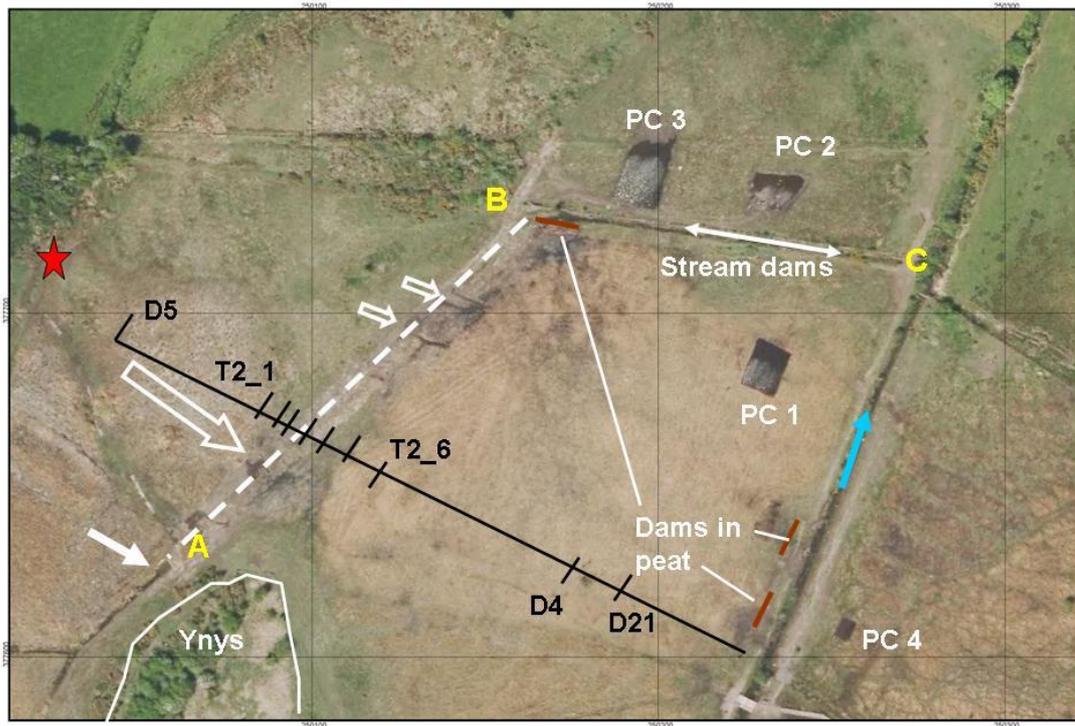
Three lengths of peat dams were installed in the peat body down-gradient of the restored groundwater pathway in site management compartment CB1E (Figure 18). Two c. 6 m lengths were installed adjacent to the main drain in areas where winter overflow of water was causing some erosion of peat into the drain, with down-cutting of some of the runnels into the peat body (Figure 19). The third 6.5 m length was installed E of the bypass pipe outflow at point B to help retain directed spring water on the site. The piling was installed using a combination of installation in cut trenches and also by being pushed in vertically using the excavator bucket.

**Figure 18.** Annotated 2013 aerial photograph of the area of fen (compartment CB1E) down-gradient of the restored groundwater flow pathway at Cors Bodeilio NNR. This image was taken following completion of the restoration work described in this report. It shows the four peat cuttings (PC 1-4) used to supply peat for infill of drain section A-B (dashed white line), the three sections of plastic piling dams within the peat body (brown lines – not to scale), the approximate alignment of the water level monitoring transect T2 and its extension in both directions to connect with wells D5, D4 and D21 of the hydrological monitoring network at Bodeilio, and the approximate position of the four plastic piling dams in stream section B-C. Black tick marks on the dipwell transect indicate the approximate position of wells. Fine black lines are 100 m grid lines of the BNG. Centre of image is at SH 5015.7765, with N to top of image. See also Figure 9.

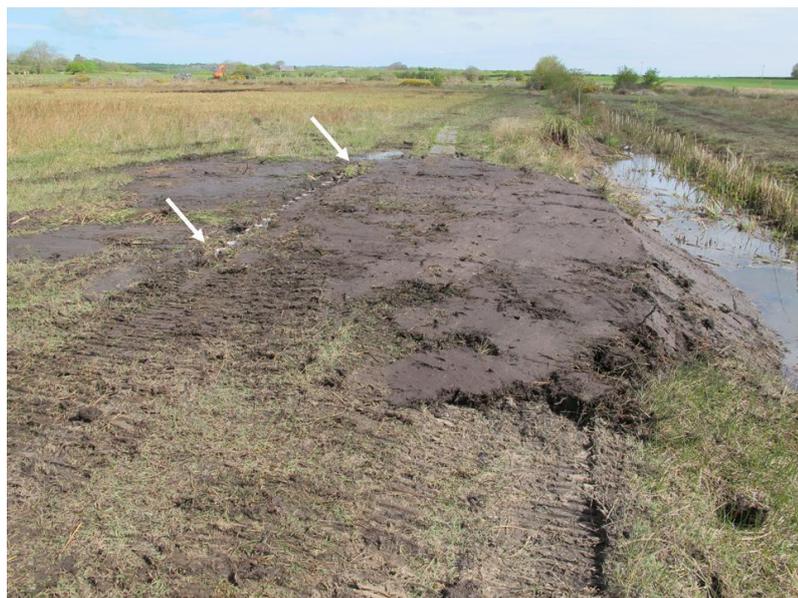
**Figure 19.** Location of one of the three plastic piling dams located at the edge of the peat body shown in Figure 18. The white arrows denote the start and end of the piling section. The image is looking NE with the main outflow drain on the R and with the direction of flow heading away from the observer. Photo taken 15 May 2013 shortly after installation – original image number IMG\_8331.

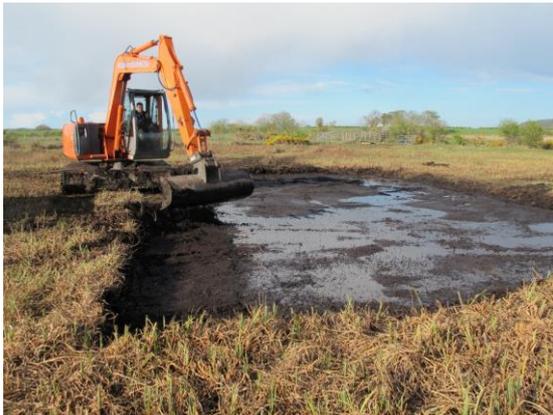
**Figure 20a.** Excavation of peat cutting #1 on 13 May 2013. Original image number IMG\_8278.

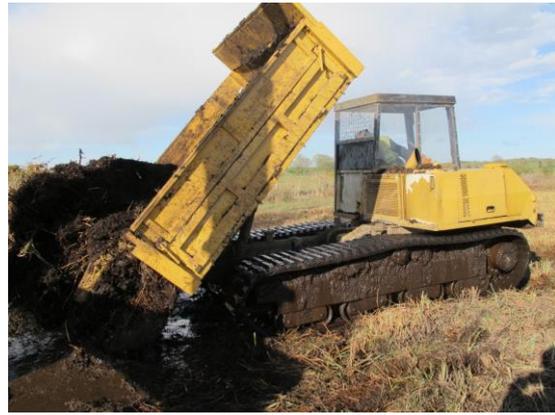
**Figure 20b.** Light-weight tracked dumper off-loading peat from peat cutting 1 at the outflow end of the bypass pipe, 13 May 2013.

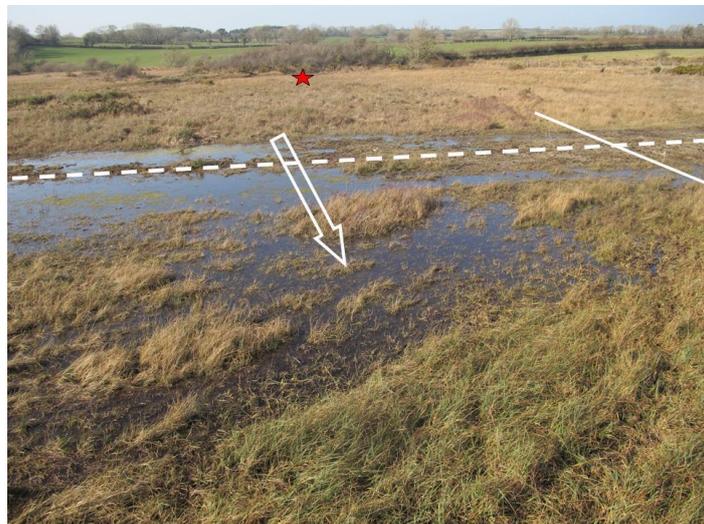
Infill of ditch section A-B has resulted in significantly wetter conditions along and down-gradient of the ditch during periods of discharge from fly orchid spring (Figure 21). These conditions extend to the outflow end of the drain (Figure 22), where one of the sheet-piled sections has aided retention of spring water at the edge of the peat body where it abuts the open section of the drain (section B-C).

**Figure 21.** 5 m high mast photograph looking NW of flooding down-gradient of fly orchid spring (red star) following infill of the ditch (former course shown as a dashed line): image 12/3/14. Flooding on this scale did not occur prior to the restoration work. The large white block arrow shows the approximate seepage gradient and surface flow in this direction is now common during periods of spring discharge. The white line shows the approximate alignment of transect T2.

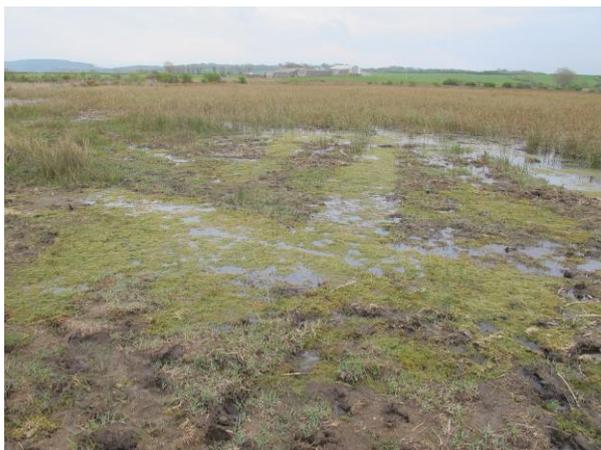
Extensive areas of open water along and adjacent to the ditch line have become colonised by stoneworts (Figures 23a and b), including the runnels cut across the slightly raised ditch infill to encourage water movement SE of fly orchid spring.

**Figure 23a.** Extensive stonewort patches up and down-gradient of the infilled ditch and also in runnels excavated to enable cross-flow and visible in this image as two broad lines heading away from the observer. 30 April 2014, original file number IMG\_5156.

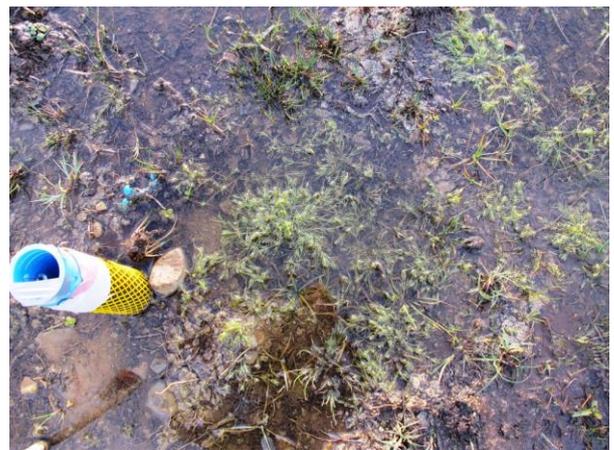
**Figure 23b.** *Chara* colonising shallow calcareous pools adjacent to dipwell T2\_3, 13 December 2013. Original file number IMG\_3526.

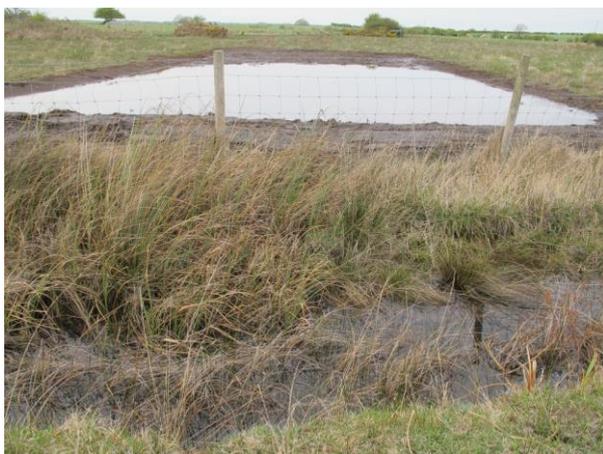
Ditch water levels upstream of the bypass pipe intake are now significantly higher, with almost bank-full conditions noted during the winter and after periods of rainfall (Figure 24). Ditch water levels have also been raised in ditch section B-C (Figure 25 a & b), though bank-full conditions could not have been achieved without immersion of the bypass pipe outlet.

**Figure 25a.** View N from the south side of ditch section B-C with peat cutting number 3 in compartment CB1NE visible on the N side of the ditch. Image date 14 May 2013, original file number IMG\_8309.

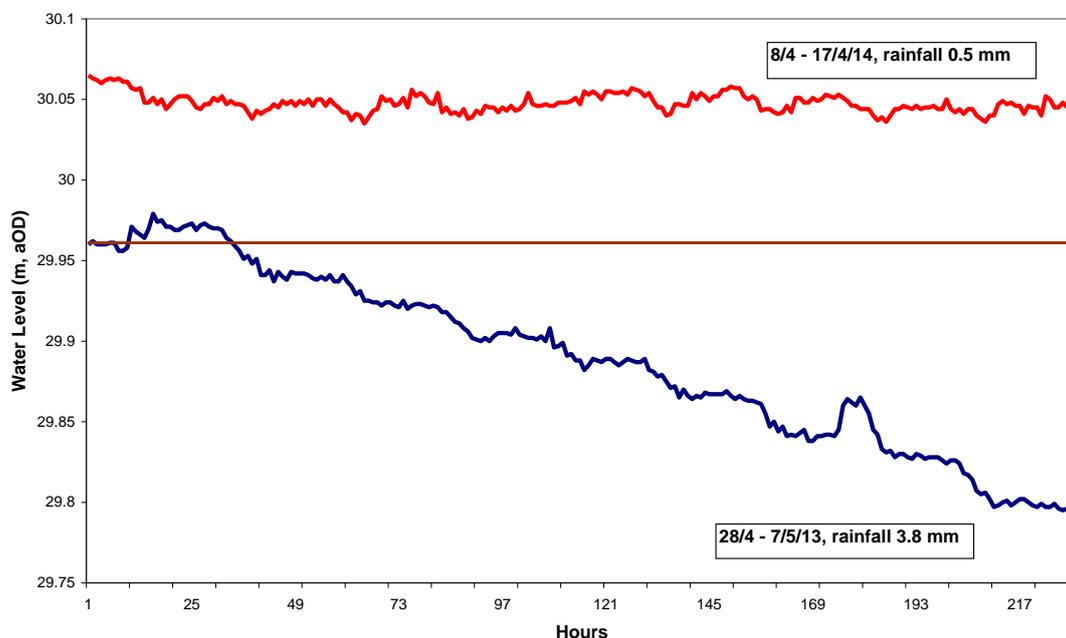
**Figure 26.** Comparison of water level trends down-gradient of ditch section A-B before (blue line) and after (red line) infill. These are hourly records of water level for dipwell T2-6 (see Figure 18 for location) over two broadly comparable ten day spring-time periods. Flow from fly orchid spring was occurring during both periods, with only minor rainfall recorded. The lower (blue) plot pre-dates infill of the ditch; the top (red) plot shows the situation after completion of the ditch by-pass work. The brown line shows ground level. Rainfall data sourced from <http://www.llansadwrn-wx.info/obs> copyright of Dr Donald Perkins; these data are for a station c. 7 km ESE of Bodeilio.

The 2013 (lower) plot shows a decaying water table level in the absence of rainfall and increasing evapo-transpiration, but the 2014 (upper) plot shows a higher water level with little evidence of decline in response to lack of rainfall. These data are for dipwell T2-6 (Figure 18) which lies c. 15 m from the ditch in an area of *Cladio-Molinietum* calcareous fen with patches of M13 as both mosaic elements and more discrete stands: it is reasonable to assume that the improved hydrological status at this location (i.e. higher and more stable water levels sourced from a calcareous spring) also applies more generally parallel to and down-gradient of the drain.

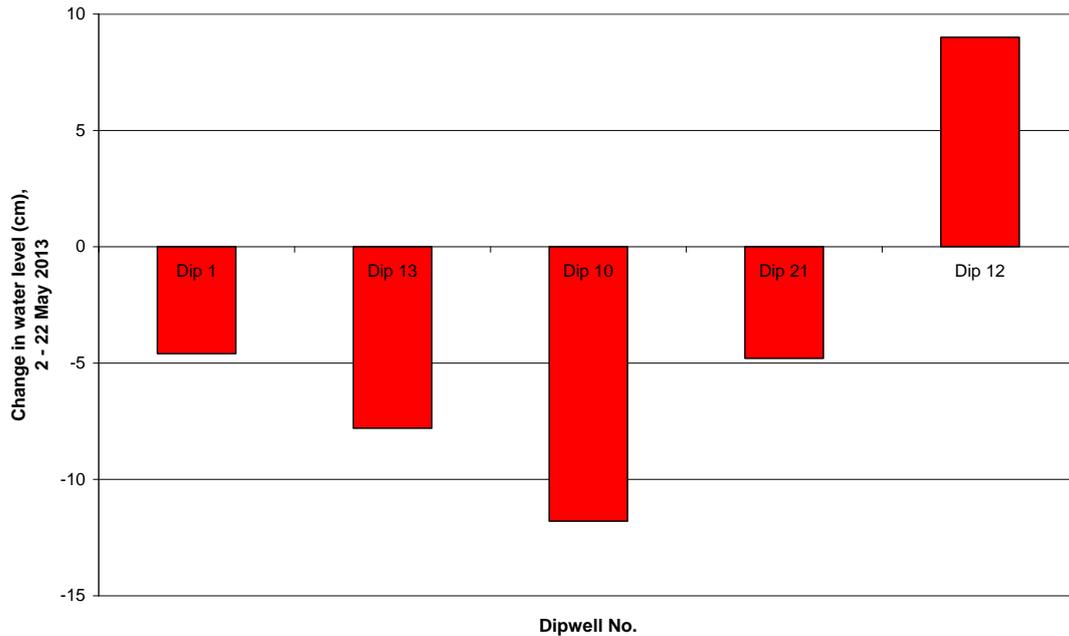
The immediate effect of infilling the ditch can be seen by comparing the water table response of dipwell T2-6 against changes in level for the same period at a selection of other Bodeilio wells for a period spanning infill of the ditch (Figure 27). The overall trend for the comparison wells was one of a decline in water table level. However, well T2-6 immediately down-gradient of the infilled ditch exhibited a rise which can be attributed to reconnection of the groundwater pathway from fly orchid spring.

**Figure 27.** Change in water level recorded at five dipwells at Cors Bodeilio between 2 and 22 May 2013 and thus spanning the groundwater reconnection works described here. Dipwell 12 is the same well as T2-6, dipwell 21 lies in the same peat body and down-gradient of well T2-6 (see Figure 18). Wells 13 and 10 are located in periods of periodic seepage influence; well 1 is in a rheo-topogenous context. The rainfall total for this period was 30.6 mm rainfall (data of Dr Donald Perkins for Llansadwrn).

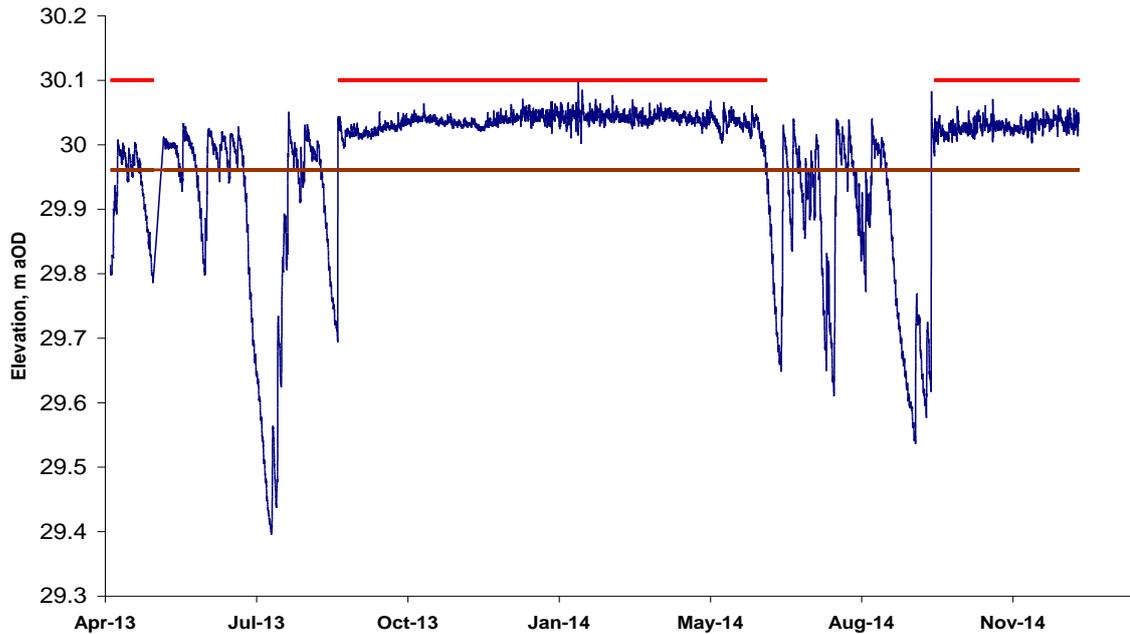
The longer term trend of water table behaviour following infill of the ditch is shown in Figure 28 which reveals that the main visible effect of ditch infill is tied to periods of flow from the spring-head, with significant drops in level occurring during periods when the spring is dry. The stable pattern of winter-time flooding resulting from the influence of fly orchid spring is striking and was not previously noted as a feature of this well prior to ditch infill (Figure 29), though unfortunately only a limited continuous water level record is available for the period before ditch infill.

**Figure 28.** Hourly record of water level fluctuations at well T2\_6 between April 2013 and January 2015. There is a hiatus in the record resulting from the removal of the logger on 9/5/13 and its replacement on 14/5/13 after infill of the ditch: the rise in levels between these periods probably relates to heavy rainfall in the intervening period. Periods when fly orchid spring was flowing are marked as a thin red line – the actual elevation of the spring is 30.92 m aOD but is plotted here at 30.1 m for ease of comparison with the other data: the brown line indicates the elevation of the peat surface. A significant rainfall event (26.5 mm) on 6/9/13 accounts for the last rapid rise in water levels in 2013 and renewed discharge from fly orchid spring: discharge from the latter across the now infilled ditch proves sufficient to maintain high levels until the following summer of 2014. The pattern for 2014 is similar, with a very significant rainfall event on 3/10/14 being followed by renewed flow from fly orchid spring and resumption of high and stable water levels for the rest of 2014.

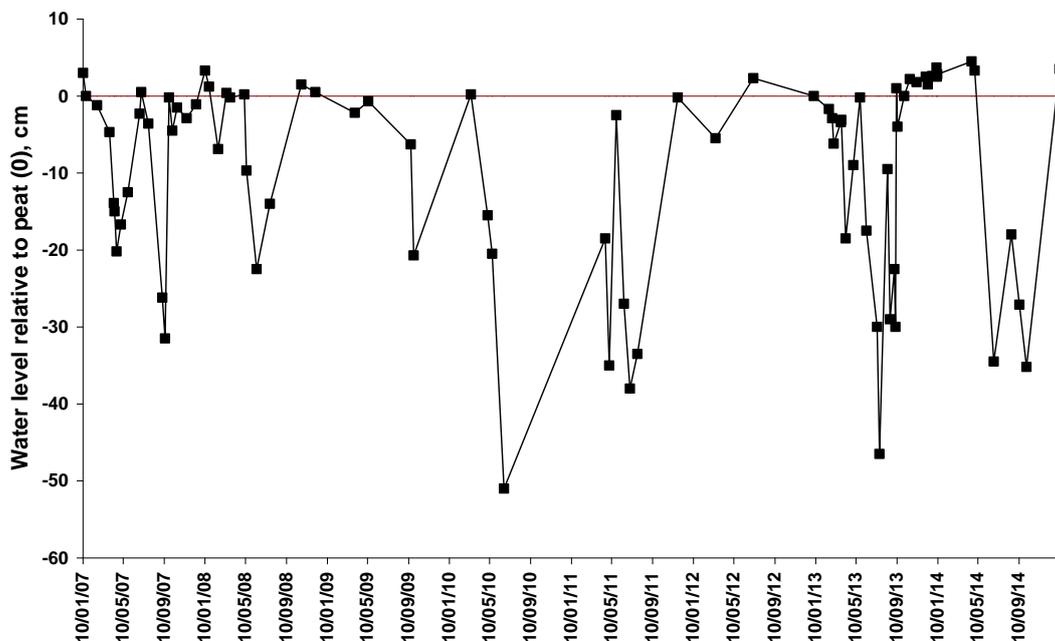
**Figure 29.** Manual dip record for dipwell T2-6.

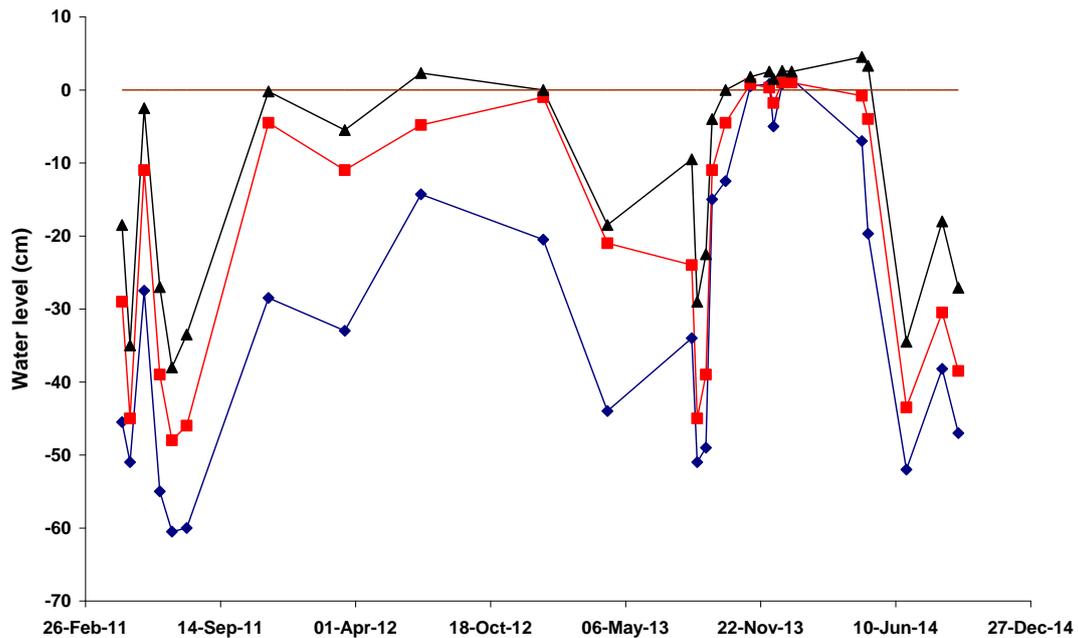
Other dipwells in transect T2 show a similar response to T2-6 (Figure 30), with a smaller difference in levels between wells since ditch infill, particularly for the down-gradient well closest to the ditch (T2-4).

**Figure 30.** Record of manual water level measurements in the three transect 2 dipwells located down-gradient of the infilled ditch, namely wells T2-4 (blue line, diamonds – closest to the ditch), T2-5 (red line, squares) and T2-6 (black line, triangles, furthest from the ditch). The peat surface at 0 cm is marked with a thin brown line. Records for well T2-6 have been edited to provide a date series comparable with wells T2-4 and T2-5.

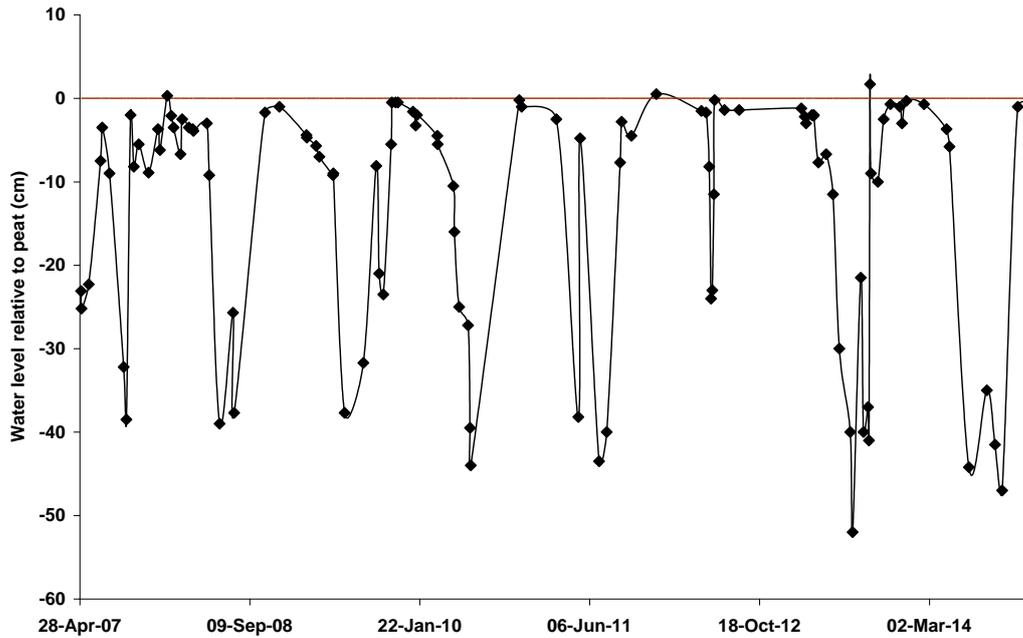
The influence of this project on water levels further away from the ditch is less clear (Figure 31). There is an indication of slightly wetter winter-time conditions, but little evidence of an effect on summer-time minima when fly orchid spring ceases to flow. However, the overall water table profile across the peat body down-gradient of the infilled ditch (Figure 32) does suggest there should be a wider hydrological influence resulting from this project, although the contour plot of ground elevations also shows a counter trend for drainage being focussed down-gradient of but along the line of the former ditch (Figure 10). This may be mitigated by the sheet piling installed at the end of the bypass pipe (Figure 22), particularly if this is extended to the east alongside drain section B-C.

**Figure 31.** Record of manual water level measurements for dipwell 21 (see Figure 18 for location), c. 100 m from ditch section A-B. The lowest water level was recorded during the summer of 2013 – this yielded record lows at other wells remote from the influence of fly orchid spring. The peat surface at 0 cm is marked with a thin brown line.

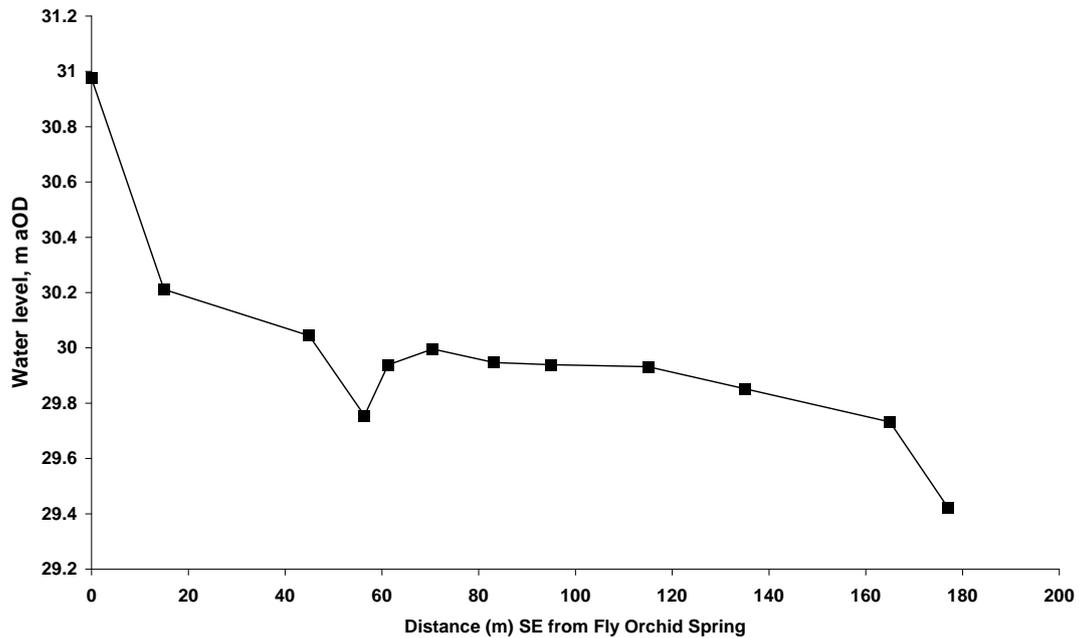
**Figure 32.** Water table profile between fly orchid spring and the main drain bridge, 6 December 2012.

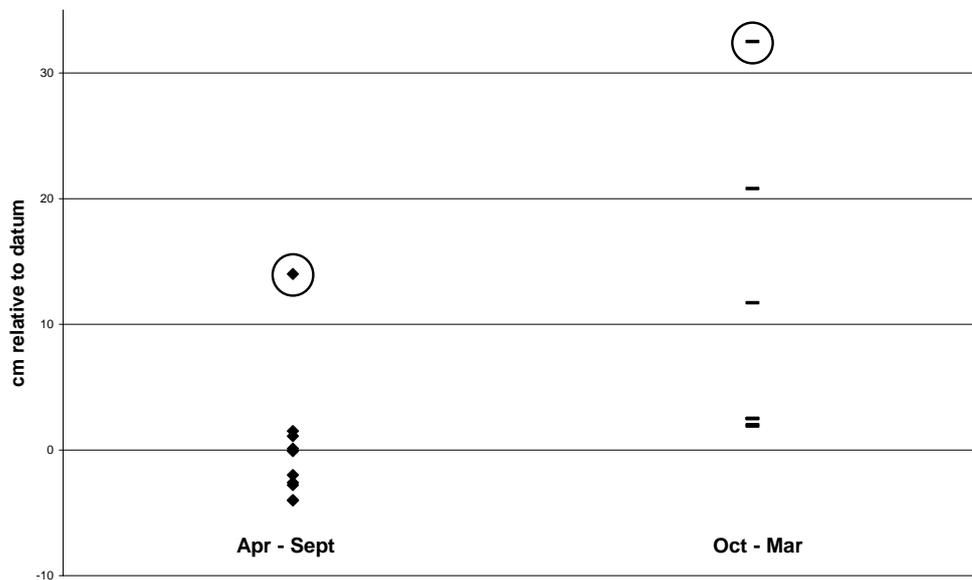
Further manual measurements of ditch water level are available for station C6 of Jones (in-prep.) and LIFE project transect T1 (Table 8, see also Figure 33 for C6 only). Both datasets show historic average levels 0.3 m lower than the water level measurement of 16/1/14, with the latter also exceeding the maximum recorded ditch stage height prior to restoration. The summertime measurements of 26/6/14 are significantly higher than the pre-restoration mean levels for all three stations.

**Figure 33.** Comparison of pre and post restoration (encircled) measurements of ditch water level at station C6 on ditch section A(x) – D split into 6 month periods. See Figure 37 for location. Both post-restoration measurements (for 16/1/14 and 26/6/14) lie significantly above the respective pre-restoration maxima.

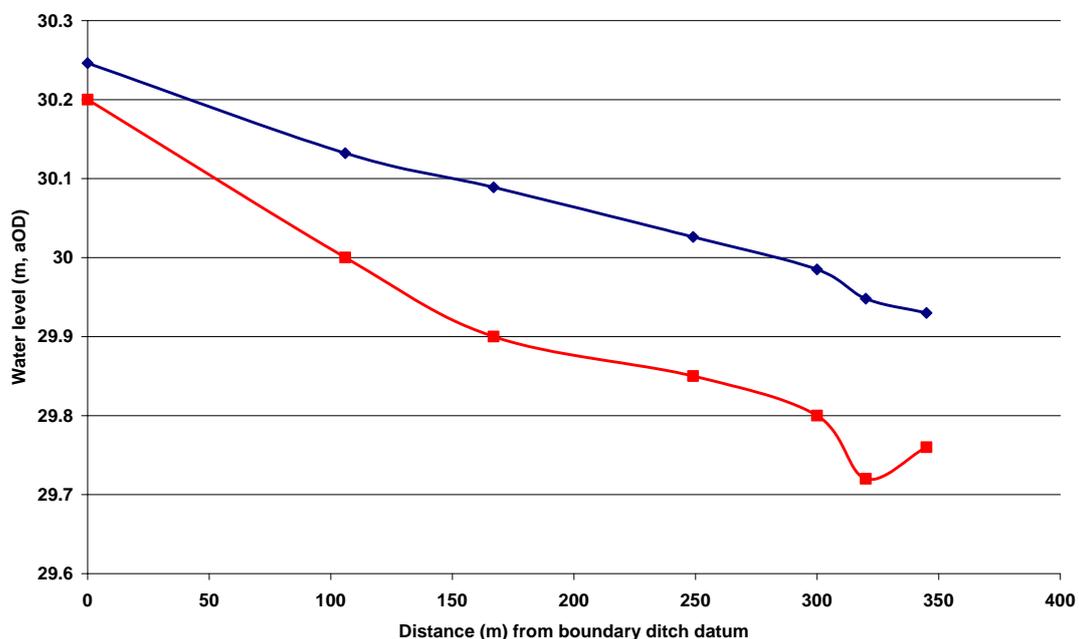
Further comparison of pre versus post restoration ditch water levels for the CB1 system is shown in Figure 34 for the seven locations mapped on Figure 37 downstream from the boundary ditch with Bodeilio Farm. All points show a significant rise in ditch water level since the PM Surveys topographic survey of February 2012, with the difference decreasing with progression upslope towards the western site boundary. Water levels on the 16<sup>th</sup>. January were close to bank full (Figure 34), with very subdued water table gradients into the adjacent fen (see below) and some evidence of recent limited over-banking judging from *Cladium* litter strandlines within a few metres of the ditch. The very significant increase in storage provided by over-banking at an approximate elevation of 30 m<sup>7</sup> should prevent any significant further rise in levels in the boundary ditch (Figure 12 and 37 and shown at 0 m in Figure 34) just east of the boundary with Bodeilio Farm land. Furthermore, ground level adjacent to the boundary ditch lies at about 30.4 m aOD, some 0.2 m lower than the boundary fence (PM Surveys drawing PMS-12006, 8 February 2012), thus further ruling out any additional risk of nuisance flooding resulting from this work.

**Figure 34.** Comparison of estimates of ditch water level elevation for 7 stations running from (and including) the Bodeilio Farm boundary ditch pin datum (left, at 0 m) to Fly Orchid Spring bypass pipe inlet pool (right) based on the PM Surveys (red) assessment of February 2012 and the levelling survey of 16 January 2014 (blue). The apparent dip and then rise in levels in the PM Surveys record may be a measurement error or a local reversal of gradients due to impeded flow resulting from vegetation infill of the ditch. See Figure 37 for locations.

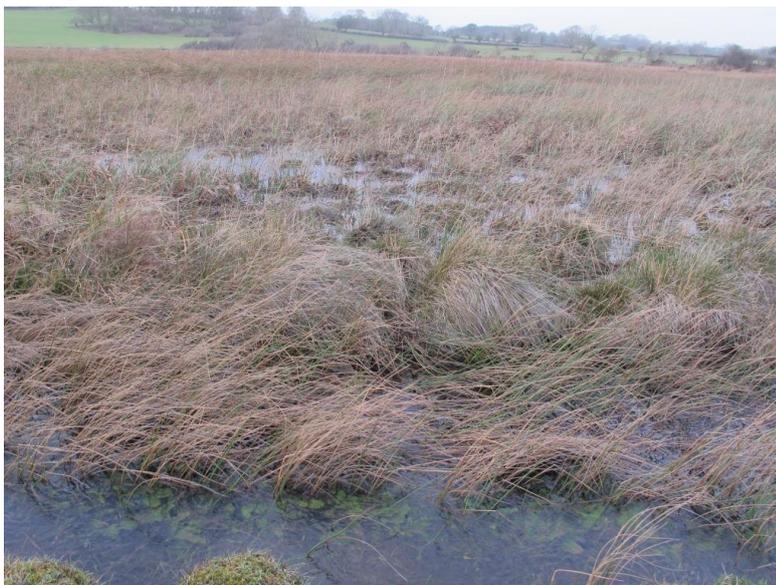
Comparison of water levels in the ditch system upstream of the bypass pipe and adjacent fen water table levels indicates the expected close coupling between the two. These levels compare with adjacent fen ground levels immediately to the NW of the bypass pipe intake of around 30 m aOD (PM Surveys drawing 12006, 8 Feb. 2012), thus indicating shallower water level gradients towards the drain post restoration. This was confirmed by a spot levelling comparison on 16 January 2014 which showed a ditch water level elevation of 29.948 m 25 m NW of the 90 degree pipe pool compared against a water table elevation for the adjacent stand of M13 of 30.117 (see Figure34). Further details of water level gradients at transect 1 are provided in Annex 6.

**Figure 34.** Photo looking NW from point indicated on Figure 37 for original photo number IMG\_3861. Image shows high ditch water levels in foreground immediately upstream of the bypass pipe intake and correspondingly high levels in the adjacent stand of M13 in the middle distance. Photo taken 6 January 2014. Surface runoff to the drain from the adjacent M13 was evident in January 2014.

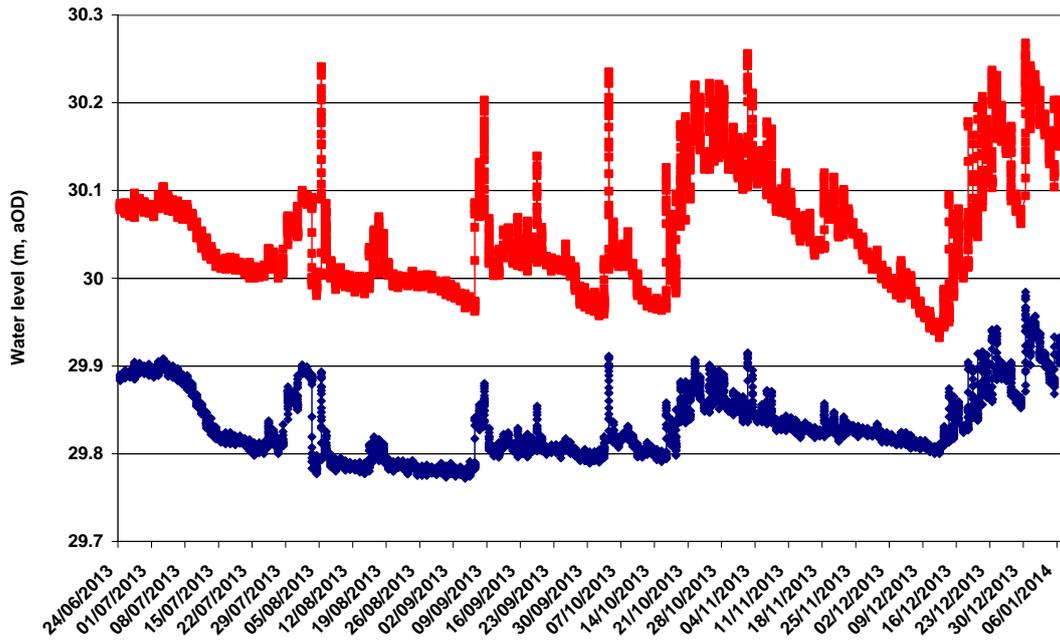
Comparison of the two water level records shows (not surprisingly) that the same key rainfall and dry weather events are recorded (Figure 35a & b), but that the confluence station generally shows more significant changes in relation to rainfall, with some evidence of a greater drop in level during dry weather (Table 9). The former observation is more easily observed in an extract of the hourly water level plot for a specific significant rainfall event (Figure 38a & b) and is probably the result of vegetation in the ditch section downstream of this station inhibiting the dissipation of rapid increases in water level, particularly when compared with the more readily drained bypass pipe inlet station which is adjacent to the orifice of the 90 degree pipe elbow. Rapid but short duration increases in level of 25+ cm have been recorded at the confluence station and these can approach the elevation of the boundary drain at the western edge of the compartment, though as already mentioned above overbanking between the confluence and bypass pipe intake pool would ultimately place a limit on how high water levels might rise in response to rainfall.

Water level recession in periods of dry weather is subdued, especially for the bypass pipe intake well. This is likely to reflect the slow release of water from the wetland into the drainage network as a result of low surface gradients, the significant vegetation and litter cover and the expected relatively low hydraulic conductivity of the peat. It may also reflect the influence of sustained groundwater discharge into the western fen counteracting the influence of drainage to a degree. Bodeilio Farm Pond is thought to be an important source of groundwater in this part of the site (SWS, 2010), but there is also evidence of a groundwater upwelling in the western part of CB1 at the western end of LIFE transect T4 (see Annex 7). Relatively open patches of M13 alkaline fen has been recorded amongst closed *Cladio-Molinietum* in this area: these may also be indicative of relatively stronger groundwater influence. More significant water level recessions in dry weather might be expected for the confluence well given the slightly larger catchment of the bypass pipe intake pool well.

**Figure 35a.** Hourly plot of ditch water level elevation (m aOD) for the confluence (red) and bypass pipe inlet pool (blue) stations for the period 24 June 2013 to 6 January 2014. See Figure 37 for well locations and Table 3 for installation details.

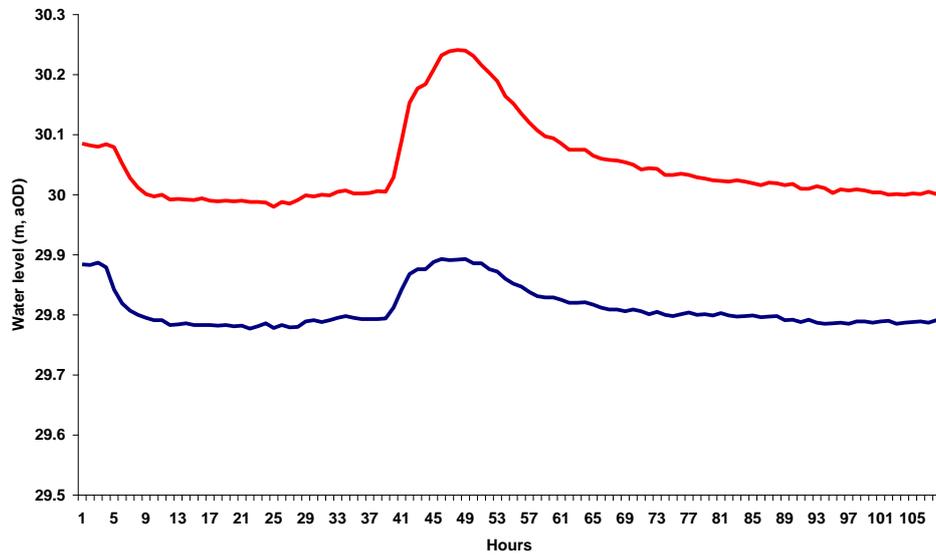
**Figure 38a.** Hourly plot of ditch water level elevation (m aOD) for the confluence (red) and bypass pipe inlet pool (blue) stations for the period 3/8/12 12:00 hrs to 7/8/13 23:00 hours.

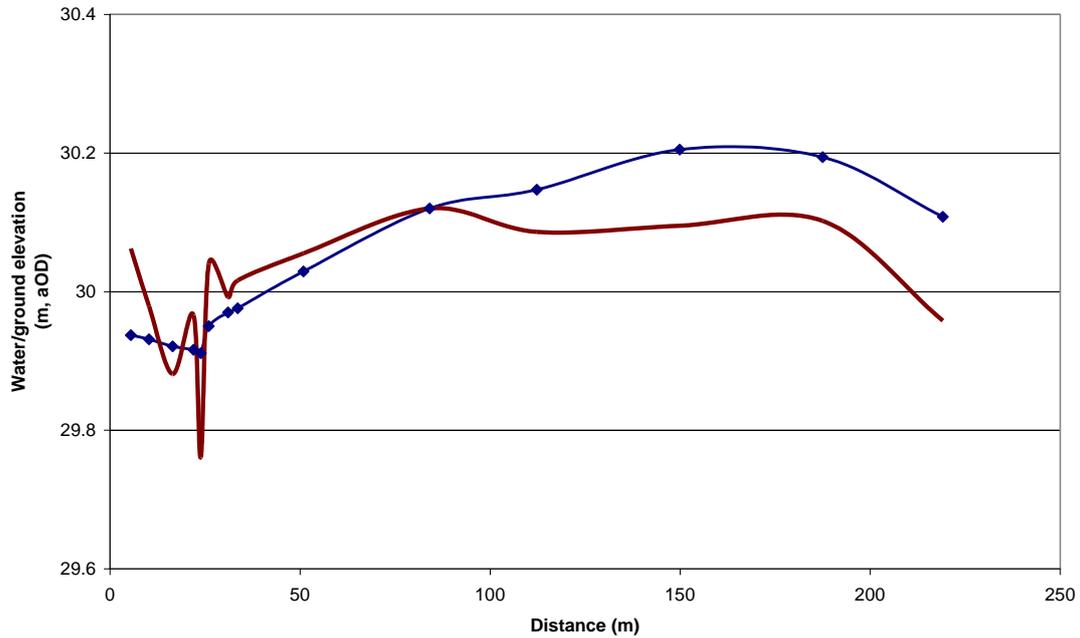
The water table profile is domed and strongly asymmetric, with the highest point recorded from dipwell 18 of Jones *et al.* (in-prep.) at 150 m (Figure A.7.2). This is a stand of M13 in which the *Cladium* cover has been managed by hand-strimming initiated by Mr Les Colley, the former Site Manager, and then continued and extended as part of the LIFE project. It may be that the occurrence of the groundwater high is indicative of groundwater discharge – the presence of M13 would be consistent with this. The Ynys margin seepage face (left-hand side of the plot) shows sub-surface water levels initially and then some ponding before the ditch line. The relative dryness of the upper part of the seepage face may be natural. Water levels are again subsurface immediately to the WNW of the drain, but much wetter conditions occurs to the W.

Complete infill of the ditch west of the Ynys was considered at an early stage of the LIFE project but the levelling exercise reported here indicates that very limited hydrological benefits would arise. The base of the Ynys seepage face supports some very species-rich patches of M13 and these may benefit from the function of the ditch in maintaining a seepage gradient. However, the limited rise in level of the

ditch attributed to the current setting of the bypass pipe intake is likely to be beneficial, especially in high summer.

**Figure A.7.2.** LIFE transect T4 water level elevation (blue) and peat surface (brown) plot for 25 March 2011: all heights are m aOD. The plot runs from ESE to WNW and is thus a plot of water level and peat surface profile as if seen from the north (cf. Figure A.7.1). The ditch below the Ynys is the 5<sup>th</sup>. point from the left. Several of the long-term monitoring dipwells of Jones *et al.* (in-prep.) occur along this transect, namely dipwell 8 at 5.5 m, dipwell 7 at 84.1 m and dipwell 18 at 149.9 m. Datum pins occur in the ditch just WNW of the Ynys at 23.9 m and in the ditch at the western edge of the compartment in the boundary drain (219.1 m)
